**MOUNT POLLEY MINING CORPORATION
MOUNT POLLEY PROJECT
TAILINGS STORAGE FACILITY**

**OPERATION, MAINTENANCE
AND SURVEILLANCE MANUAL
FOR STAGE 1b EMBANKMENT (El. 934m)
(REF. NO. 10162/7-3)**

NOVEMBER 24, 1997

Knight Piésold
CONSULTING ENGINEERS

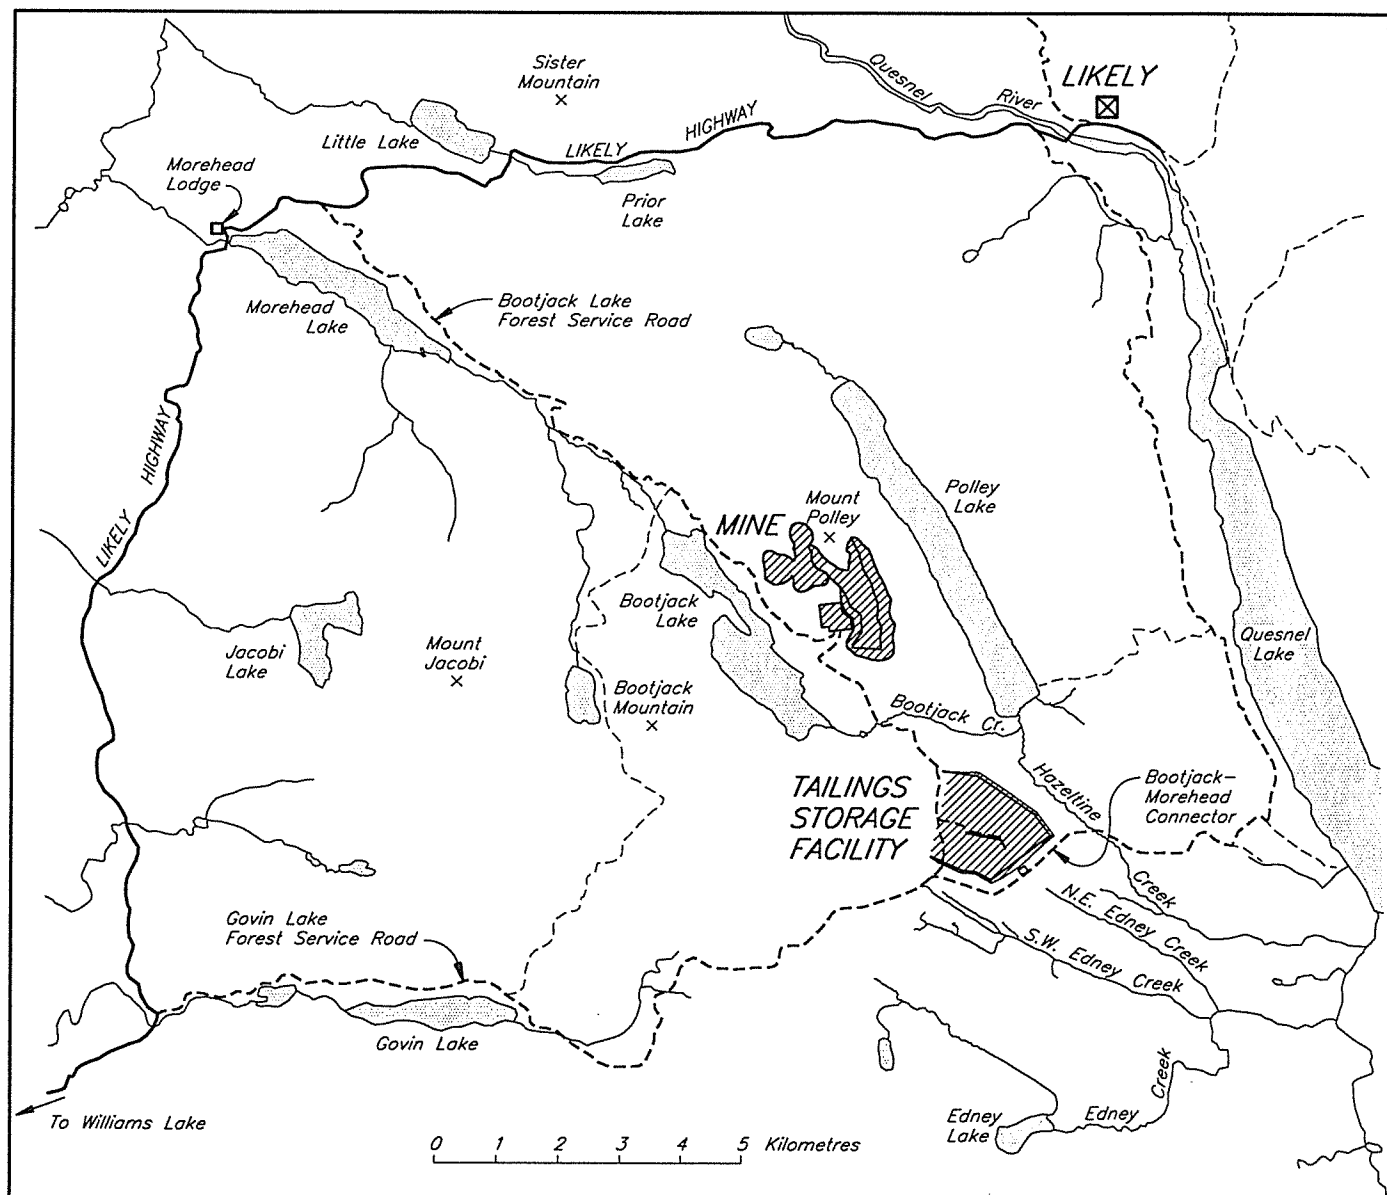
FIGURE 1.1

MOUNT POLLEY MINING CORPORATION
MOUNT POLLEY PROJECT
PROJECT LOCATION AND ACCESS PLAN

The Mount Polley Mine is located in central British Columbia, approximately 60 km northeast of Williams Lake. The main access route is via the paved highway to Likely. The turn to the Mine is located approximately 1.5 km east of Morehead Lake. The Mine is located a further 11 km to the southeast, on the Bootjack Lake Forest Service Road. The location of the Mine and access roads are shown on Figure 1.1.

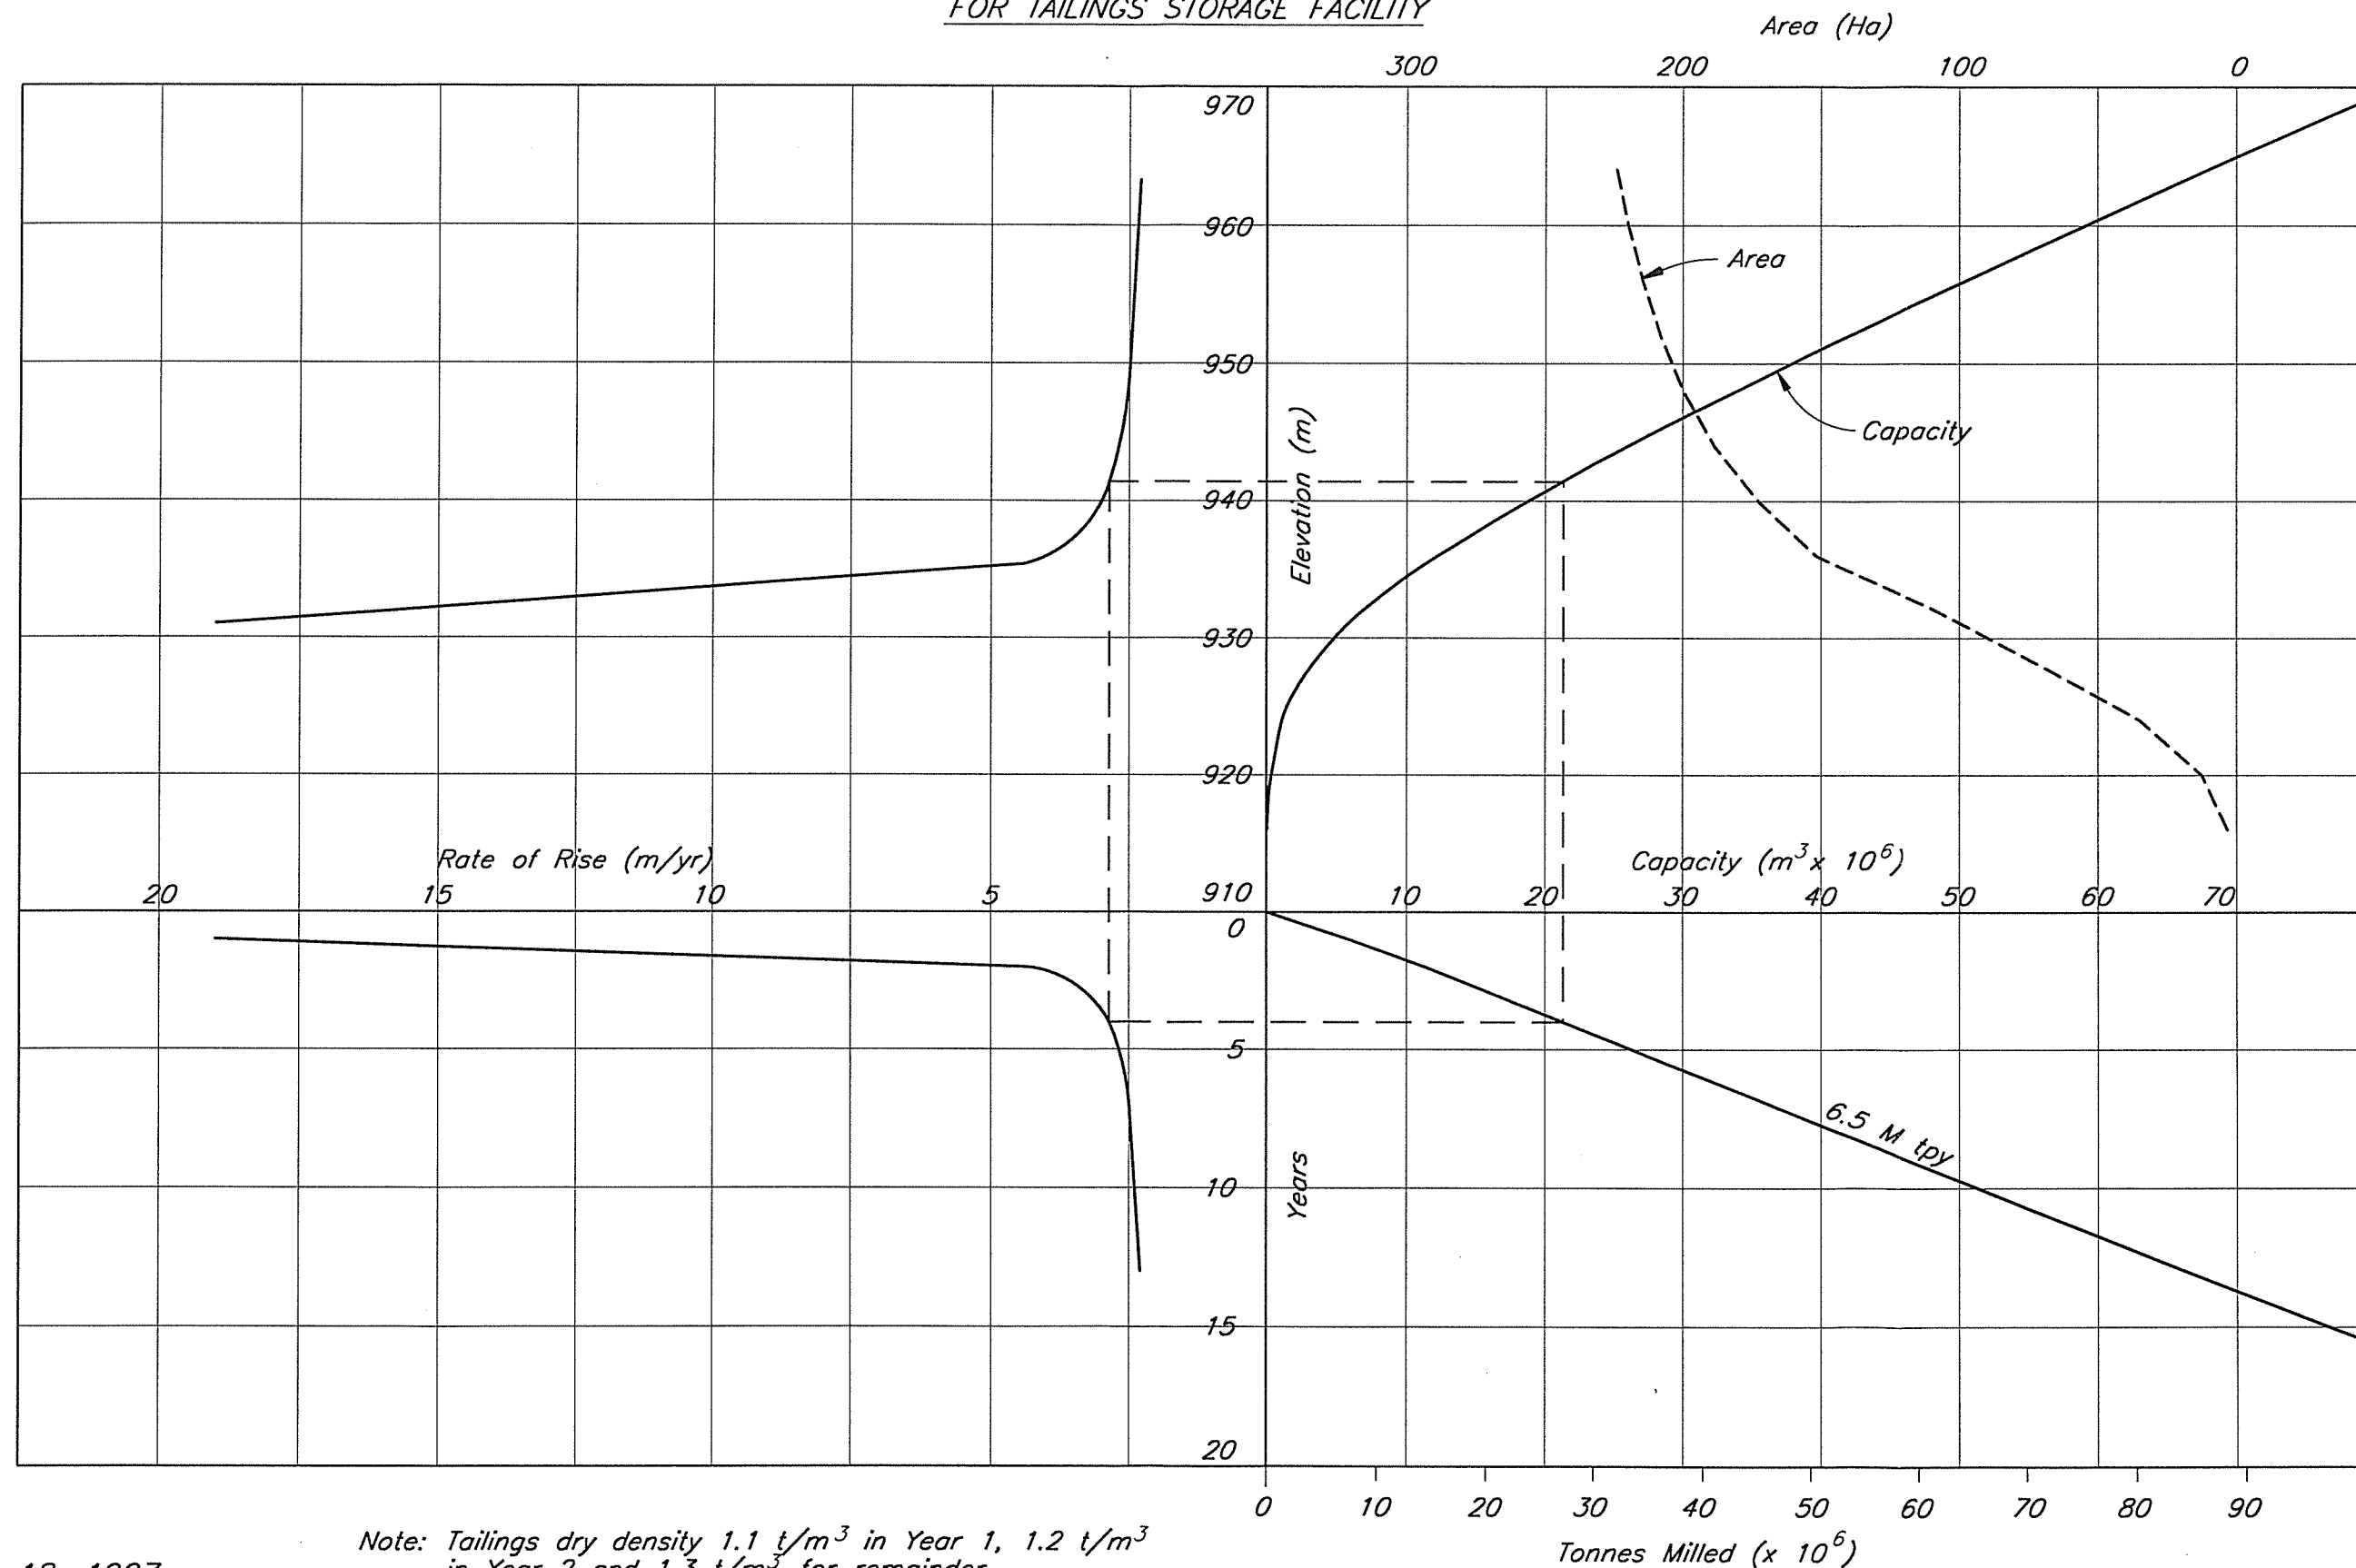
MOUNT POLLEY MINING CORPORATION
MOUNT POLLEY PROJECT
DEPTH/AREA/CAPACITY/FILLING RATE
FOR TAILINGS STORAGE FACILITY

Note: Tailings dry density 1.1 t/m³ in Year 1, 1.2 t/m³ in Year 2 and 1.3 t/m³ for remainder.

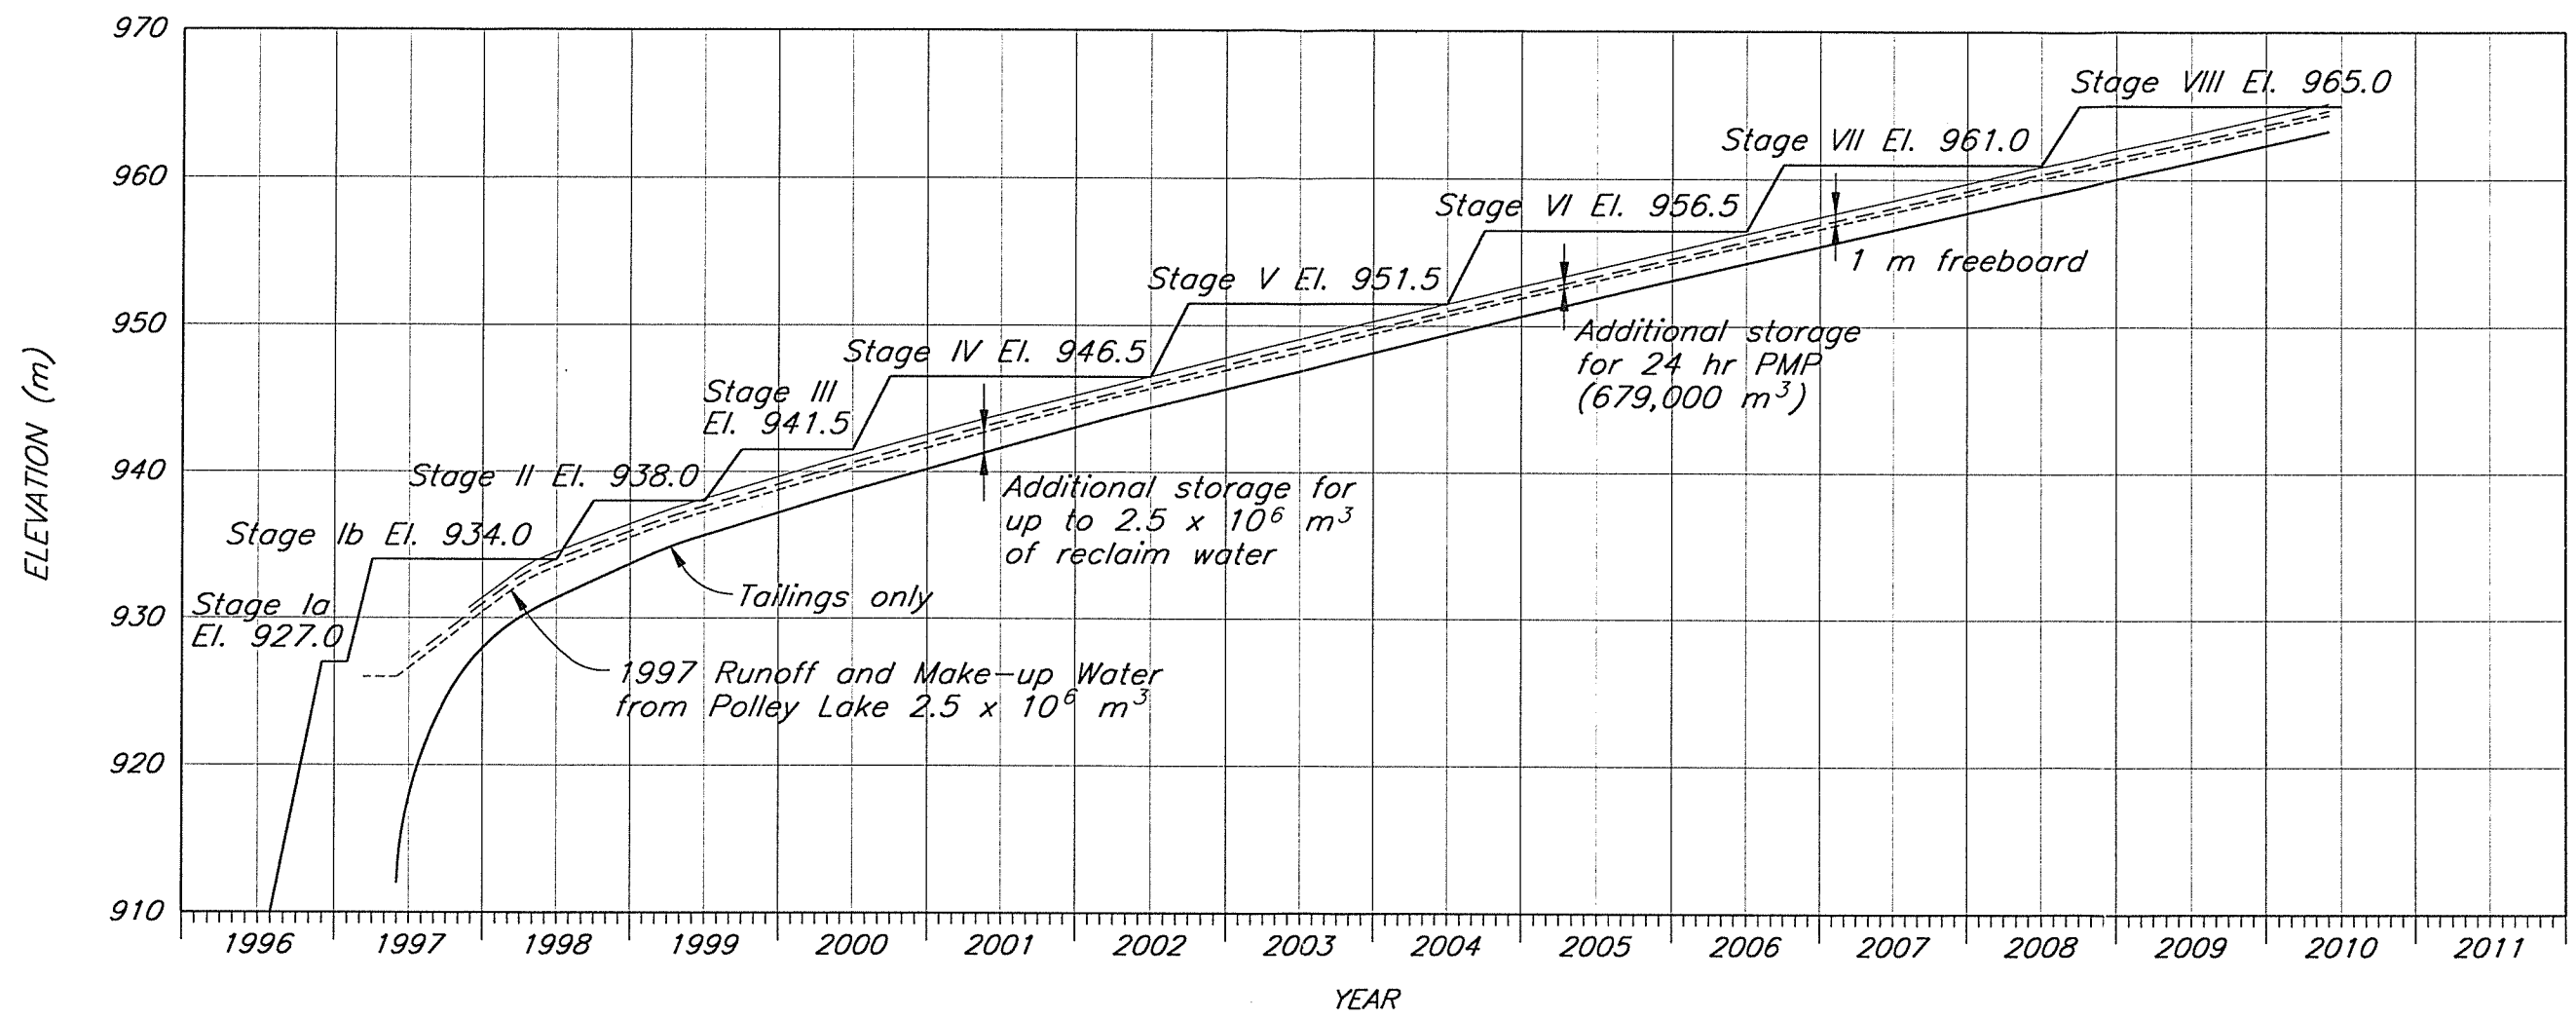
MOUNT POLLEY MINING CORPORATION
MOUNT POLLEY PROJECT
TAILINGS AREA FILLING SCHEDULE AND STAGED CONSTRUCTION
FOR 6,500,000 tpy THROUGHPUT

1. All construction periods shown are for July through September, except Stage Ib, which is February through March.
2. Filling schedule based on tailings dry density of 1.1 t/m³ in Year 1, 1.2 t/m³ in Year 2 and 1.3 t/m³ for remainder.
3. Embankment crest elevations for each of the staged expansions will be determined annually based on tailings production, in-situ density and water management requirements.

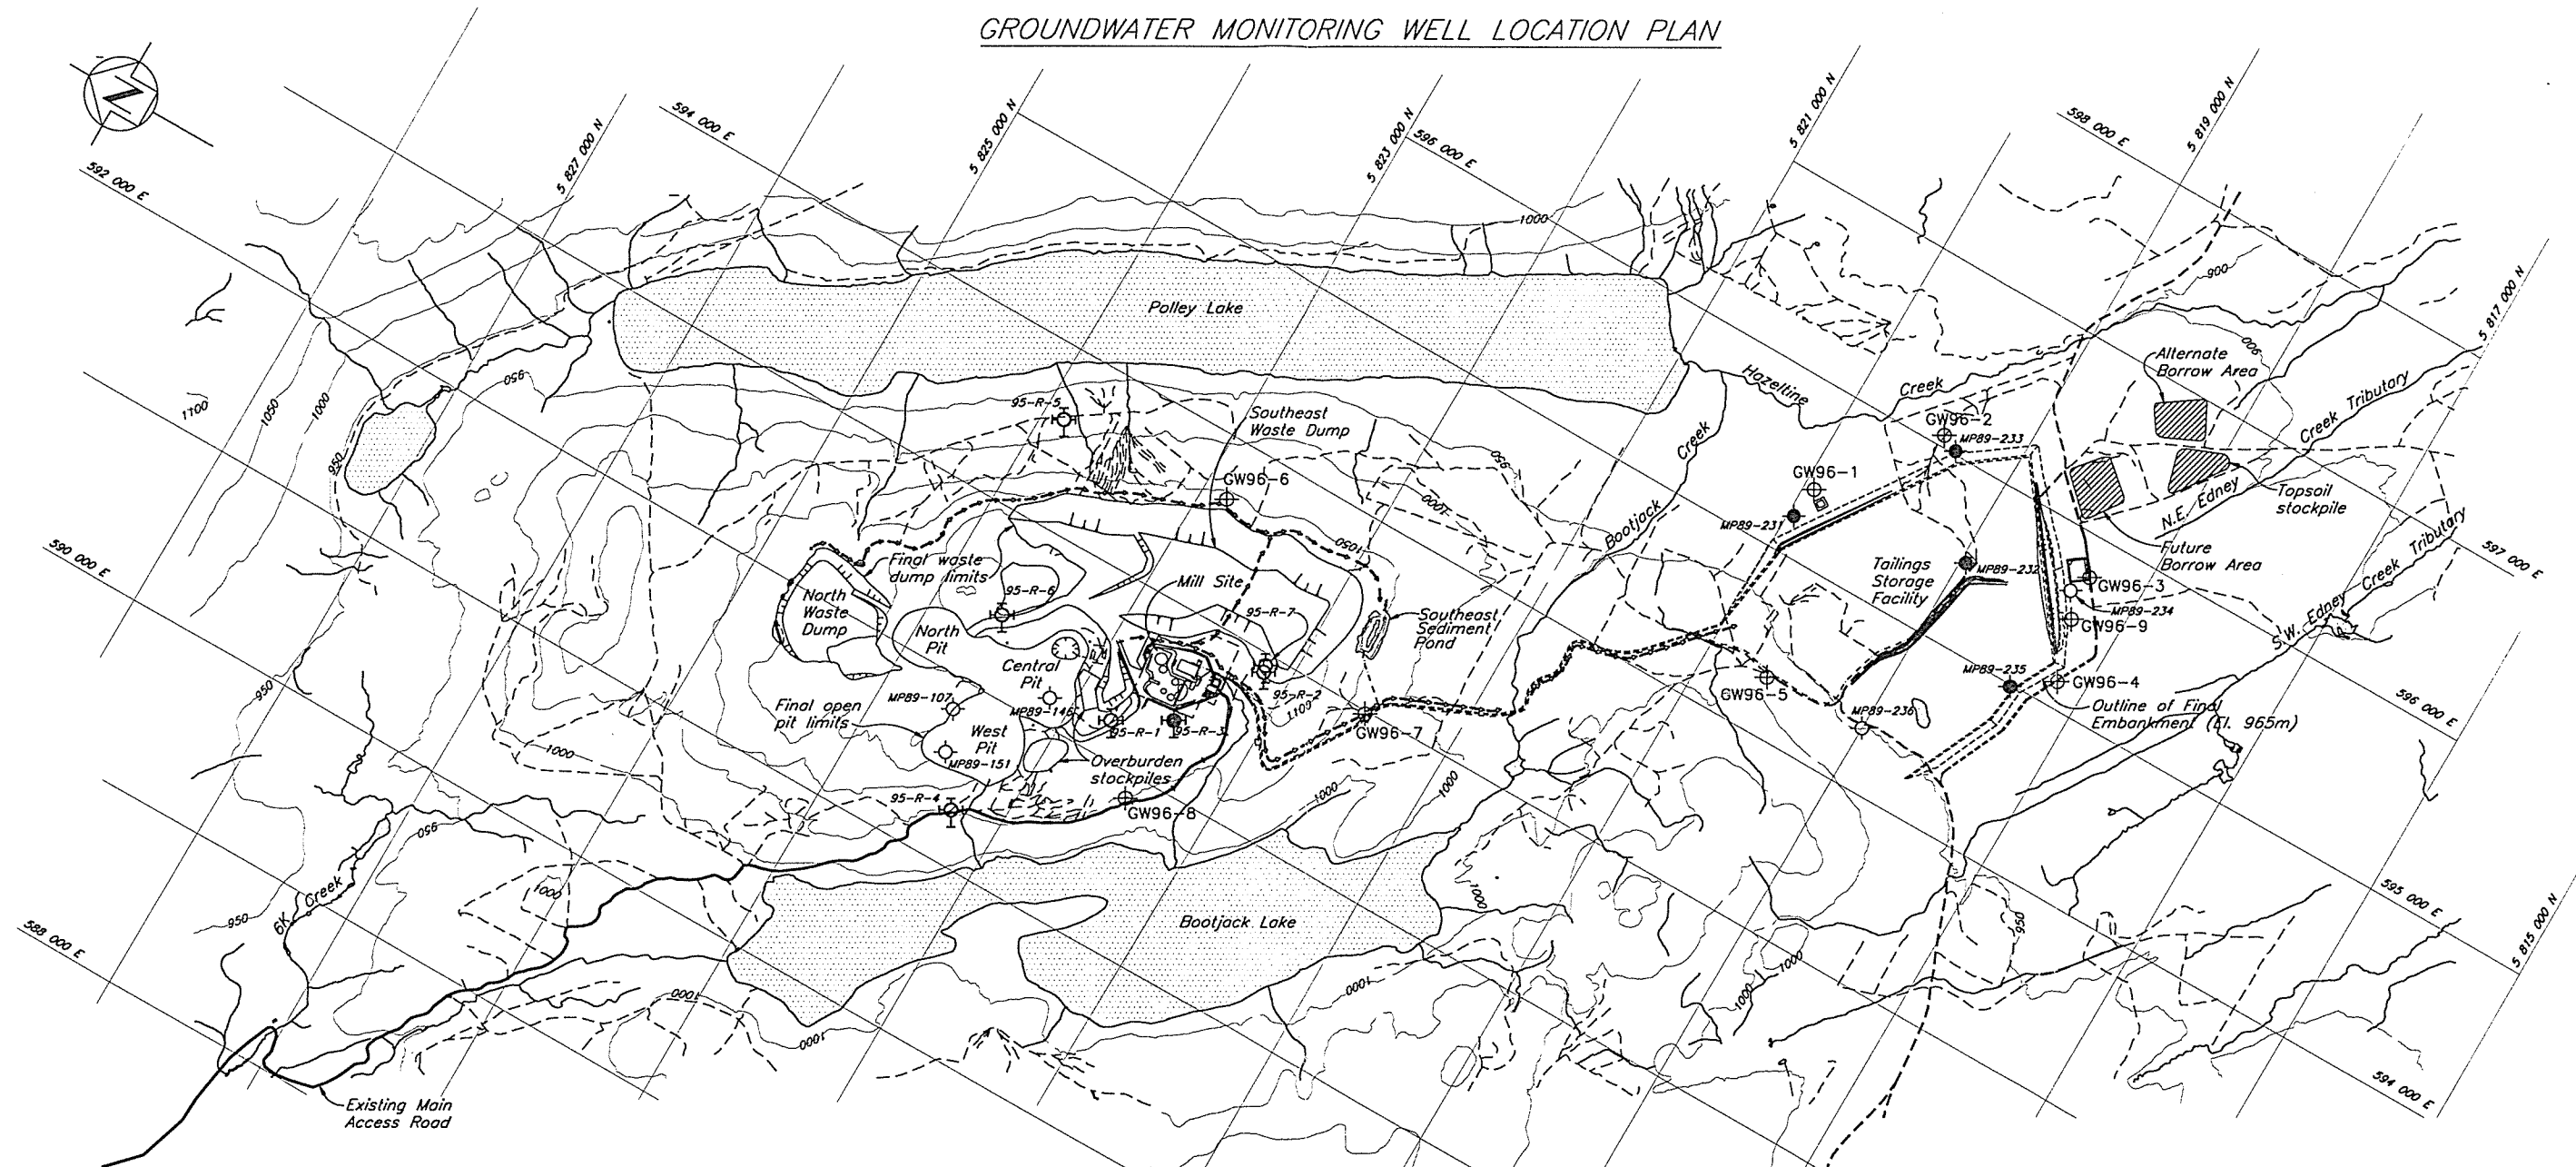
MOUNT POLLEY MINING CORPORATION
MOUNT POLLEY PROJECT
GROUNDWATER MONITORING WELL LOCATION PLAN

1. Open Pits and Waste Dumps are shown in their final configurations.
2. 1989 Monitoring Wells consist of 38 mm PVC with slotted screens.
3. 1995 Monitoring Wells consist of 110mm PVC well pipe installed primarily as a water supply source. Wells are screened at multiple intervals.
4. Monitoring installation 95-R-3 has been blocked at a depth of approximately 70 metres below the collar. This installation is no longer operable as a screen interval is not accessible.
5. 1996 Monitoring Wells consist of 50 mm PVC with one slotted screen section.
6. All previously installed monitoring wells with the tailing basin have been decommissioned.

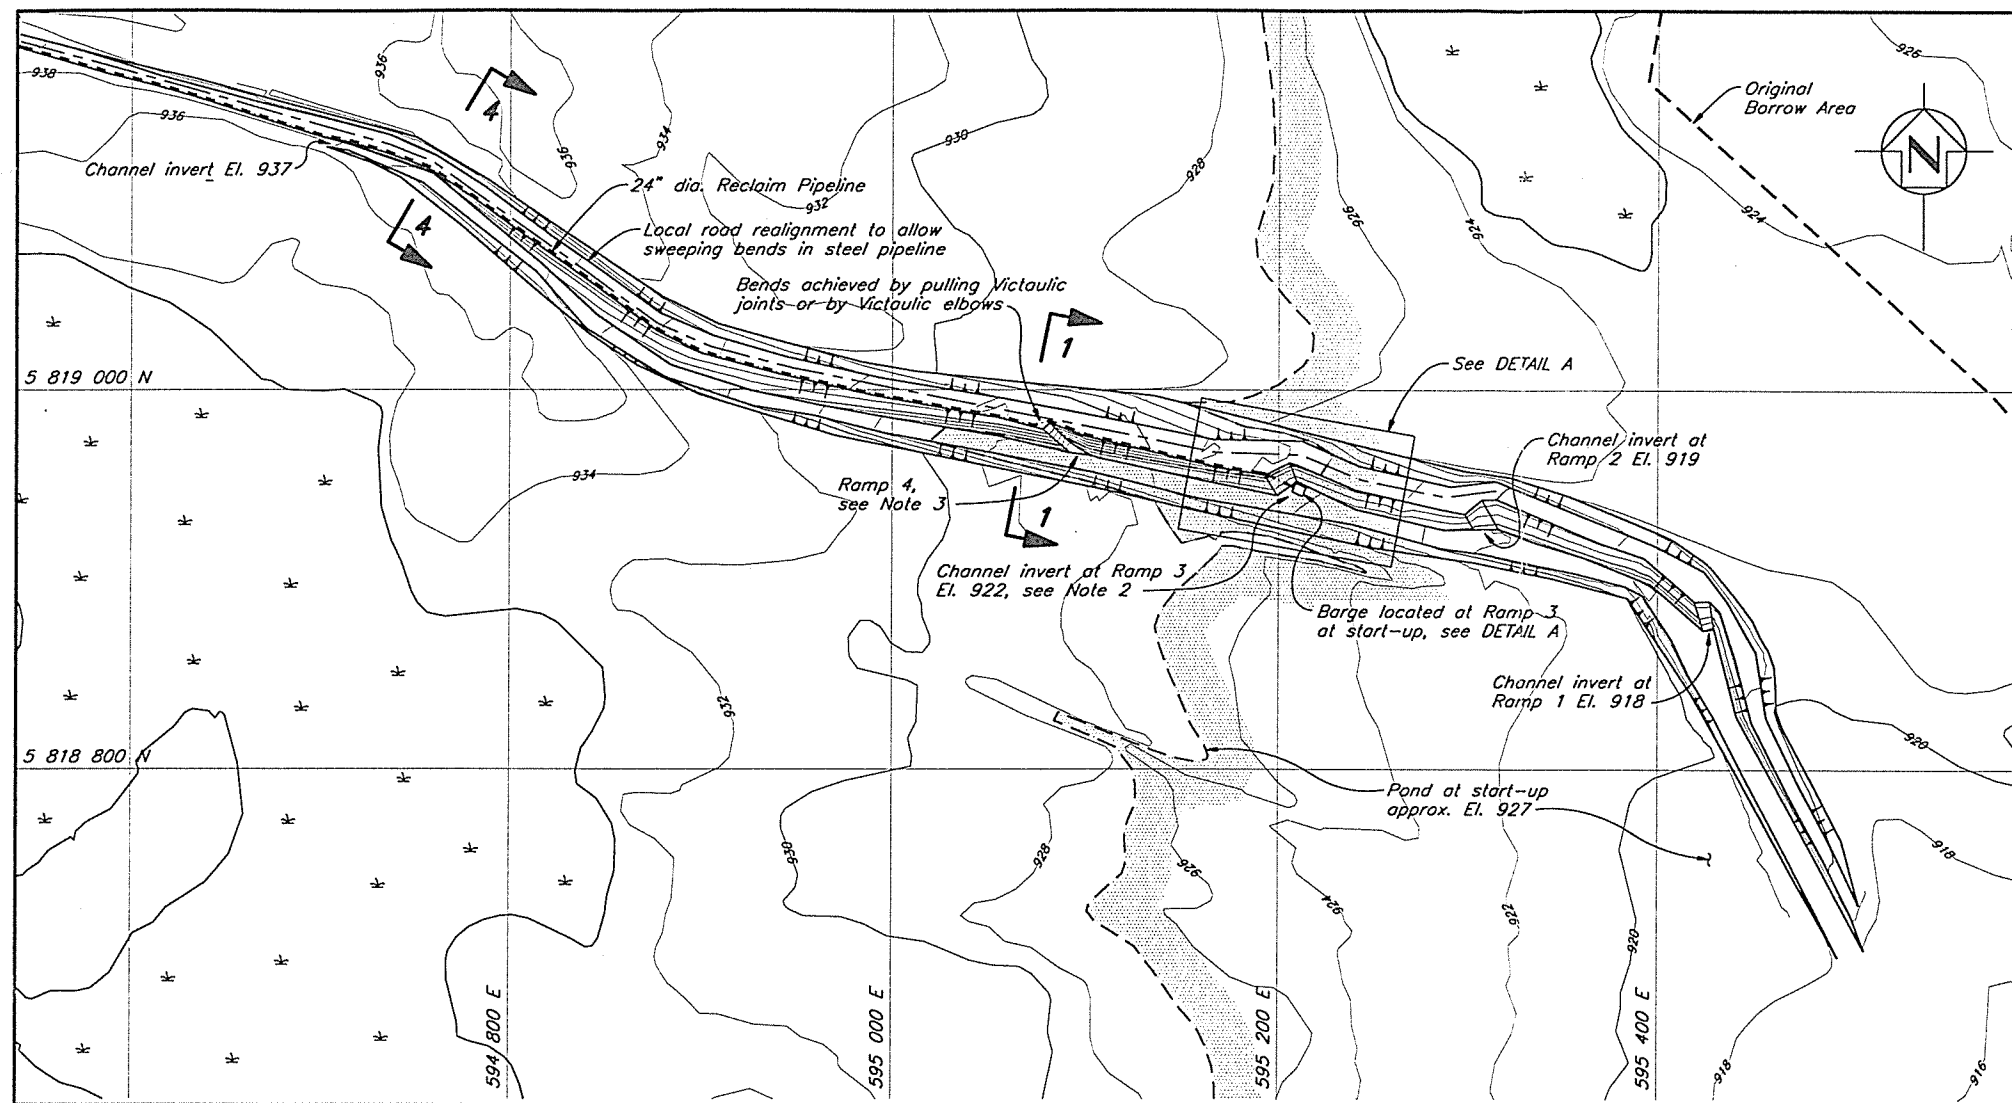
PLAN - RECLAIM BARGE CHANNEL
Scale A

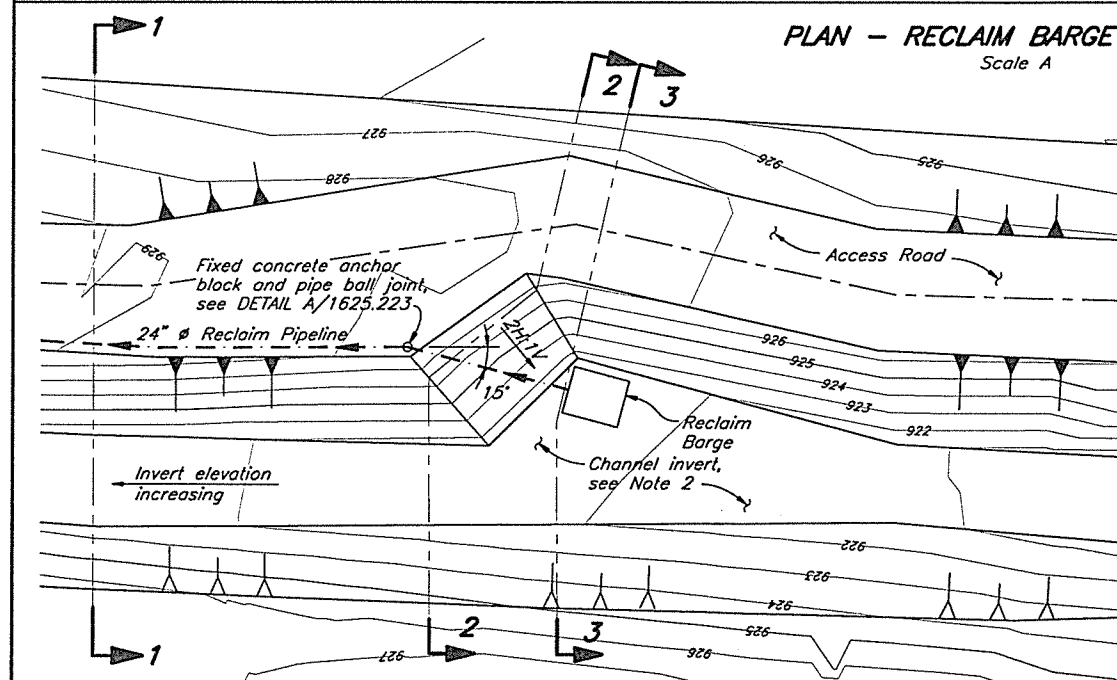
DETAIL A
BARGE ACCESS RAMP
Scale C

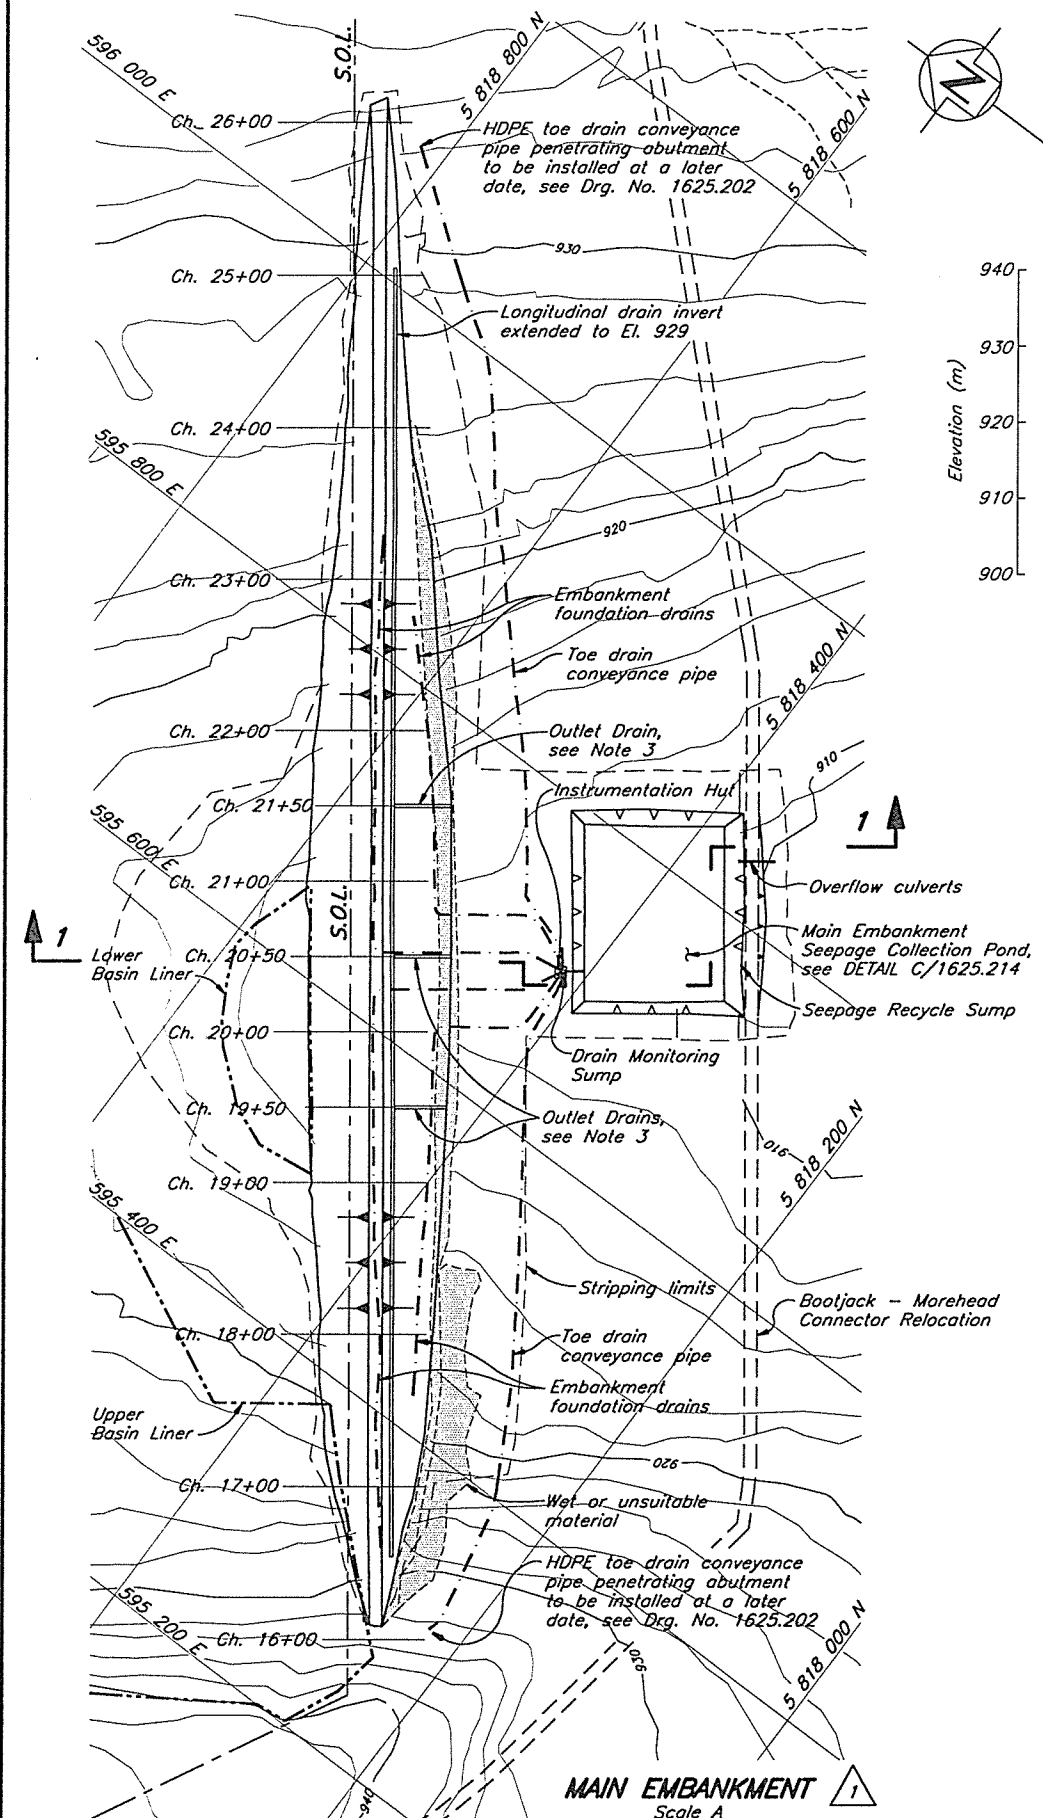
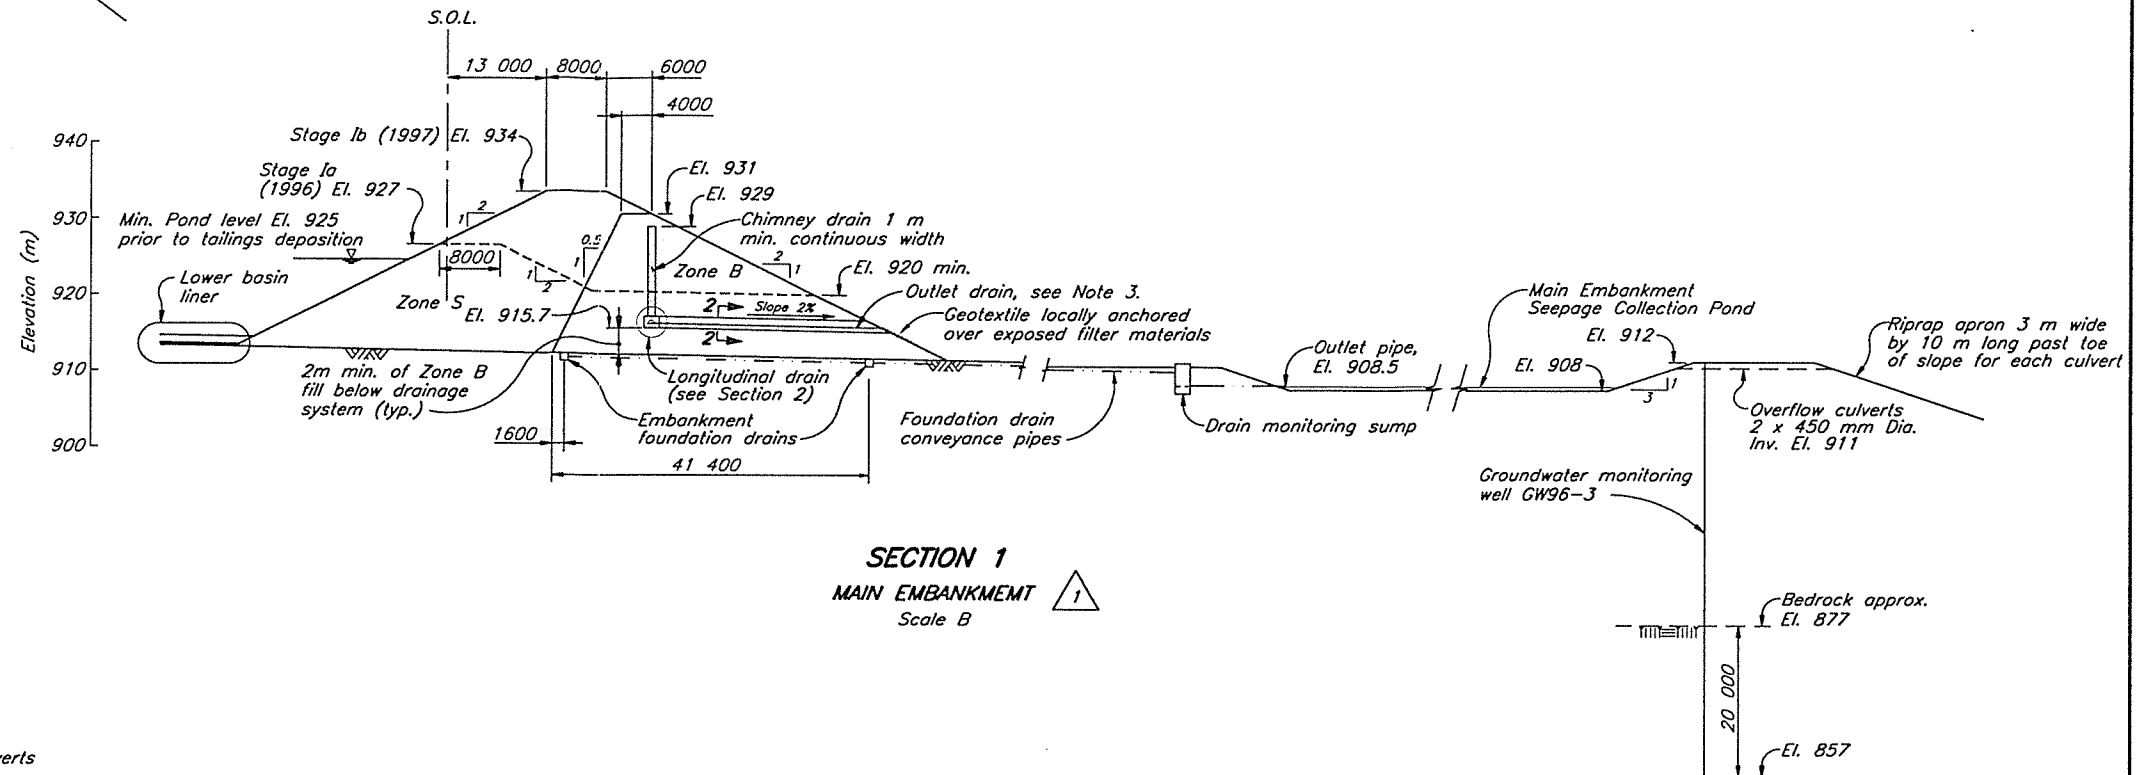
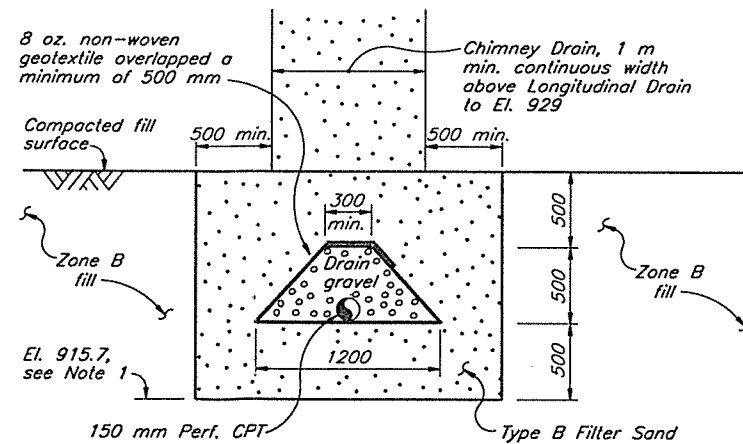
DATE SEPT. 4, 1996 SCALE AS SHOWN DRG. NO. 1625.207 REV. 1

- NOTES
1. Longitudinal drain installed with invert El. 915.7 m approx. Ch. 18+50 to 23+00. On the right abutment, (Ch. 16+00 to 18+50) it was installed to invert El. 929 m in placed and compacted Zone B fill. On the left abutment (Ch. 23+00 to 25+25) it was installed in original ground, following the prepared ground surface.
 2. HDPE toe drain conveyance pipe to be installed at later date. To be bedded with concrete as shown on Drg. No. 1625.202.
 3. Outlet drains to be extended to Drain Monitoring Sumps during Stage II construction.
 4. As-built information provided by Mount Polley Mining Corporation.
 5. Topography has not been updated for 1997 Flyover.

MOUNT POLLEY MINING CORPORATION
MOUNT POLLEY PROJECT
TAILINGS STORAGE FACILITY
TAILINGS DAM CHIMNEY DRAIN

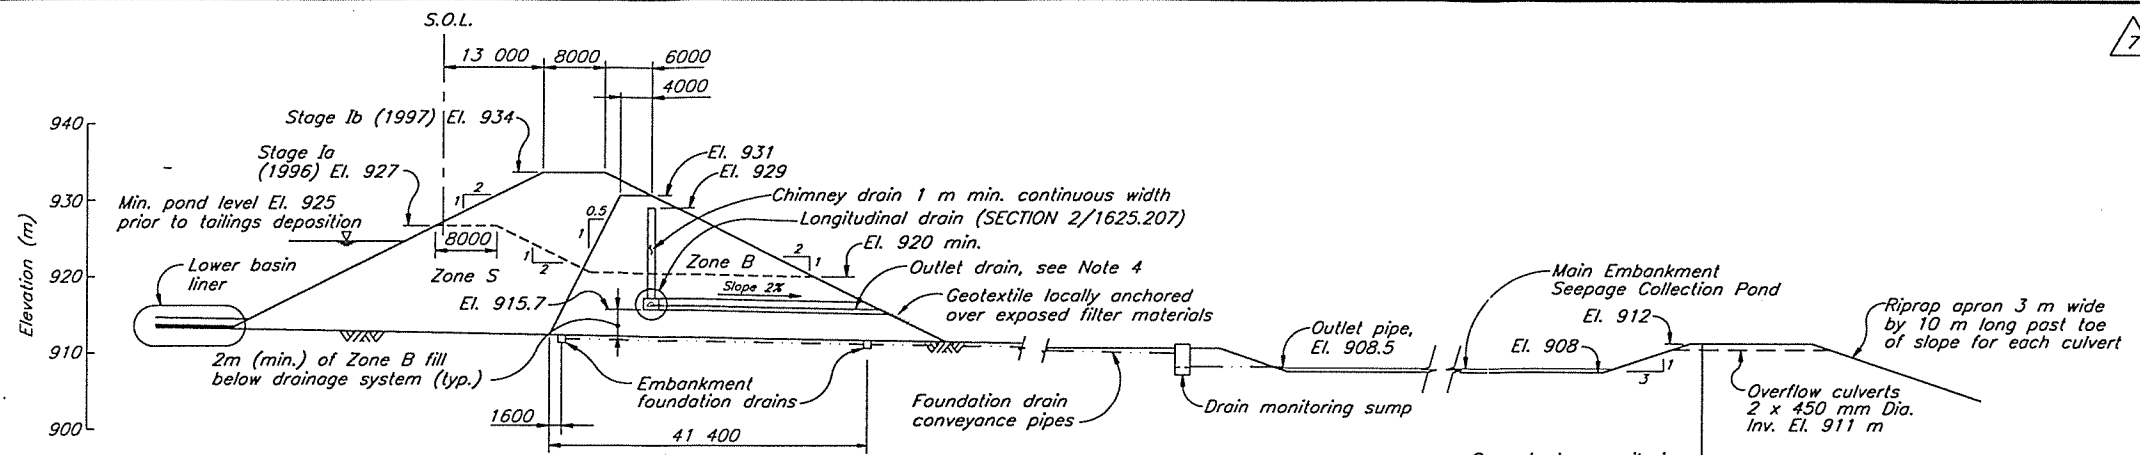
MAIN EMBANKMENT
Scale A

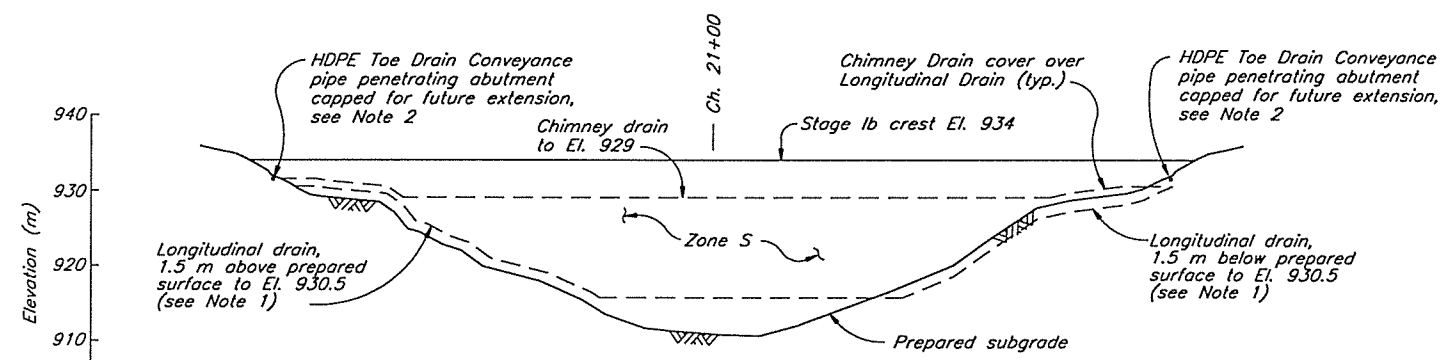
LONGITUDINAL SECTION OF MAIN EMBANKMENT
(Looking Downstream)
N.T.S.

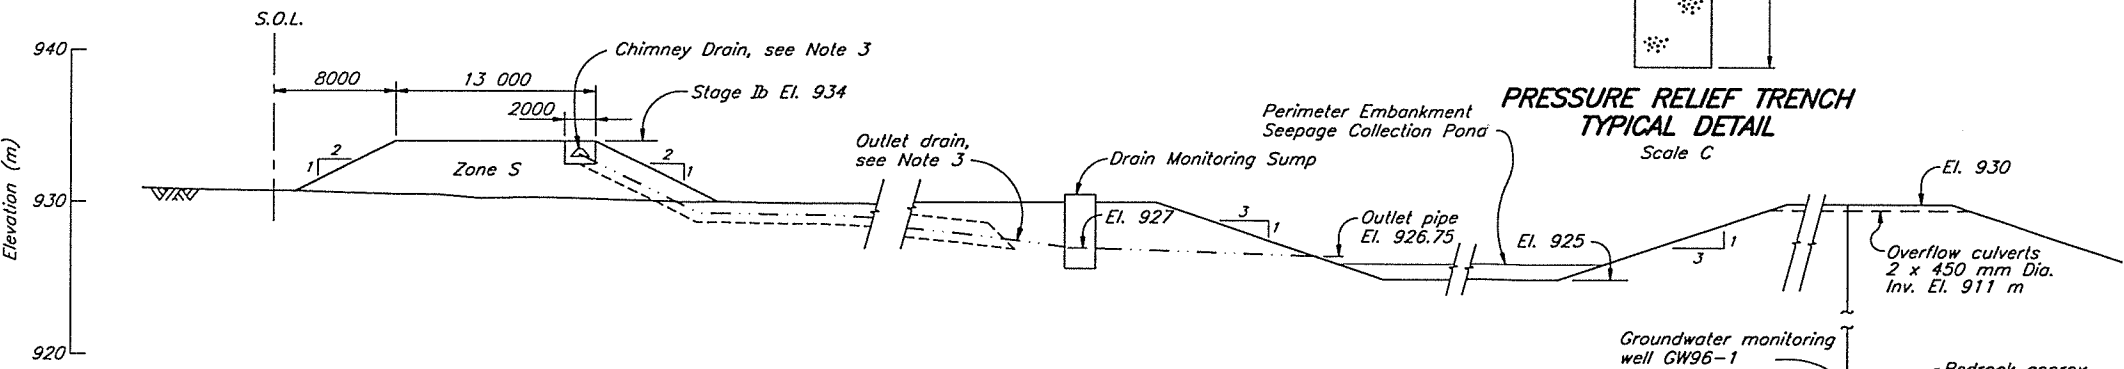
PERIMETER EMBANKMENT
Scale B

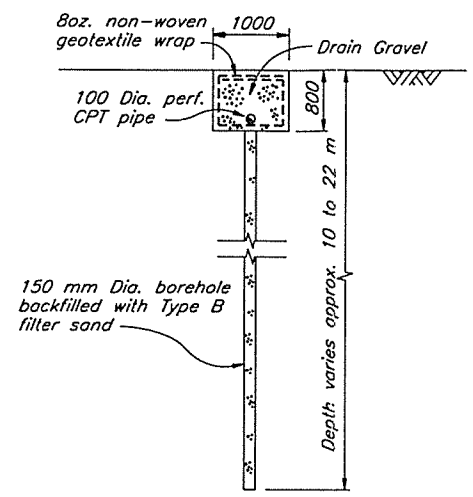
PRESSURE RELIEF WELL
TYPICAL DETAIL
Scale C

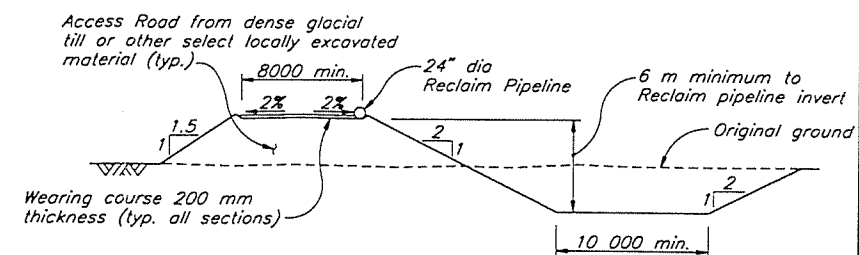
SECTION 3, SECTION 1625.218
RECLAIM BARGE CHANNEL
Scale B

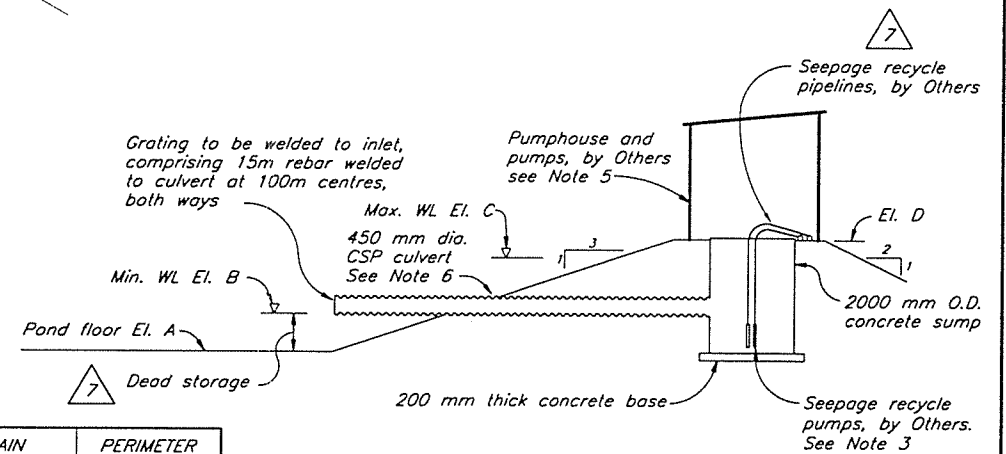
ELEVATION	MAIN EMBANKMENT	PERIMETER EMBANKMENT
A	908.0	925.0
B	908.5	926.0
C	909.5	928.0
D	911.0	930.0

DETAIL A
SEEPAGE RECYCLE SYSTEM
NTS
