**MOUNT POLLEY MINING CORPORATION
MOUNT POLLEY PROJECT
TAILINGS STORAGE FACILITY**

**OPERATION, MAINTENANCE
AND SURVEILLANCE MANUAL
FOR STAGE 1b EMBANKMENT (El. 934m)
(REF. NO. 10162/7-3)**

NOVEMBER 24, 1997

Knight Piésold
CONSULTING ENGINEERS

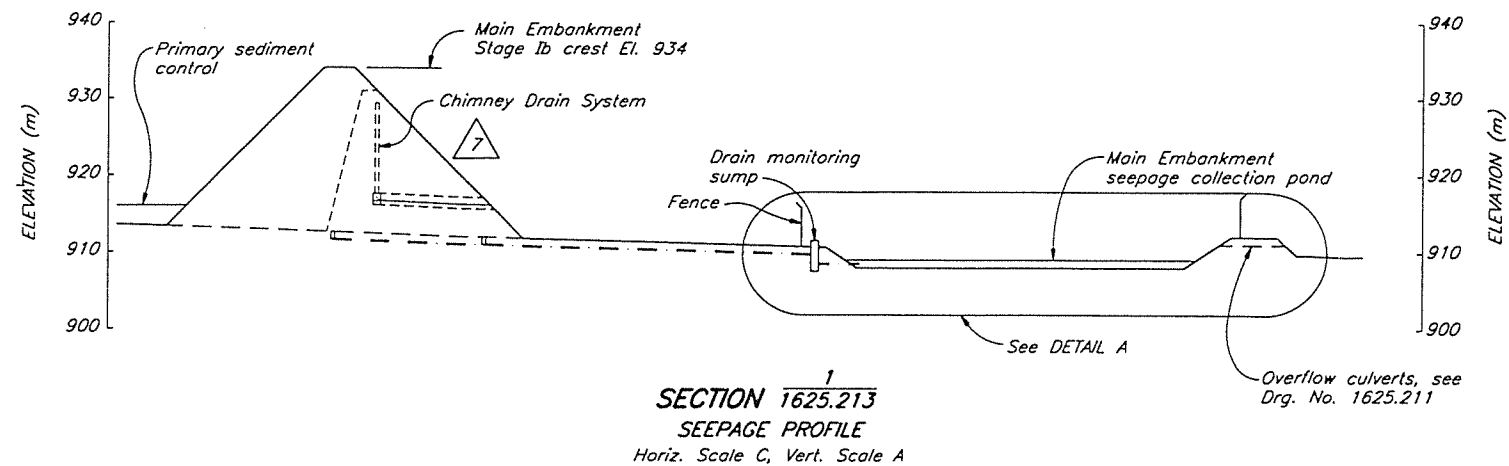
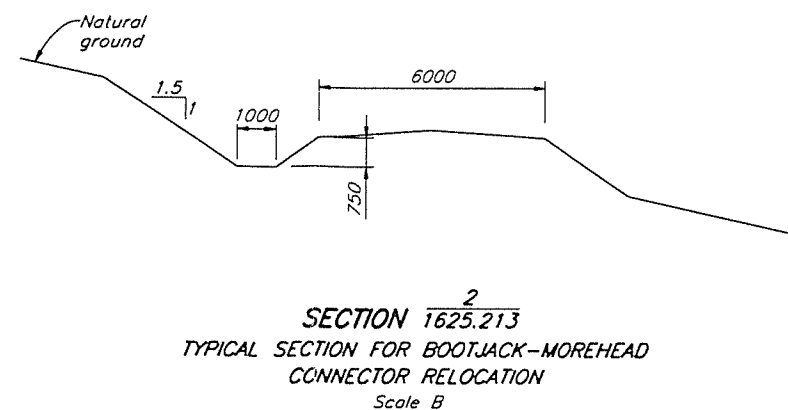
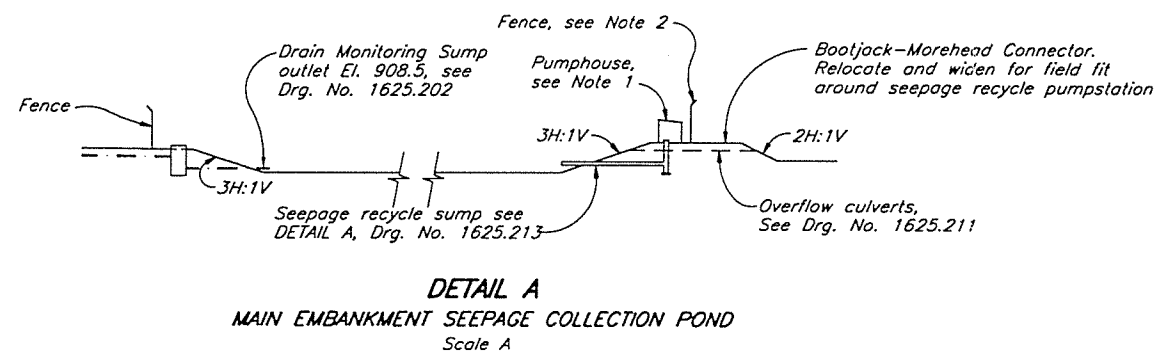
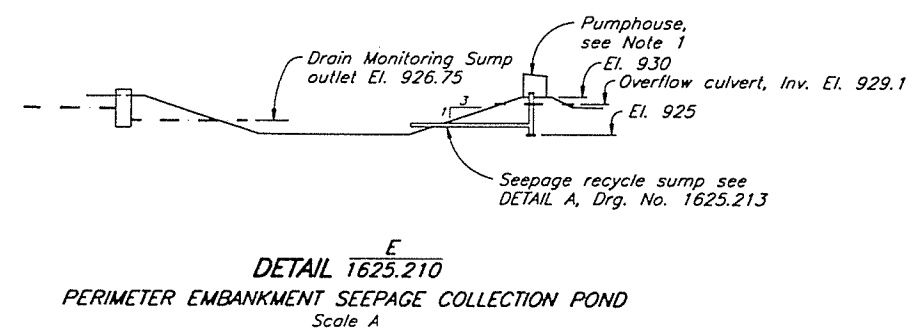
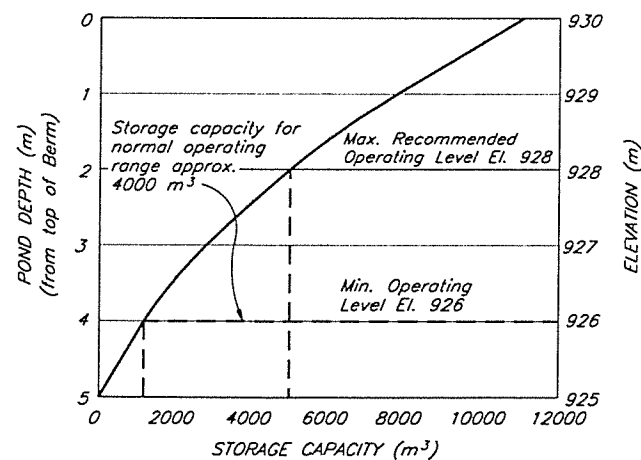
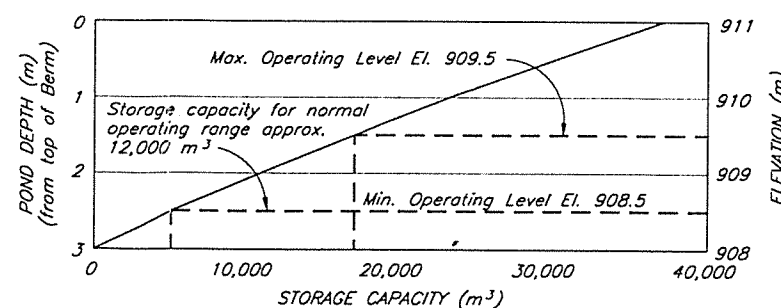
MOUNT POLLEY MINING CORPORATION	
MOUNT POLLEY PROJECT	
TAILINGS STORAGE FACILITY	
SEDIMENT CONTROL AND SEEPAGE	
COLLECTION - SECTIONS AND DETAILS	
DRG. NO.	510-19-02-1625.214
REV.	7

1. Pumphouse by C.S.F.M. Engineering Ltd. see Drg. No. 903
2. Fence to be six feet high, chain link with 2 inch galvanized posts and two six foot wide access gates. Not yet installed (May 27, 1997)
3. As-built information provided by Mount Polley Mining Corporation.

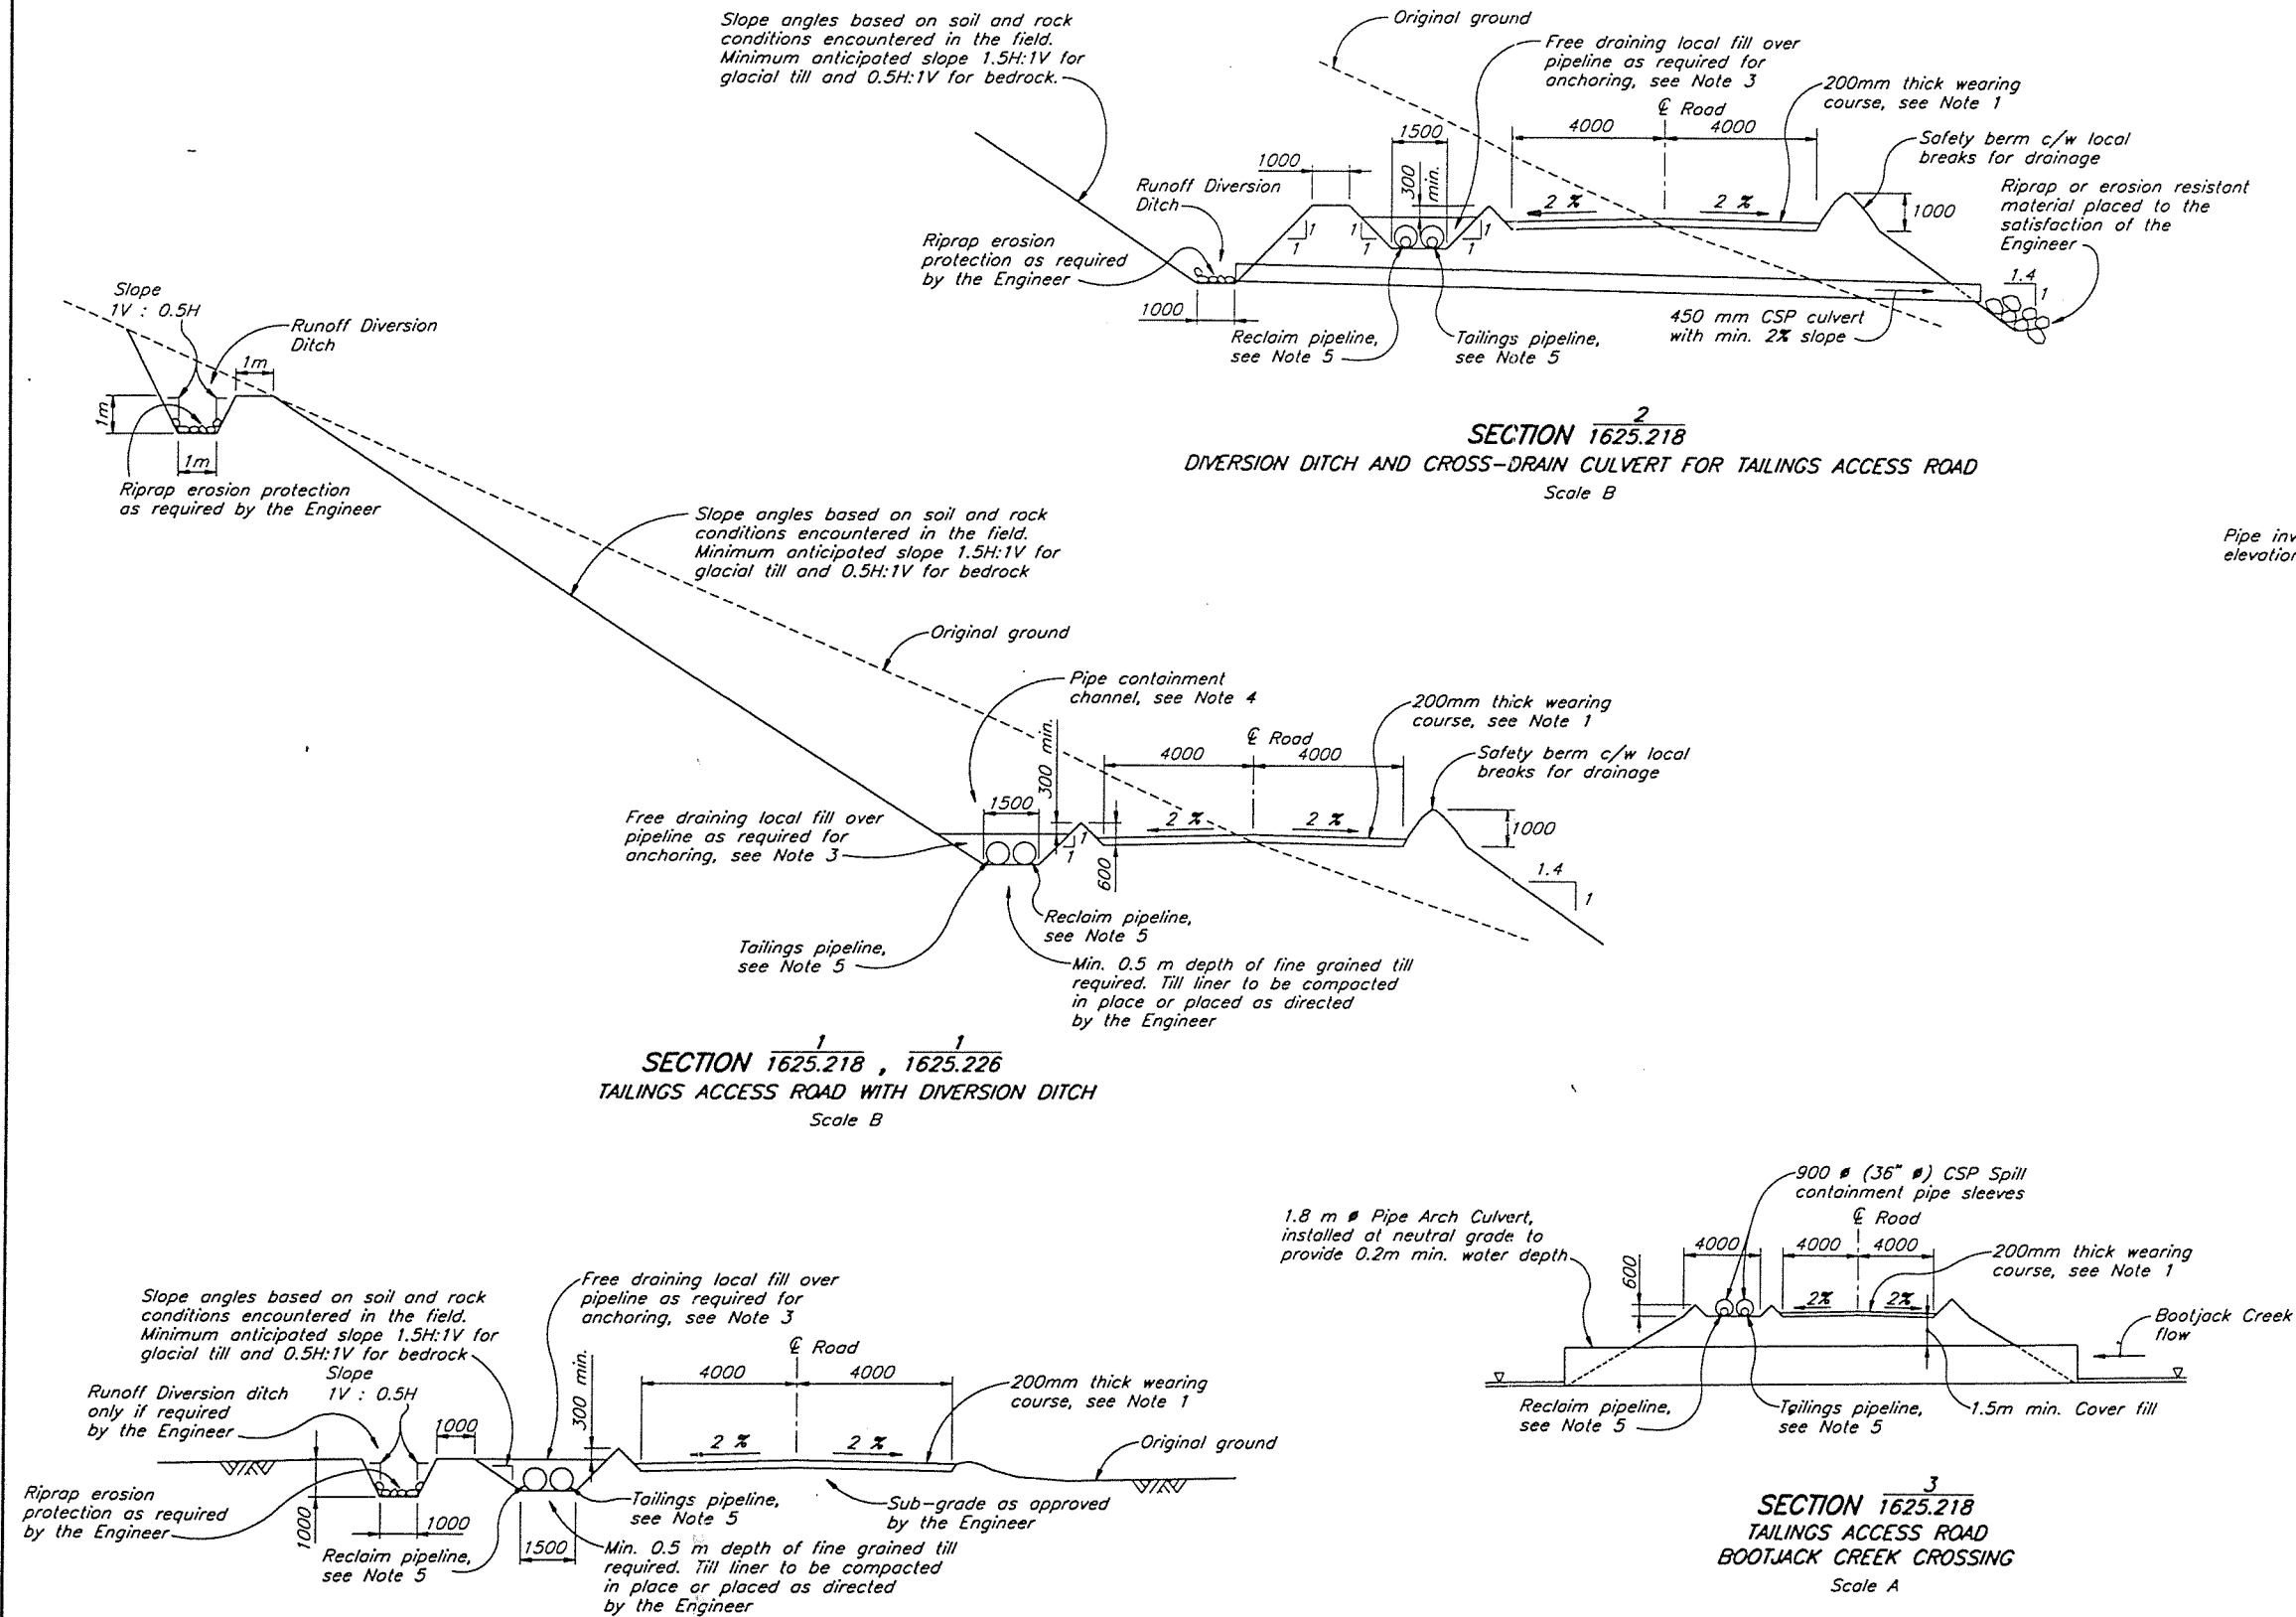
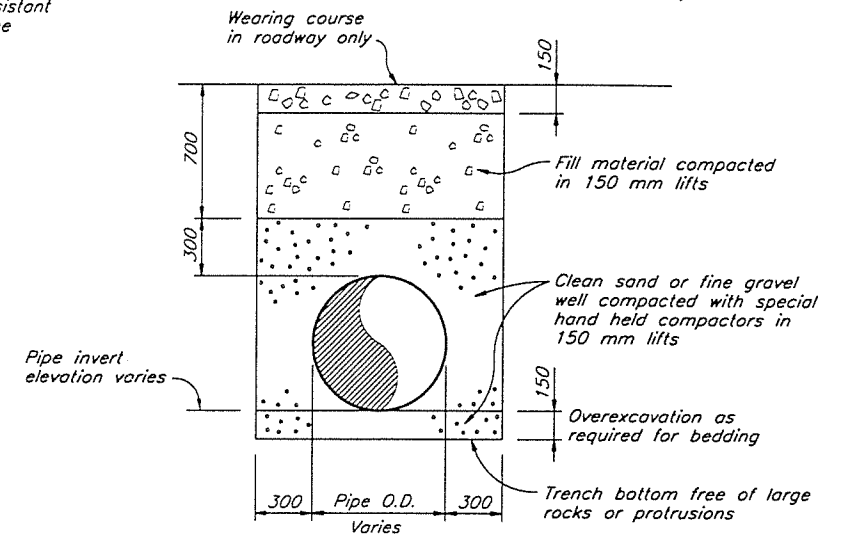
SCALE AS SHOWN
DRG. NO. 510-61-02-1625.219
REV. 7

1. Wearing course required for Tailings Access Road, Reclaim Barge Access Road and Bootjack-Morehead connector relocation only.
2. For crossing under road, tailings and reclaim pipelines to be installed in individual 900 mm (min.) dia. culverts laid under road with 500 mm min. cover. Culverts laid immediately downslope of cross-drain.

**TAILINGS STORAGE FACILITY
TAILINGS DISTRIBUTION AND
RECLAIM SYSTEM - SECTIONS AND DETAILS**

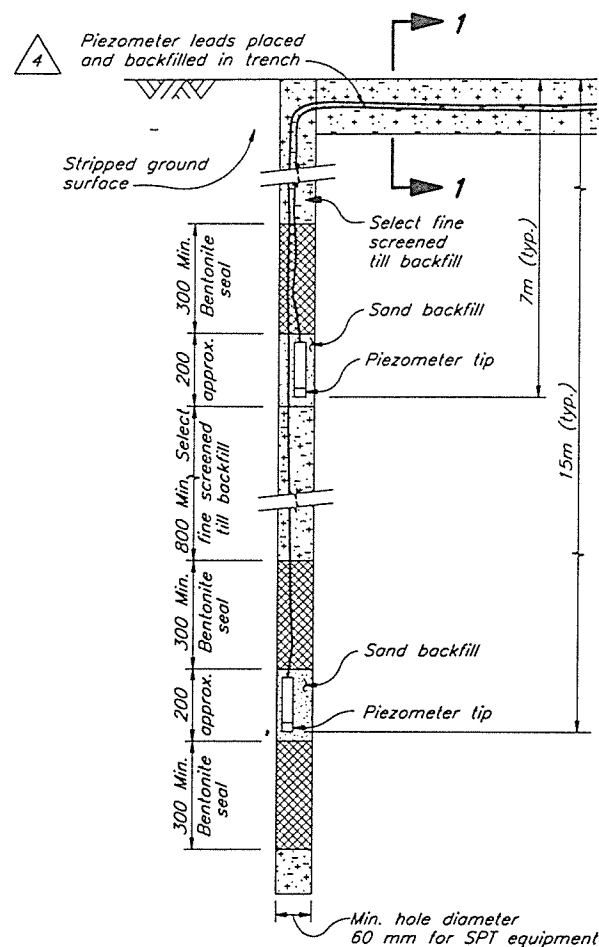
DETAIL A
INSTALLATION OF PIEZOMETERS
IN BOREHOLES
N.T.S.

- Piezometers are vibrating type, RST model VW-2100 with a pressure rating of 100 psi or equivalent, connected to a readout panel via standard non-vented model VW-232 direct burial cable.
- Piezometer leads are to be extended to Instrumentation Monitoring Hut after foundation preparation for final embankment during Stage II construction.
- Future survey monuments not shown. A minimum of 2 monuments will be installed for each embankment raise.
- Seepage cutoffs placed at 5m intervals with 10% bentonite added to fine grained till backfill, see Drg. No. 1625.221.
- As-built information provided by Mount Polley Mining Corporation.
- Topography has not been updated for 1997 flyover.
- Installation details for borehole piezometers as shown on Drg. No. 1625.221.

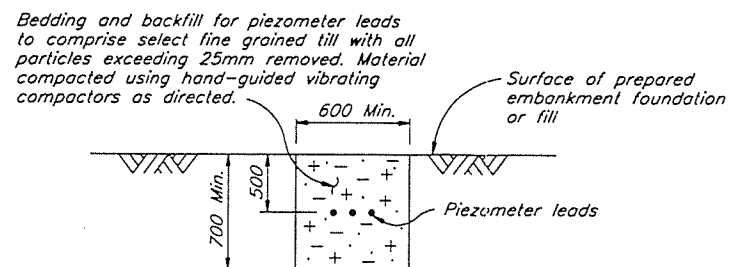
SECTION 1
TYPICAL SECTION THROUGH PIEZOMETER LEAD
TRENCH IN PREPARED EMBANKMENT FOUNDATION
OR IN ZONE S AND B FILL
N.T.S.

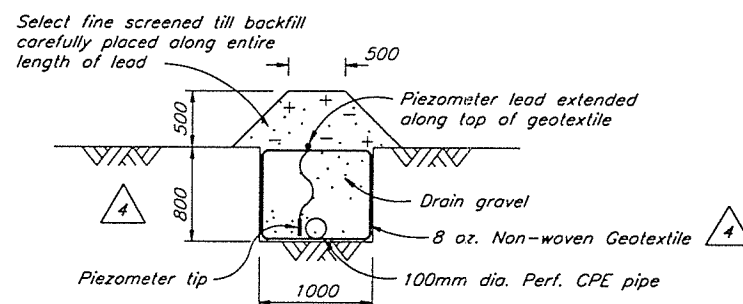
DETAIL C
TYPICAL PIEZOMETER INSTALLATION IN
EMBANKMENT FOUNDATION DRAIN OR TOE DRAIN
N.T.S.

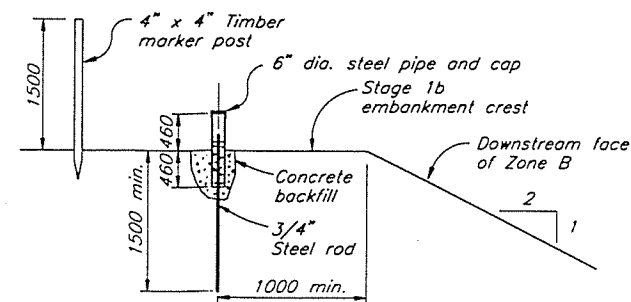
DETAIL OF
SURFACE MOVEMENT MONUMENT
N.T.S.

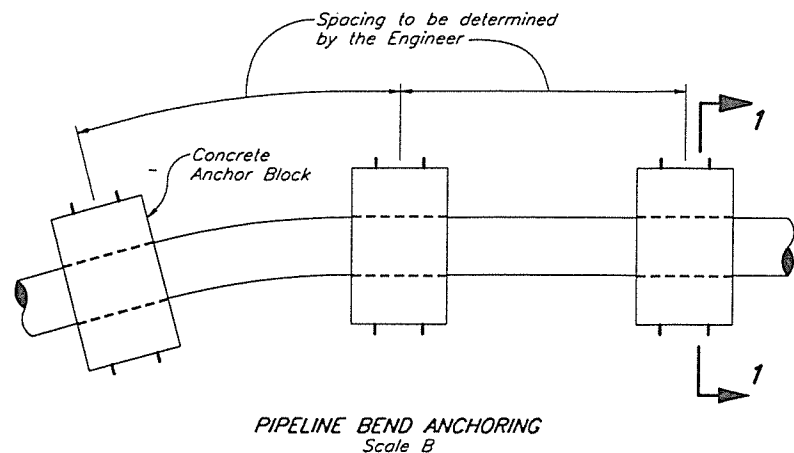
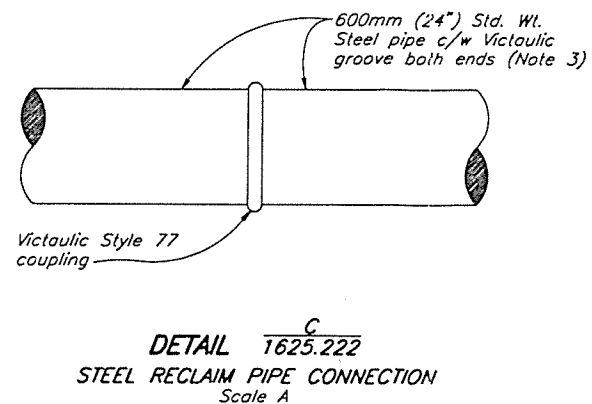
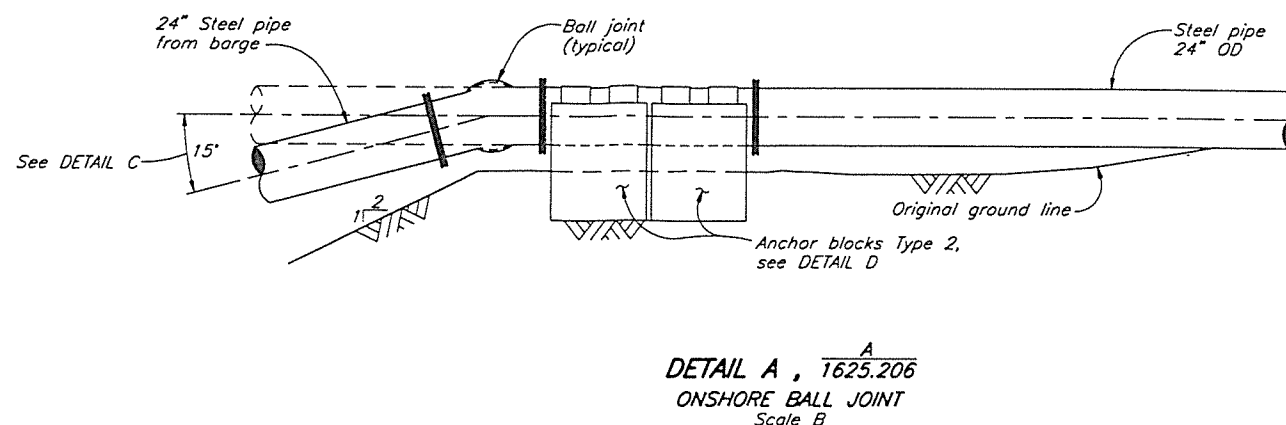
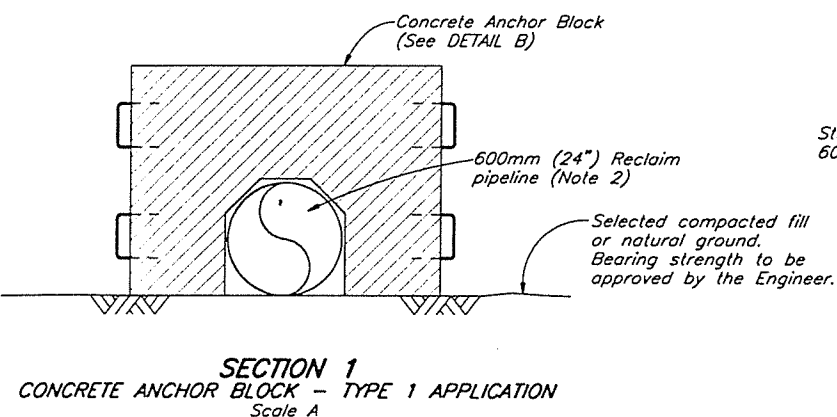
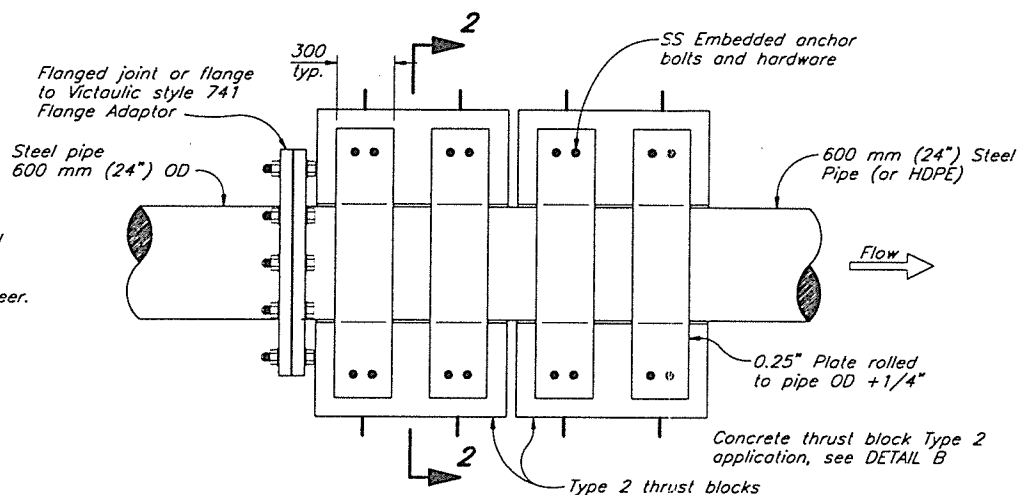
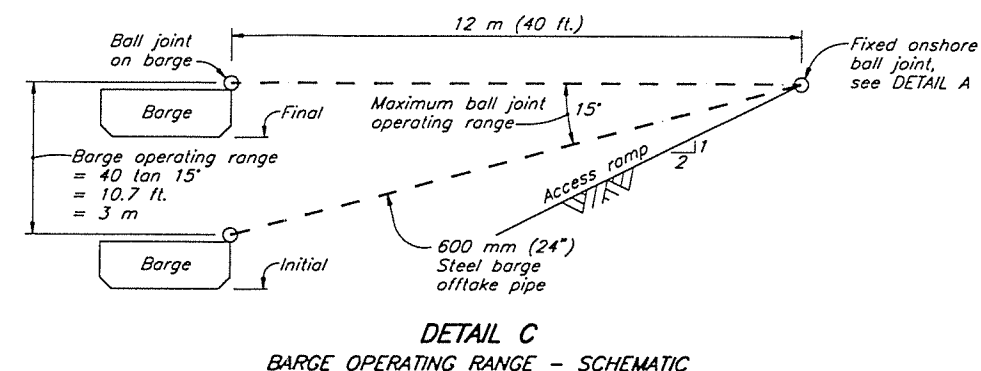
MOUNT POLLEY MINING CORPORATION	
MOUNT POLLEY PROJECT	
TAILINGS STORAGE FACILITY RECLAIM PIPELINE DETAILS	
DATE	JULY 15, 1996
SCALE	AS SHOWN
DRG. NO.	1625.223
REV.	1

- NOTES**
- Concrete anchoring blocks to be used at barge ball joint and at locations where pipeline changes from steel to HDPE.
 - Anchor blocks may be used for reclaim or tailings pipeline as required by the Engineer. Modifications will be required for pipe diameter other than 24".
 - Victaulic grooves to be rolled if pipe wall thickness is less than 0.375".

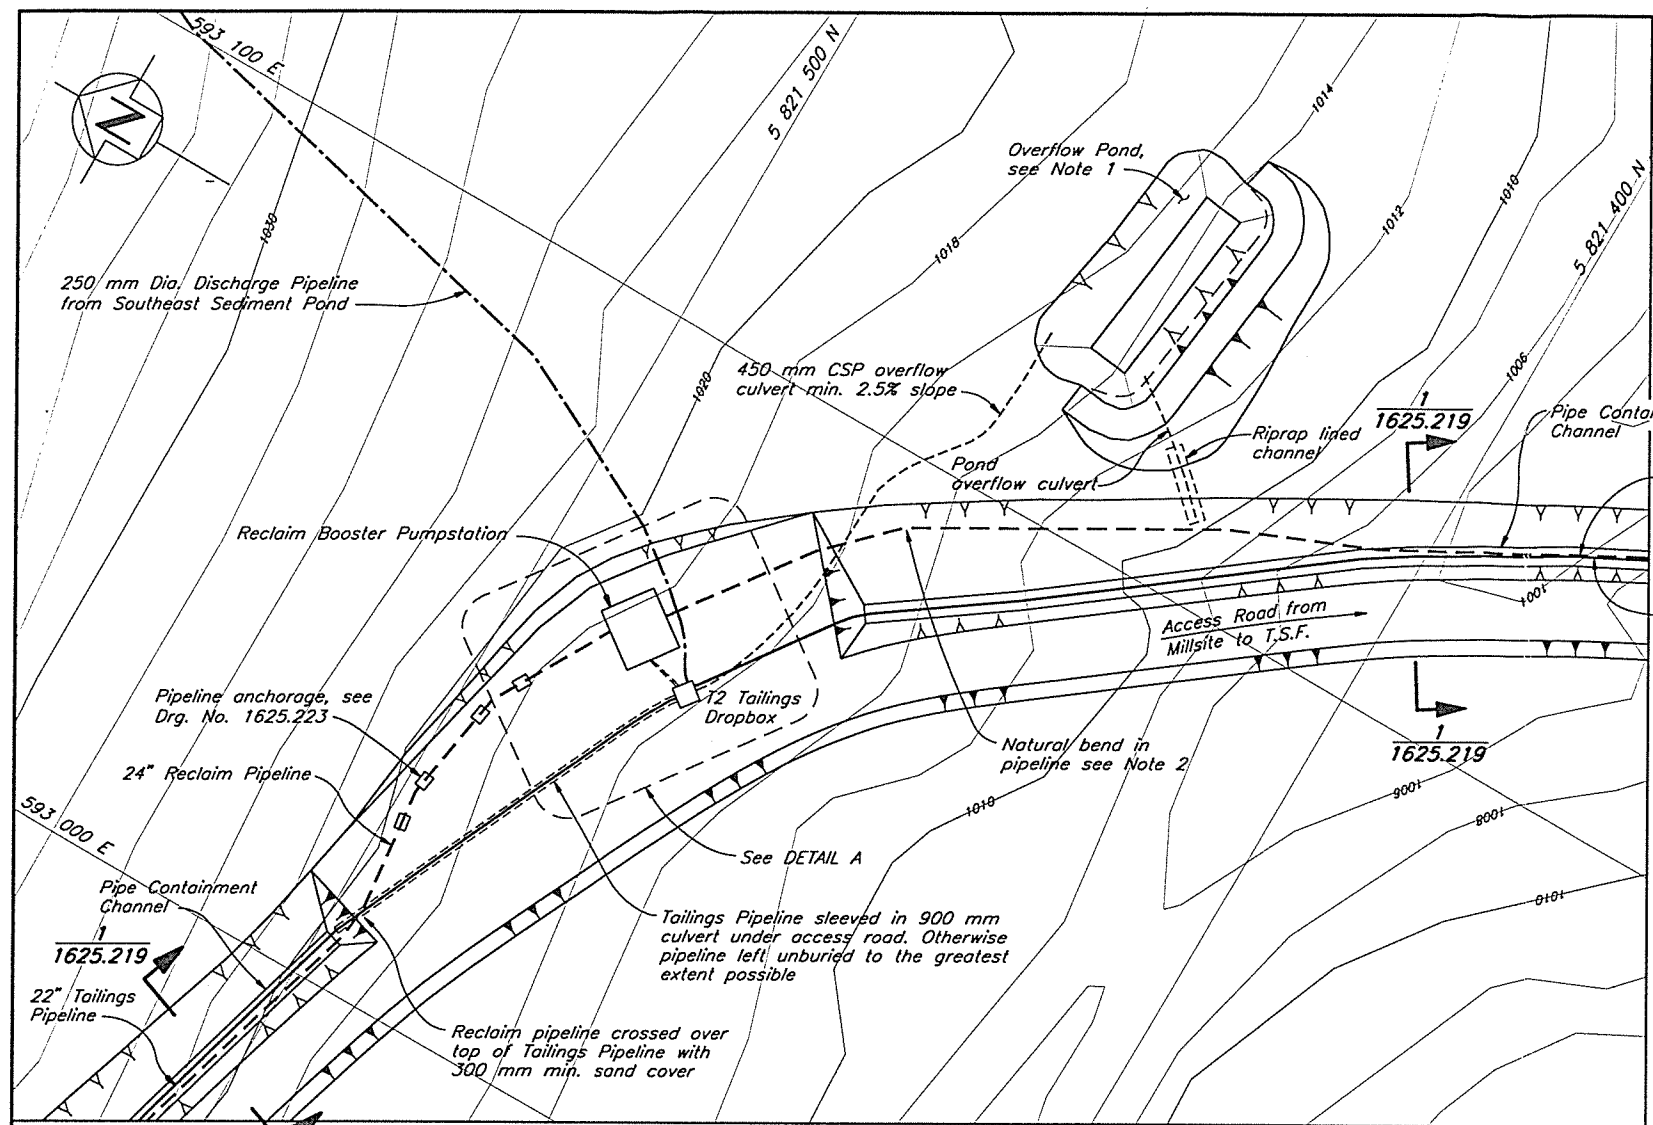
DETAIL A - SCHEMATIC
RECLAIM BOOSTER PUMPSTATION, T2 TALINGS DROPBOX AND OVERFLOW POND

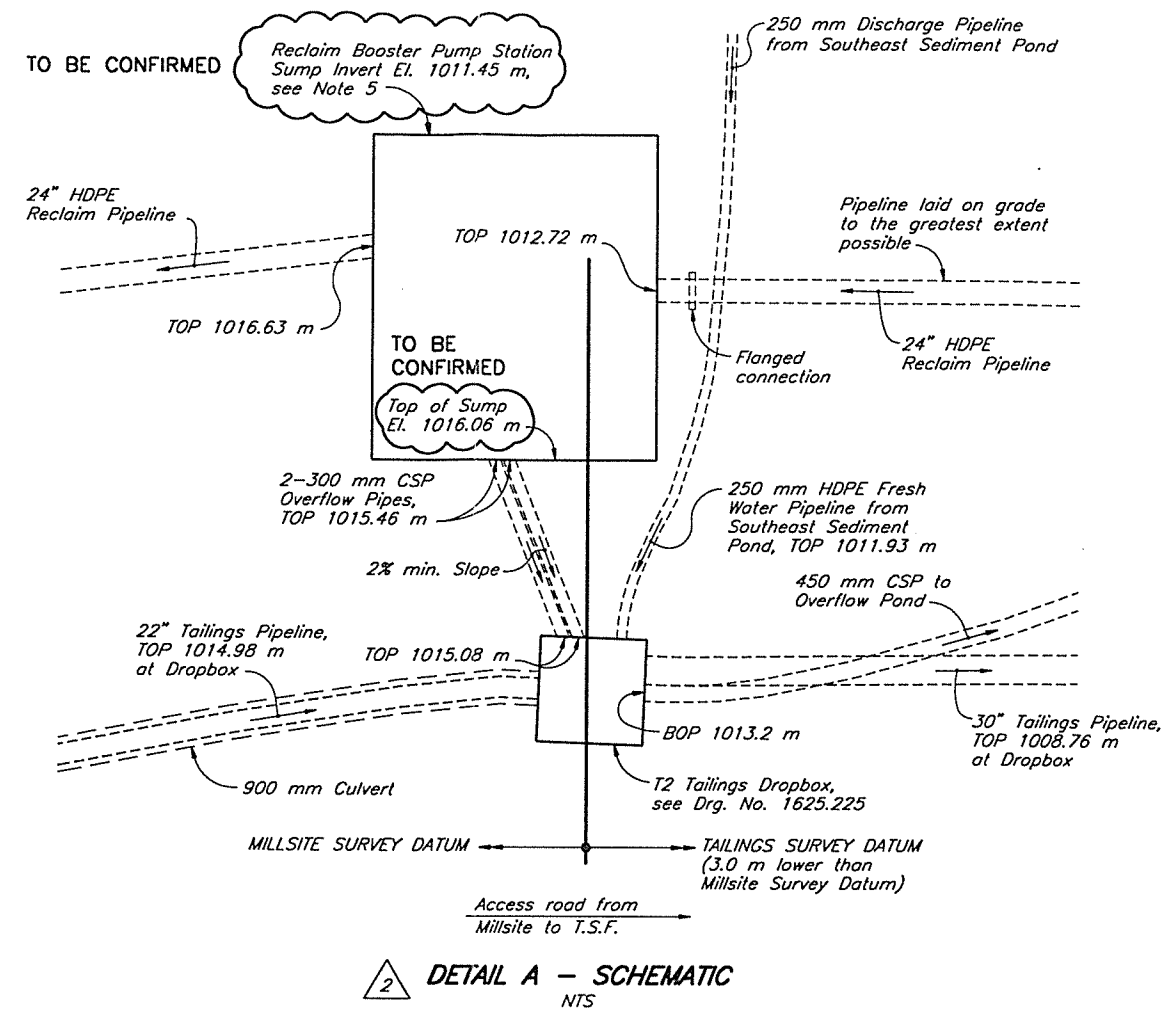
DETAIL A - SCHEMATIC
NTS

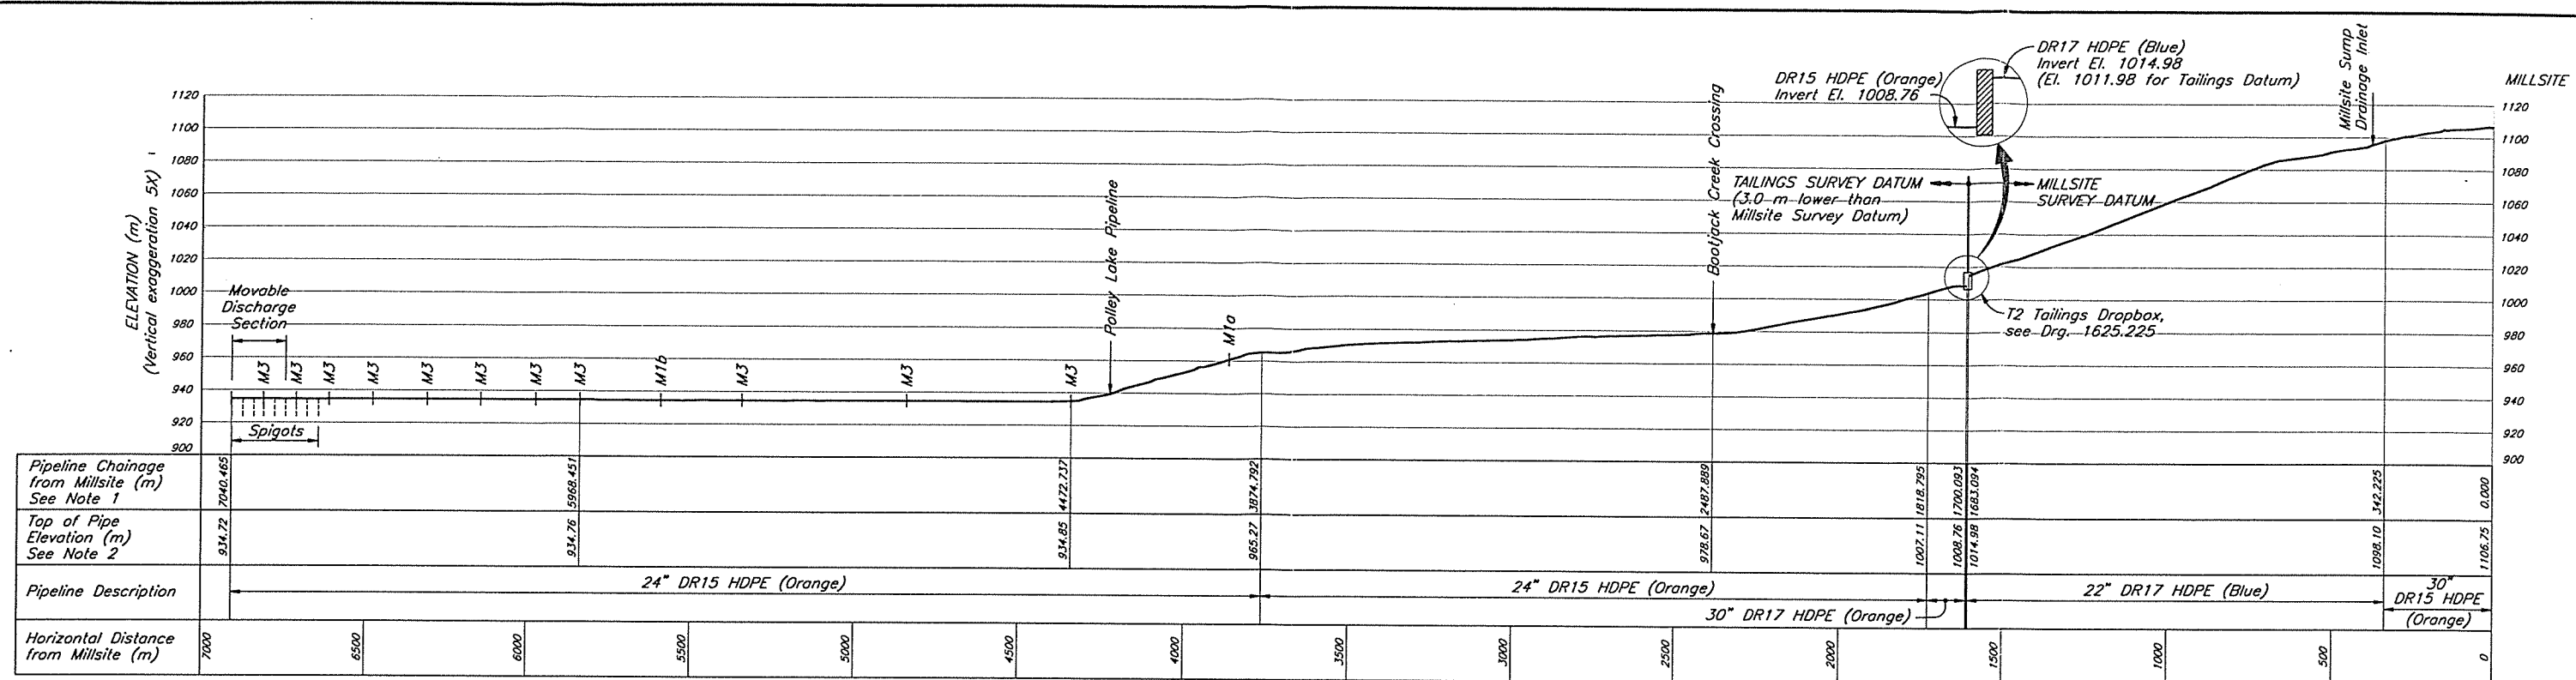
- 2 NOTES**
- Pipeline chainage is based on top of pipe (TOP) As-Built Survey.
 - Pipeline elevations from Tailings Storage Facility to T2 Dropbox and Reclaim Booster Pumpstation are based on Tailings Survey Datum (3.0 m lower than Millsite Datum). Survey control break is shown at T2 Dropbox and Booster Pumpstation.

- Flanges in pipelines must be supported off the ground if pipelines are dragged into position.
 - Any section of HDPE pipeline damaged during installation by a local reduction in wall thickness of 10% or more cut out and replaced.

- Mark 2 and 4 offtakes not installed. Replaced by Movable Discharge Section.
 - Mark 3 offtakes not installed. Flanged connections left for future use.

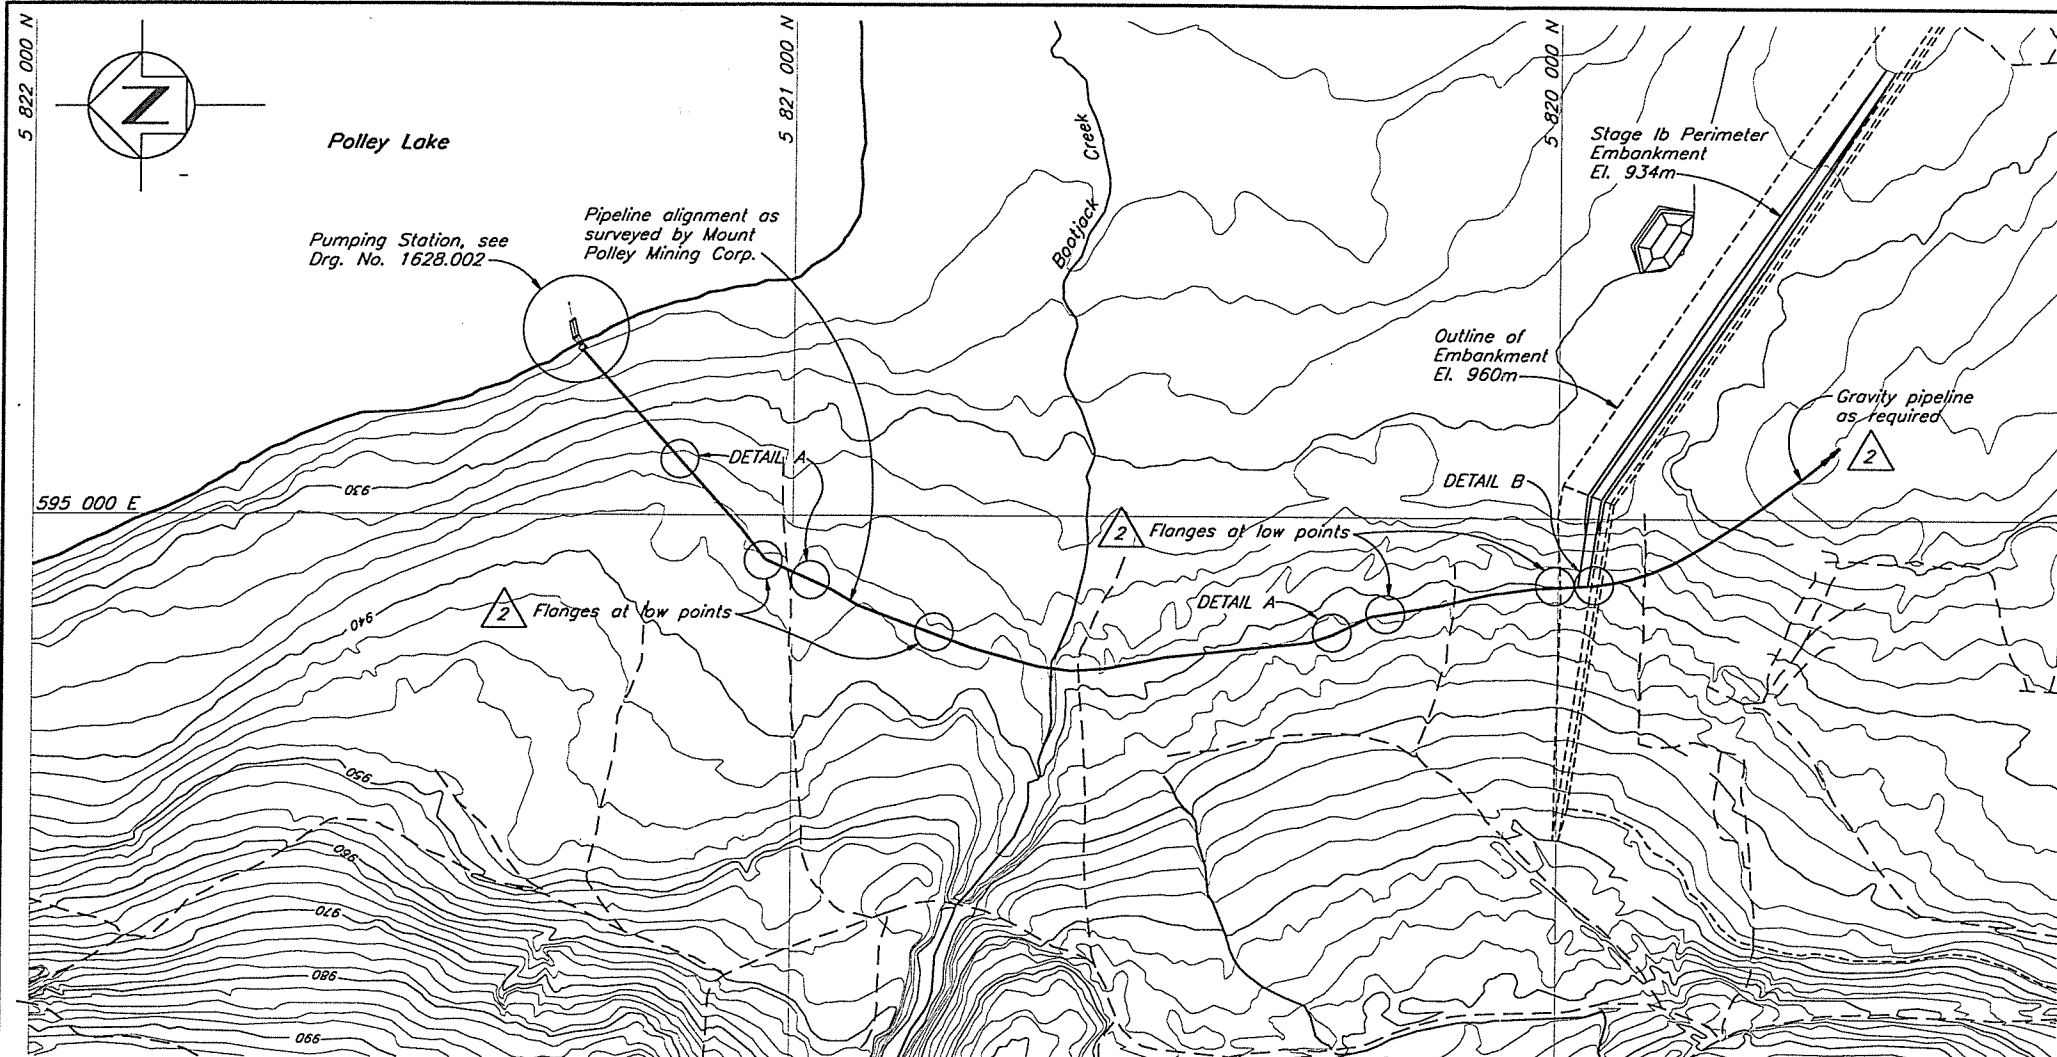
PLAN
Scale A

1. Pumping system has been designed for a maximum extraction rate of 8 000 USgpm. The extraction rate will be controlled by the pipeline I.D. and lengths selected for installation by Mount Polley Mining Corporation.
2. Pipeline profile is based on centreline of access road.
3. Pipeline may be constructed with some high sections. Air release valves required as shown.
4. Flanges to be provided at low points for pipe drainage, cleaning, and protection against freezing during prolonged shut down periods.
5. Air intake valve system required at embankment to facilitate drainage. Additional air intakes may be required at high points.
6. All air release/intake systems to be protected against freezing during pumping.
7. Elevations on pipeline profile are from survey data and do not correspond accurately to topographic contours.
8. Valves to be AWWA quality.

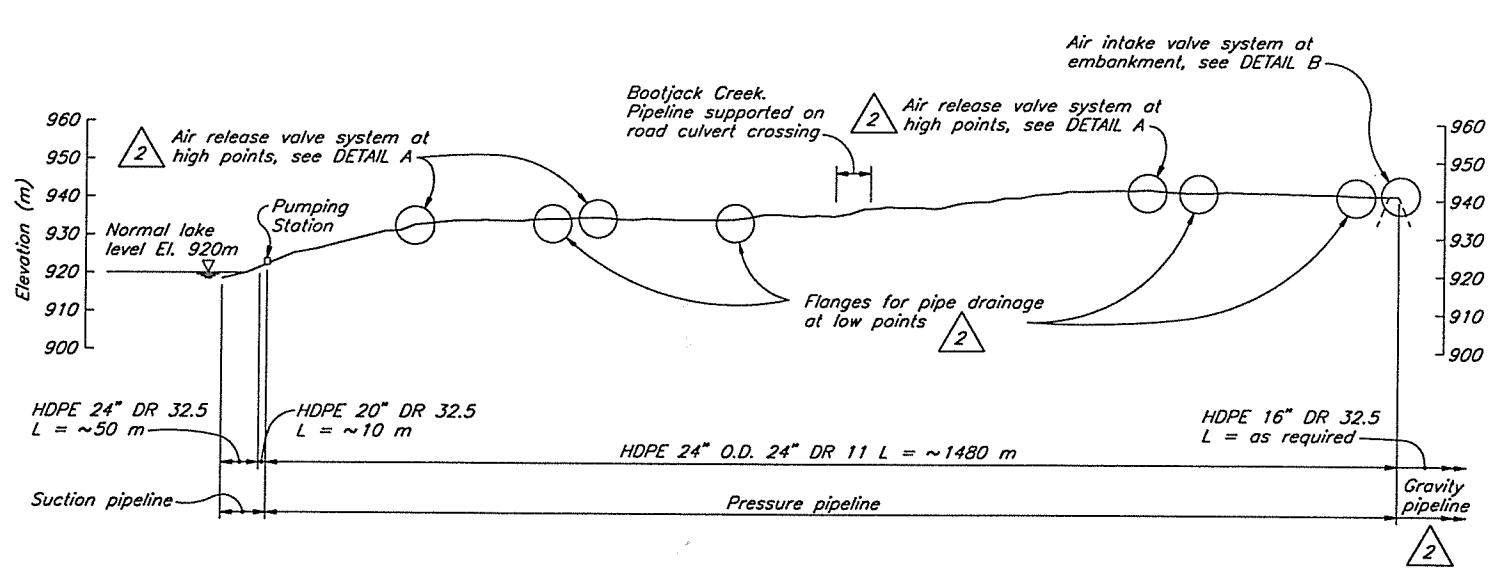
PIPELINE PROFILE
Horiz. Scale A, Vert. Scale B
