**MOUNT POLLEY MINING CORPORATION
MOUNT POLLEY MINE
TAILINGS STORAGE FACILITY
OPERATION, MAINTENANCE AND SURVEILLANCE
MANUAL
(REF. NO. VA101-00001/9-1)**

**MOUNT POLLEY MINING CORPORATION
MOUNT POLLEY MINE
TAILINGS STORAGE FACILITY**

**OPERATION, MAINTENANCE AND SURVEILLANCE MANUAL
(REF. NO. VA101-00001/9-1)**

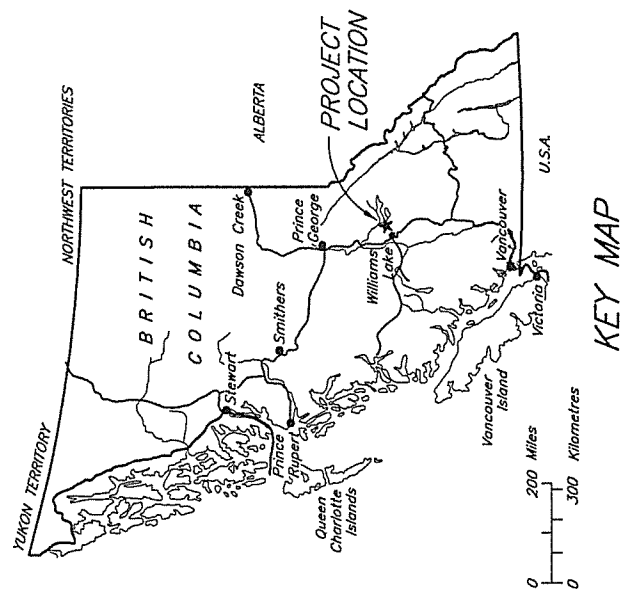
IMPERIAL METALS CORPORATION	
MOUNT POLLEY MINE	
TAILINGS STORAGE FACILITY PROJECT LOCATION PLAN	
<i>Knight Piésold</i> CONSULTING	PROJECT/ASSIGNMENT NO. VA101-1/9 REF. NO. 1 REV. 0
FIGURE 2.1

LOCATION MAP

KEY MAP

The location of the Mine and access roads are shown on Figure 2.1. The Mount Polley Mine is located in central British Columbia, approximately 60 km northeast of Williams Lake. The main access route is via Likely Road. The turn to the Mine is located approximately 1.5 km east of Morehead Lake. The Mine is located a further 11 km to the southeast, on the Bootjack Lake Forest Service Road.

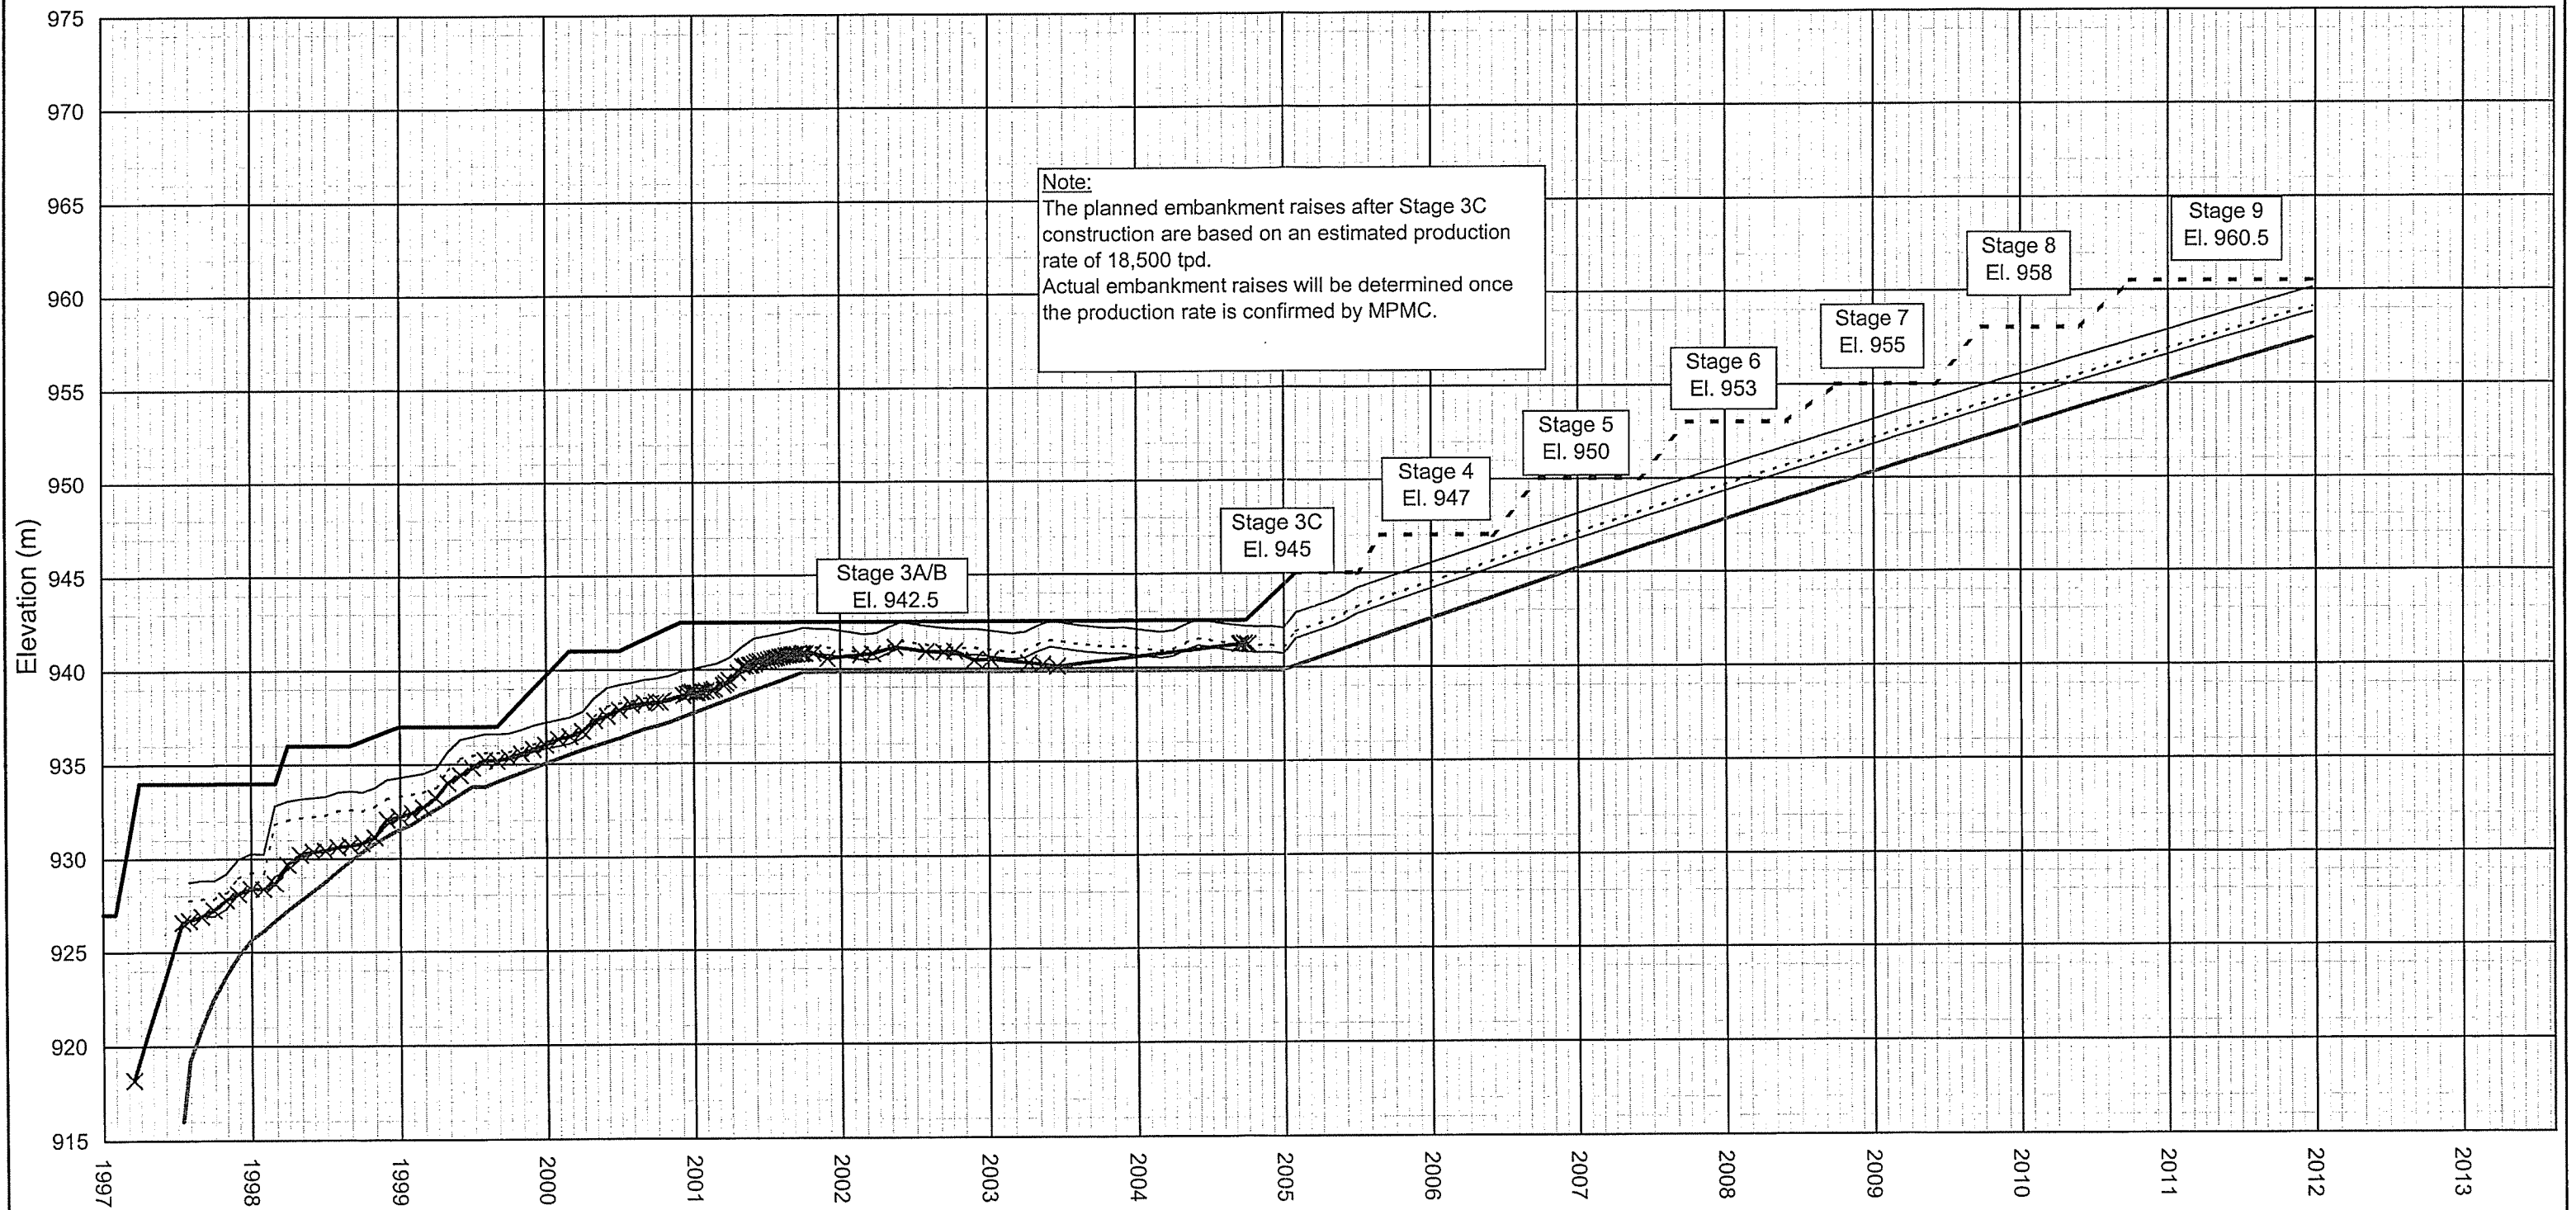
MOUNT POLLEY MINING CORPORATION		
MOUNT POLLEY MINE		
TAILINGS STORAGE FACILITY		
FILLING SCHEDULE AND STAGED CONSTRUCTION		
18,500 tpd		
PROJECT / ASSIGNMENT NO VA101-1/9	REF NO 1	REV. 0
Knight Piésold CONSULTING		FIGURE 3.1

Note:
The planned embankment raises after Stage 3C construction are based on an estimated production rate of 18,500 tpd. Actual embankment raises will be determined once the production rate is confirmed by MPMC.

— Existing Embankment Crest
— 1 m Freeboard
- - - - - 24 Hr. PMP (679,000 m3)
— Reclaim Water
— x — Measured Pond El.

Notes:
1. Production rate is estimated at 18,500 tpd.
2. Projected bulk tailings dry density is 1.36 t/m³ for tailings reporting to the TSF after August 2000.
3. Supernatant pond volume maximum of 3,000,000 m³.
4. Water in supernatant pond at startup 2.6 M m³.

The projected rate at which the tailings basin will fill, combined with storage provisions for make-up and storm water, determine the rate of rise for the embankment. The anticipated filling schedule and staged construction sequence is shown on Figure 3.1.
