<b>KNIGHT PIESOLD LIMITED</b> CONSULTING ENGINEERS - VANCOUVER, B.C.		<b>MOUNT POLLEY MINING CORPORATION</b> <b>MOUNT POLLEY PROJECT</b>	
DESIGNED	PJP	<b>TAILINGS STORAGE FACILITY</b> <b>GEOLOGICAL INVESTIGATIONS</b> <b>LOCATION PLAN</b>	
DRAWN	TAM		
CHECKED	W		
APPROVED	KJB		
DATE	MAY 16, 1997	SCALE AS SHOWN	DRG. NO. 1627.001
			REV. C

**Re: Mount Polley Mine Tailings Storage Facility  
Design of the Tailings Storage Facility to Ultimate Elevation**

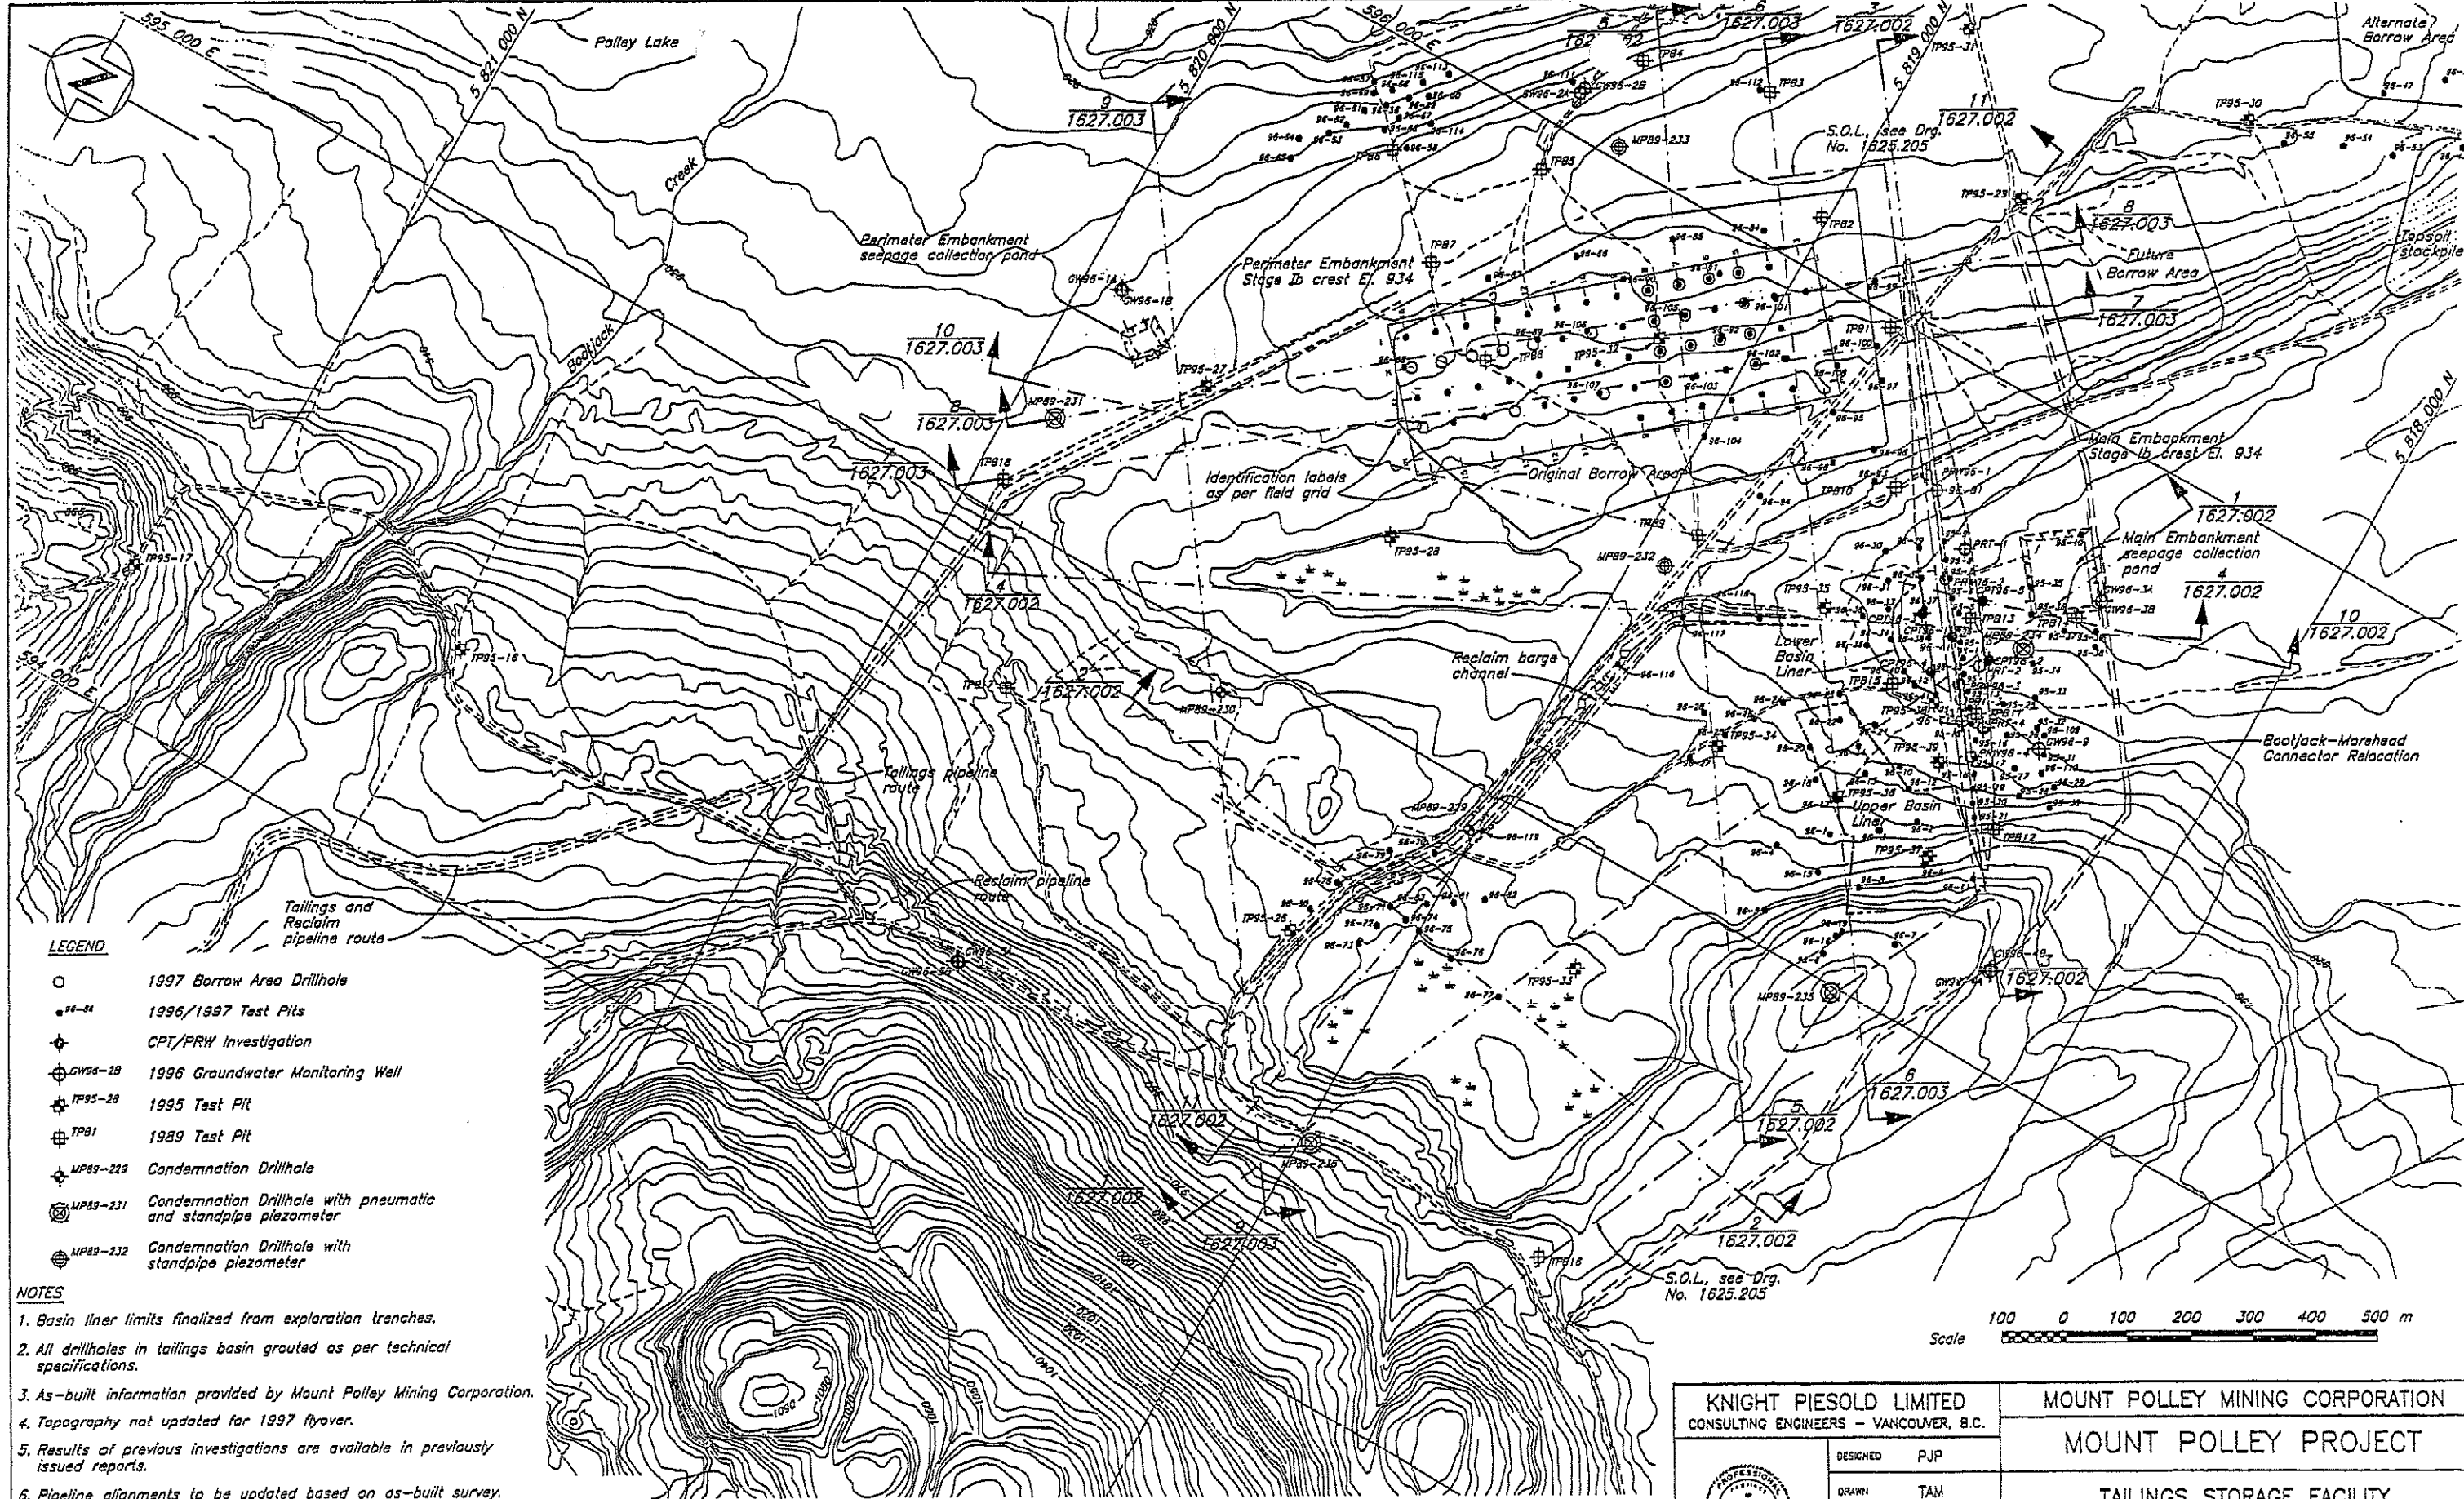
- NOTES**
1. Basin liner limits finalized from exploration trenches.
  2. All drillholes in tailings basin grouted as per technical specifications.
  3. As-built information provided by Mount Polley Mining Corporation.
  4. Topography not updated for 1997 flyover.
  5. Results of previous investigations are available in previously issued reports.
  6. Pipeline alignments to be updated based on as-built survey.
