Job Number: 14-02091
Client: Mount Polley
Project: Mount Polley Mine, Likely, BC
Sounding: VST14-10
Sounding Date: 20-Oct-2014 12:08

Vane Shear Test

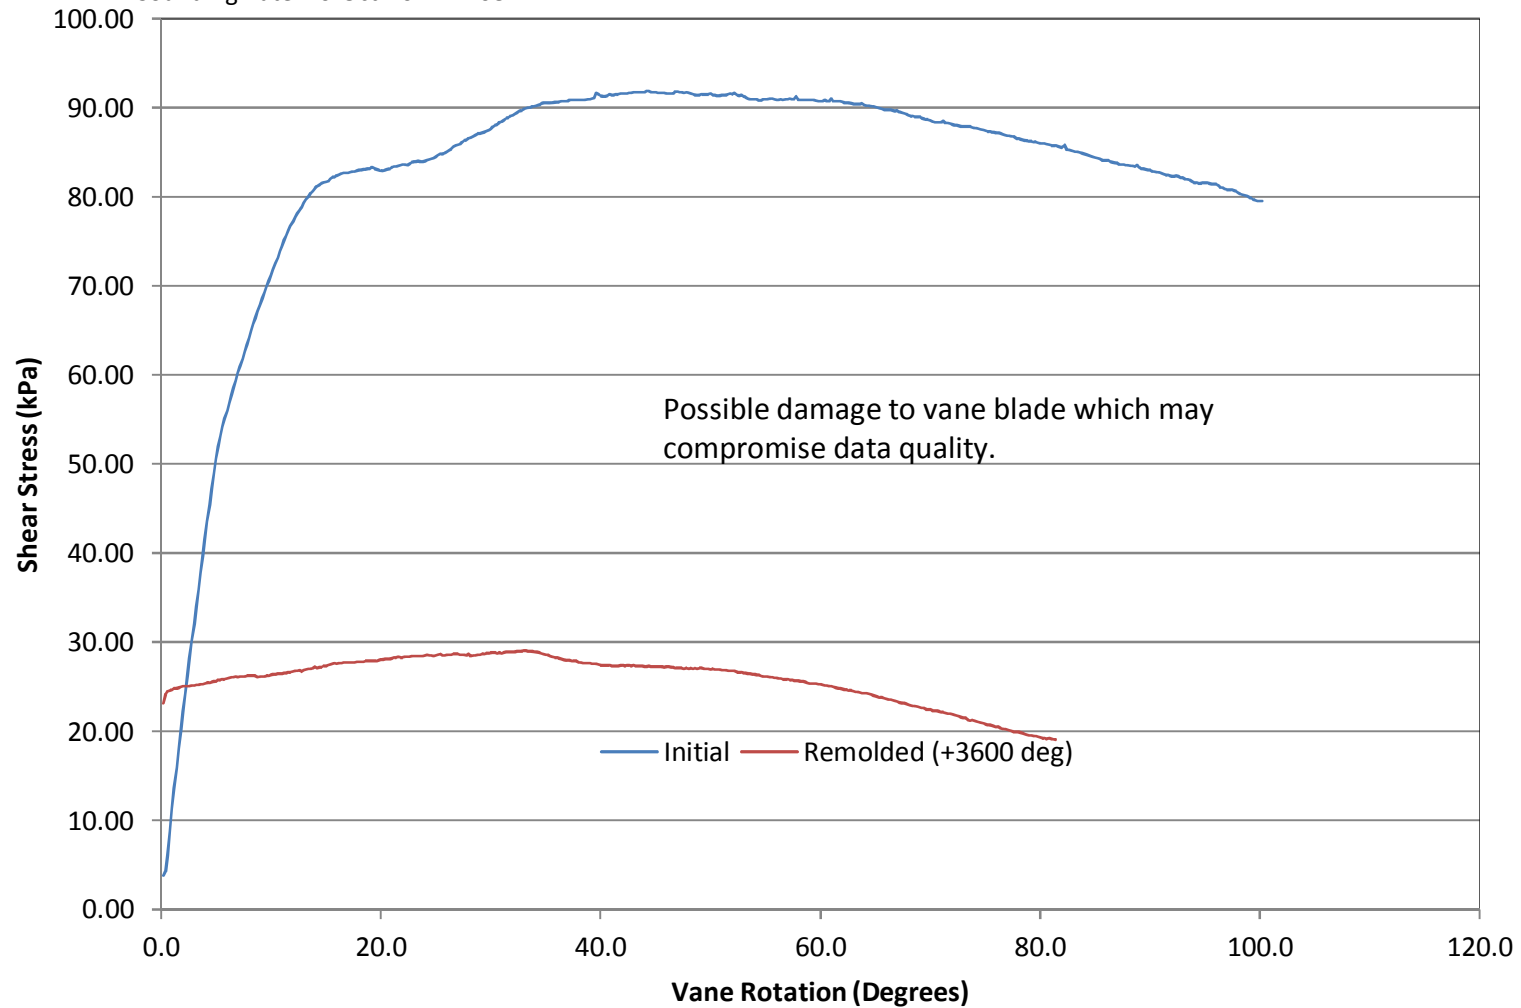
Test Depth (m): 11.48
Test Elevation (m): 920.60
Vane Type: Rectangular 55 x 110 mm

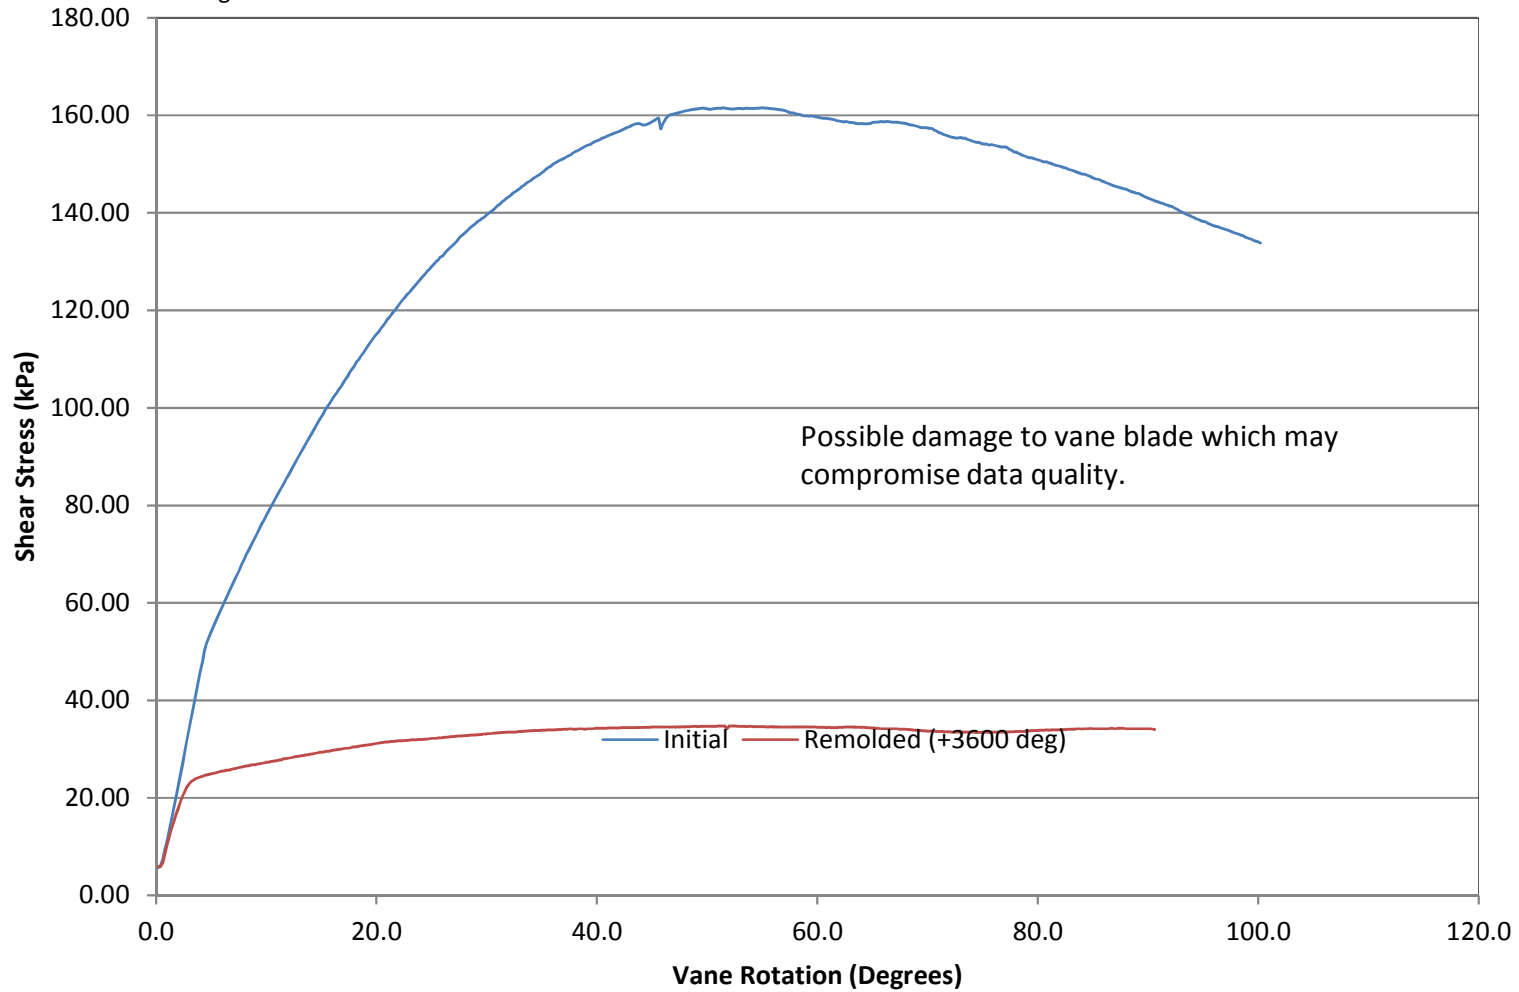
Vane Shear Test

Test Depth (m): 11.78
Test Elevation (m): 920.30
Vane Type: Rectangular 55 x 110 mm

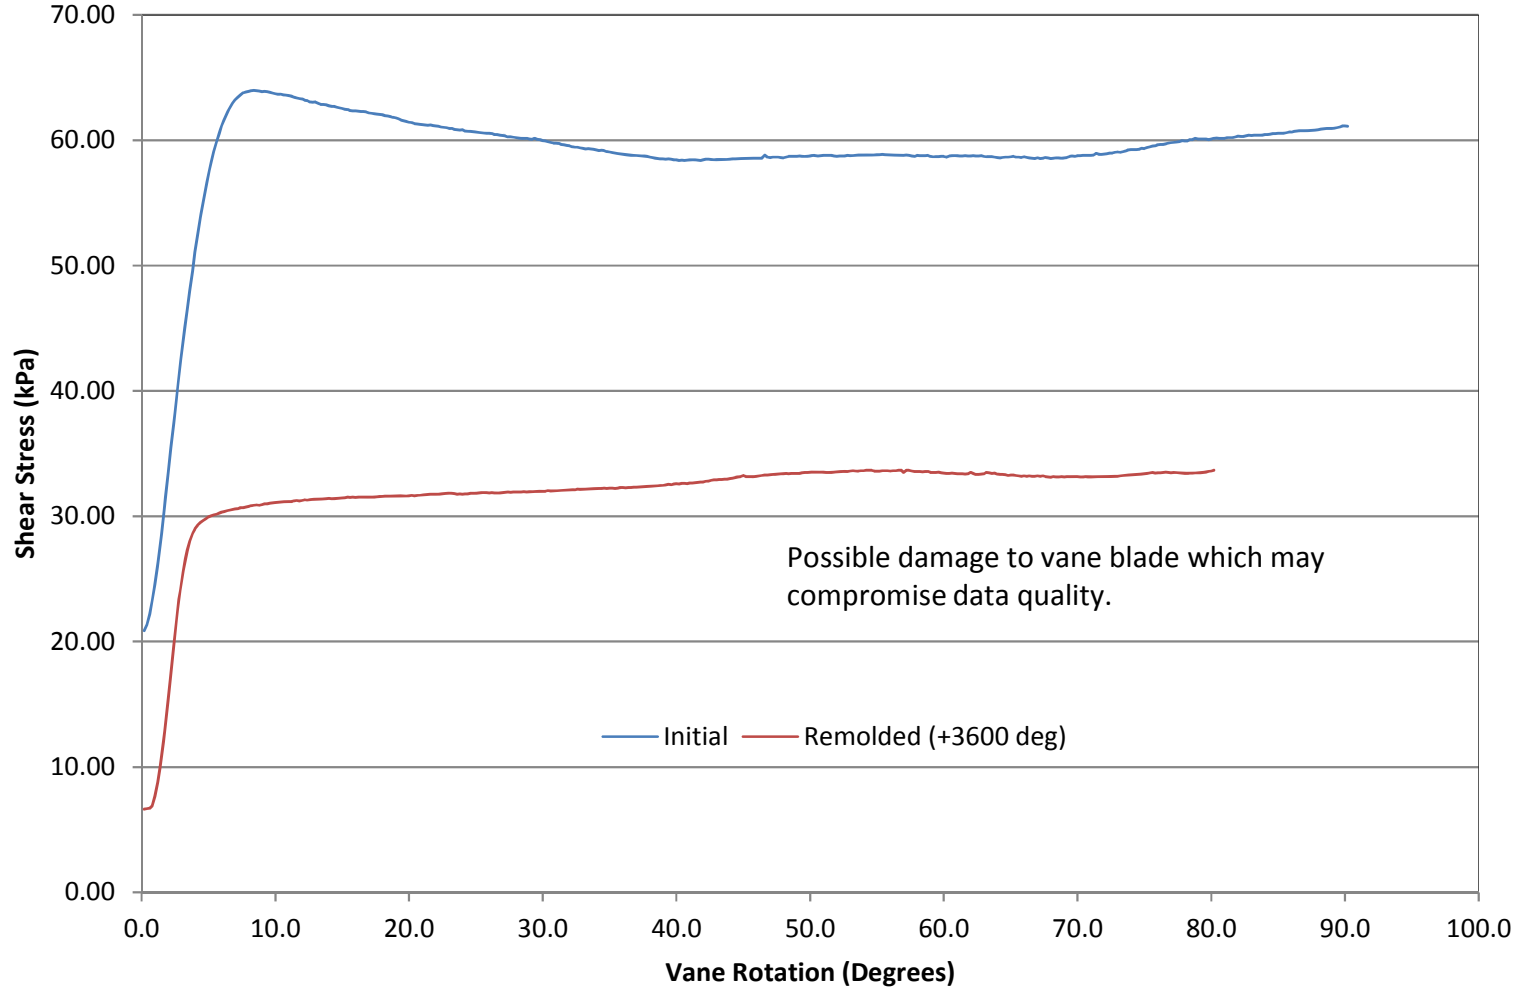
Vane Shear Test

Test Depth (m): 12.08
Test Elevation (m): 920 .00
Vane Type: Rectangular 55 x 110 mm
