**MOUNT POLLEY MINE
Tailings Storage Facility Stage 8/8A
2012 As-Built Report**

30 March 2013

VM00560A

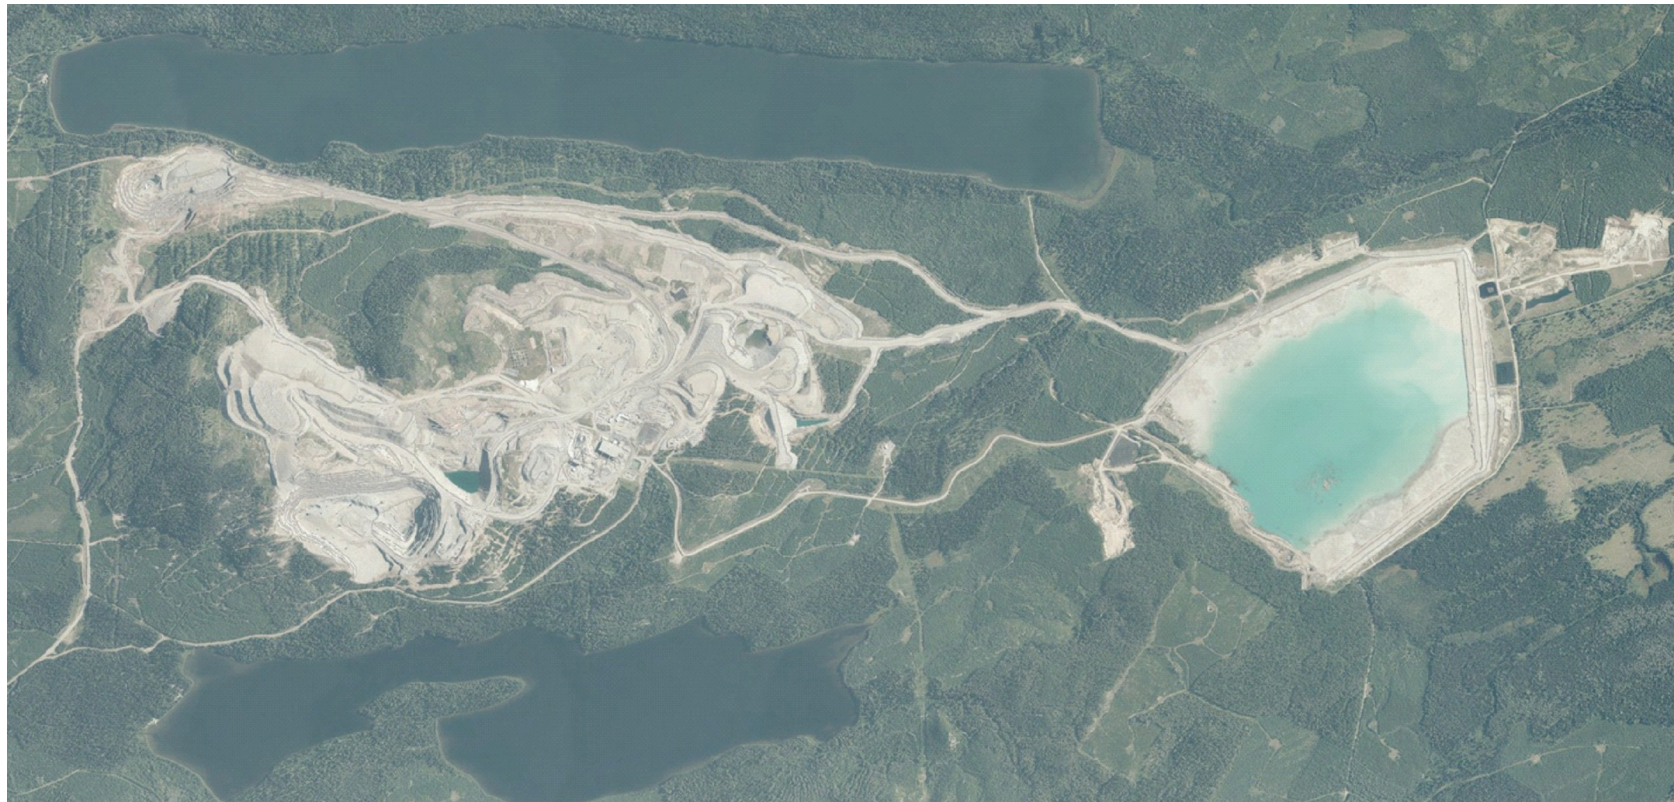
Figure 1.1: Aerial View of Mount Polley Mine Site: 2012

The Mount Polley Mine is located in central British Columbia, approximately 60 km northeast of Williams Lake. The Mount Polley copper and gold mine commenced production in 1997 and operated until October 2001 when operations were suspended for economic reasons. In March 2005 the mine restarted production and has been in continuous operation since. The mill throughput rate is approximately 20,000 tonnes per day (approx. 7.3 million tonnes per year). Mill tailings are discharged as slurry into the Tailings Storage Facility (TSF) located on the south area of the mine property. **Error! Reference source not found.** shows an aerial view of the site from 2012.
