**MOUNT POLLEY MINING CORPORATION
MOUNT POLLEY MINE
TAILINGS STORAGE FACILITY**

**REPORT ON 1999 CONSTRUCTION
(REF. NO. 11162/13-5)**

Rev. No.	Revision	Date	Approved
0	Issued in Final	August 30, 2000	KJB

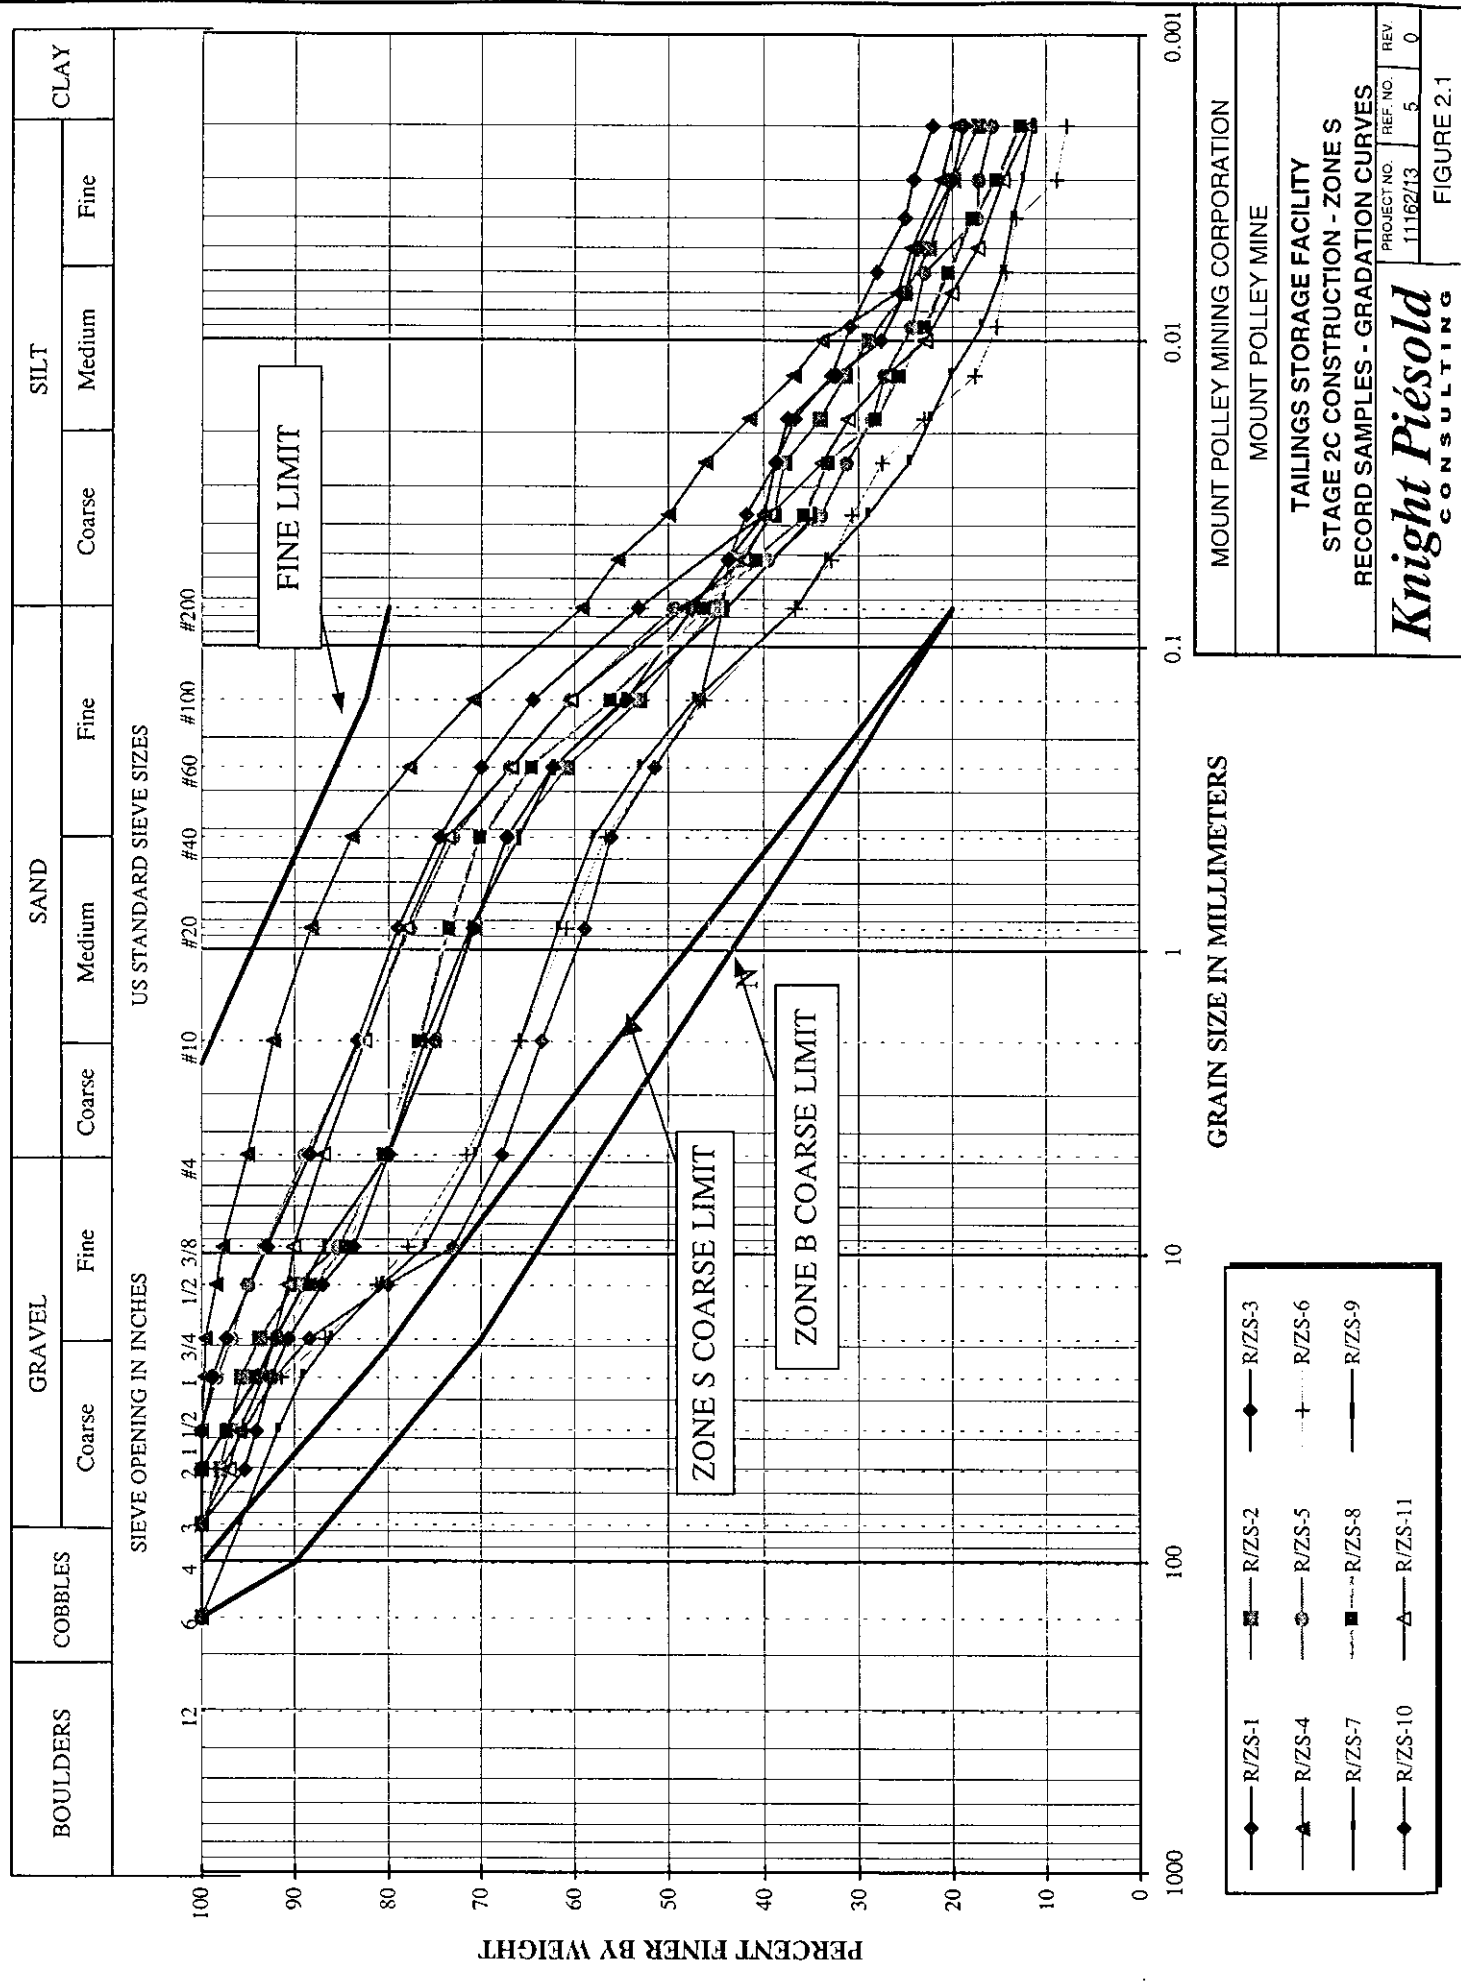
FIGURE 2.1

TAILINGS STORAGE FACILITY
STAGE 2C CONSTRUCTION - ZONE S
RECORD SAMPLES - GRADATION CURVES

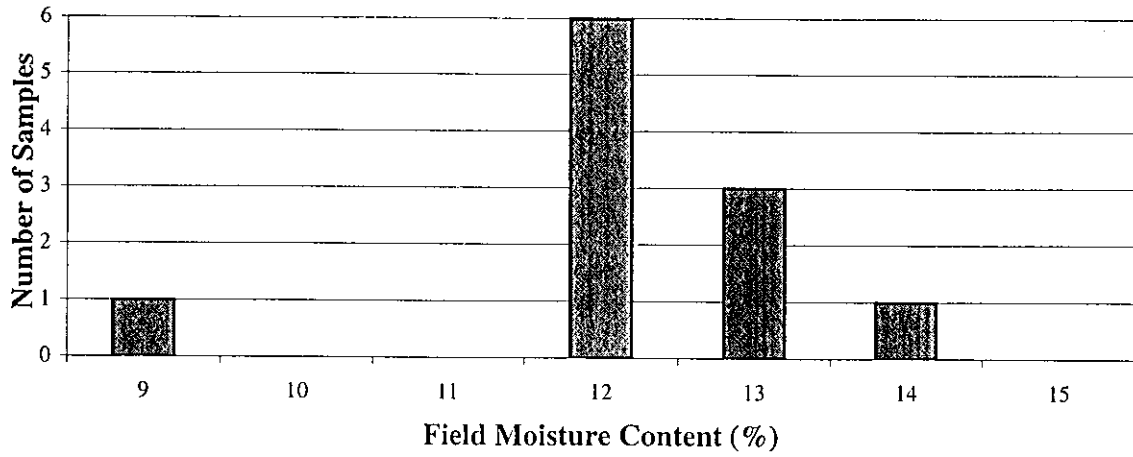
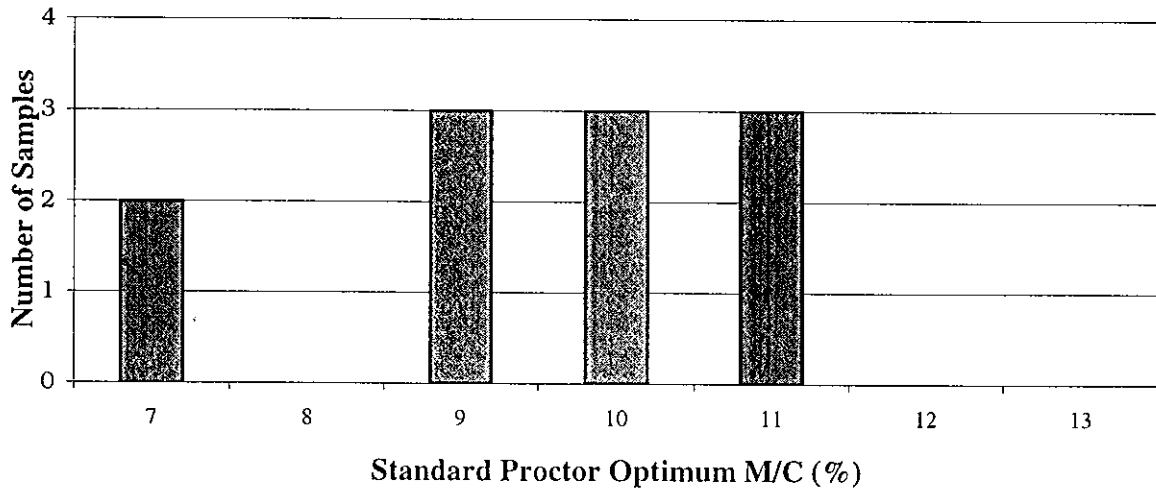
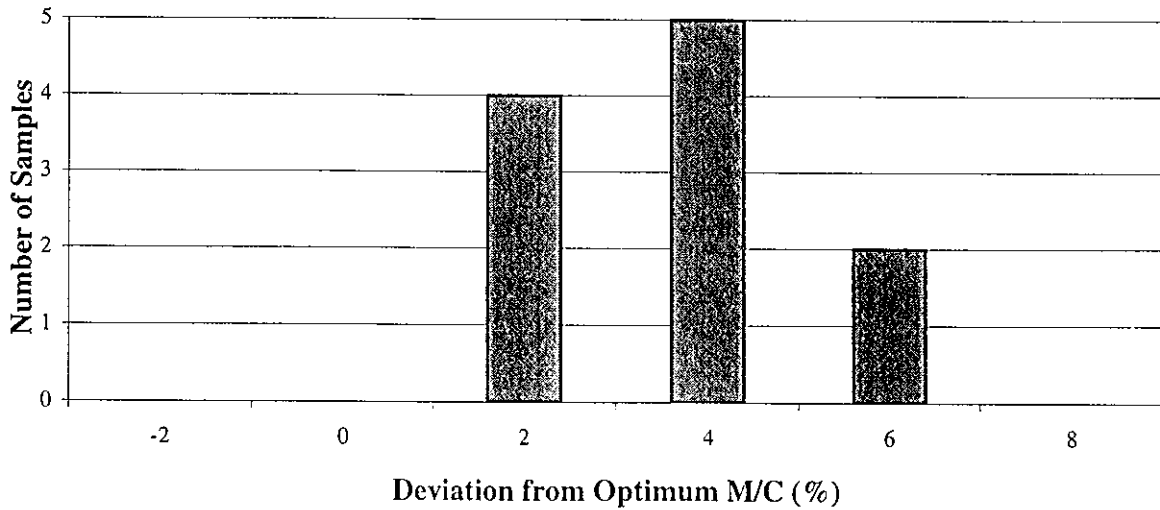
MOUNT POLLEY MINING CORPORATION		
MOUNT POLLEY MINE		
STAGE 2C CONSTRUCTION ZONE S RECORD SAMPLES MOISTURE CONTENT HISTOGRAMS		
	PROJECT NO. 11162/13	REF. NO. 5
	REV. 0	
FIGURE 2.2

N=11

The median field moisture content was 11.8 percent, while the median optimum moisture content was 9.6 percent. The median deviation from the optimum moisture content was 2.2 percent wet of optimum. Moisture conditioning was impractical due to freezing temperatures. Material too wet for direct placement in the Zone S fill was typically avoided in the borrow areas.

Histograms were generated to illustrate the results of the Field Density and Moisture Content testing. The field moisture content, Standard Proctor optimum moisture content and deviation from optimum for the Zone S Record samples are shown on Figure 2.2, while Figure 2.3 shows the measured field dry density, the Standard Proctor maximum dry density and the corresponding percent compaction. Figure 2.4 shows the results of 1472 Field Density and Moisture Content tests conducted in Zone S during Stage 2C construction.

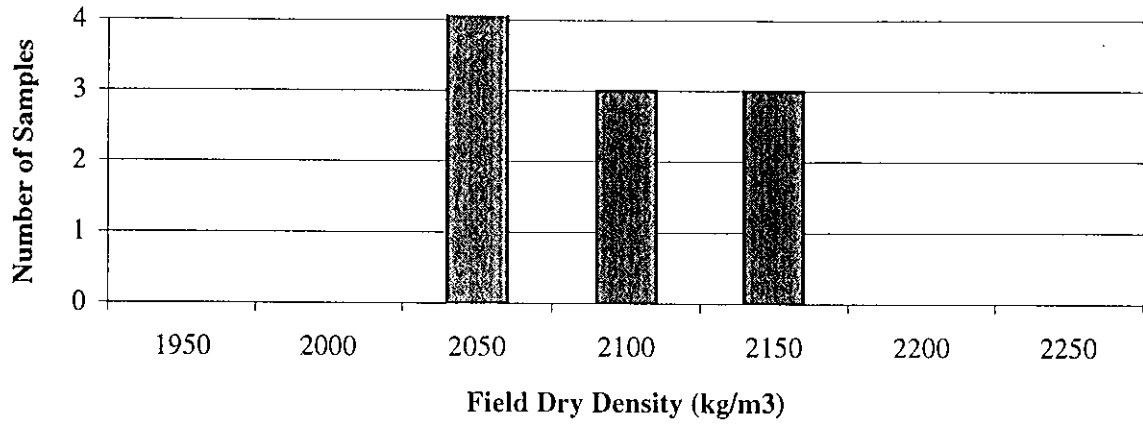
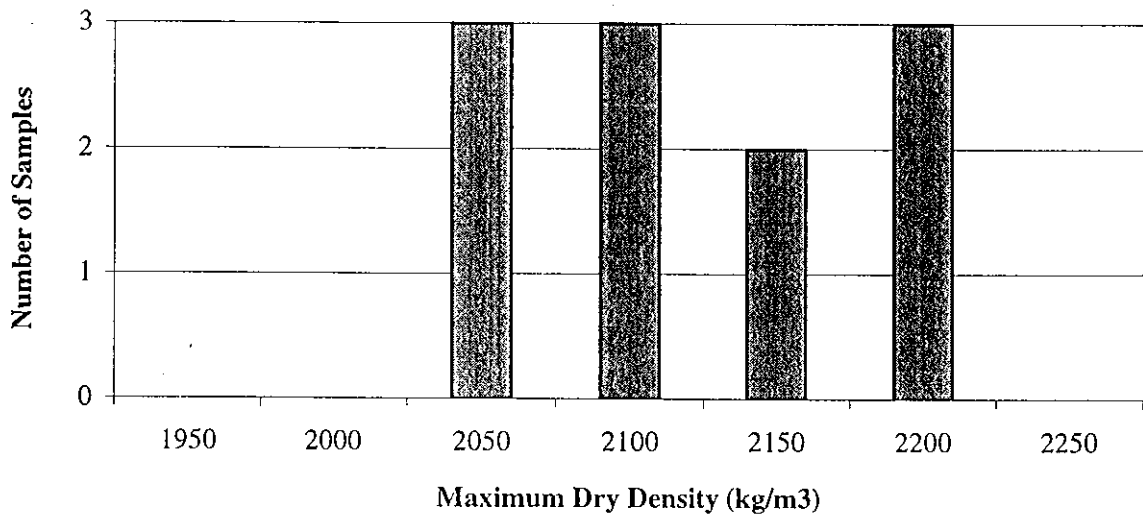
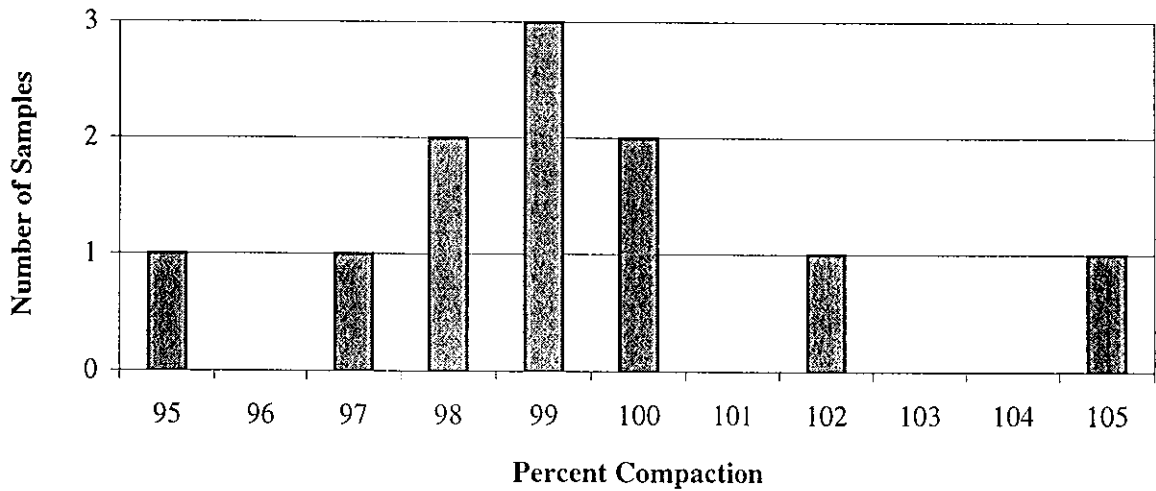
MOUNT POLLEY MINING CORPORATION		
MOUNT POLLEY MINE		
STAGE 2C CONSTRUCTION ZONE S RECORD SAMPLES DENSITY AND COMPACTION HISTOGRAMS		
<i>Knight Piésold</i> CONSULTING	PROJECT NO. 11162/13	REF. NO. 5
	REV. 0	FIGURE 2.3

N=11

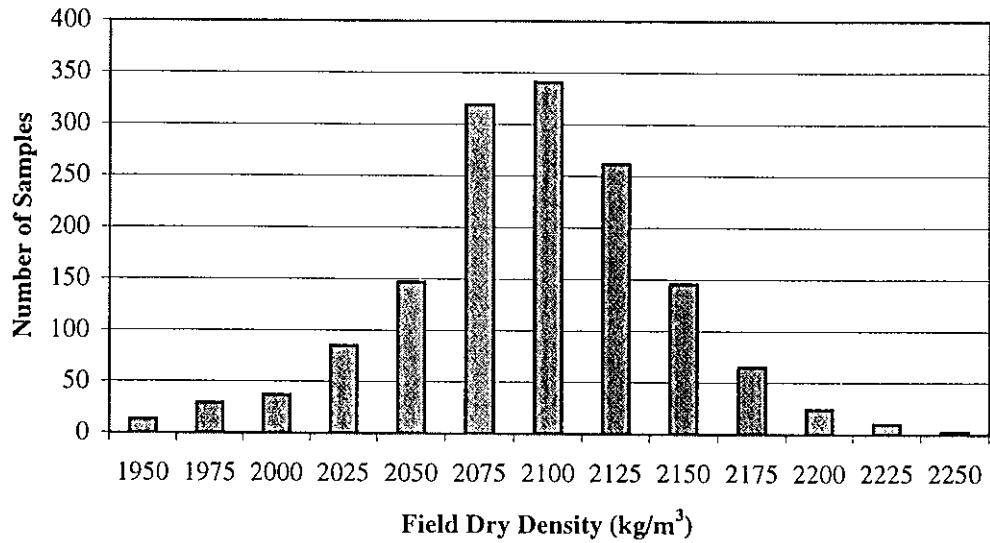
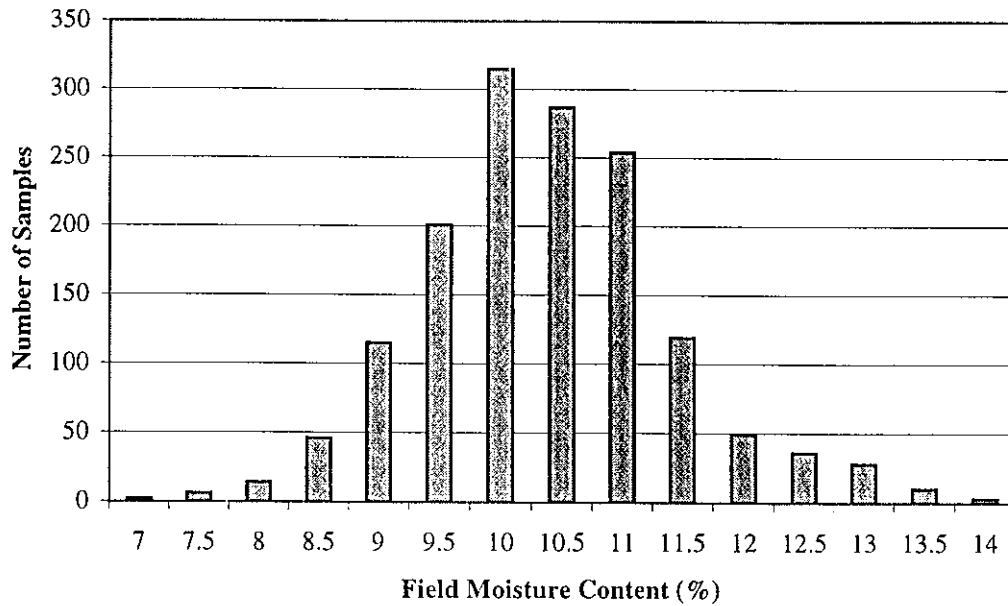
MOUNT POLLEY MINING CORPORATION		
MOUNT POLLEY MINE		
STAGE 2C CONSTRUCTION ZONE S - FIELD DENSITY AND MOISTURE CONTENT HISTOGRAMS		
Knight Piésold CONSULTING	PROJECT NO. 11162/13	REF. NO. 5
	REV. 0	FIGURE 2.4

Notes:
 1. N=1472
 2. Dry density and moisture content measured by nuclear densometer.

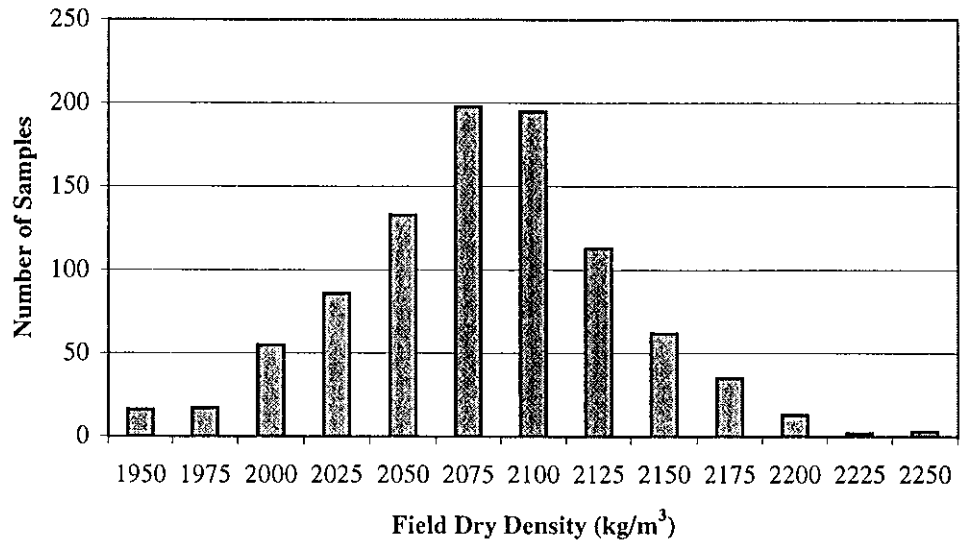
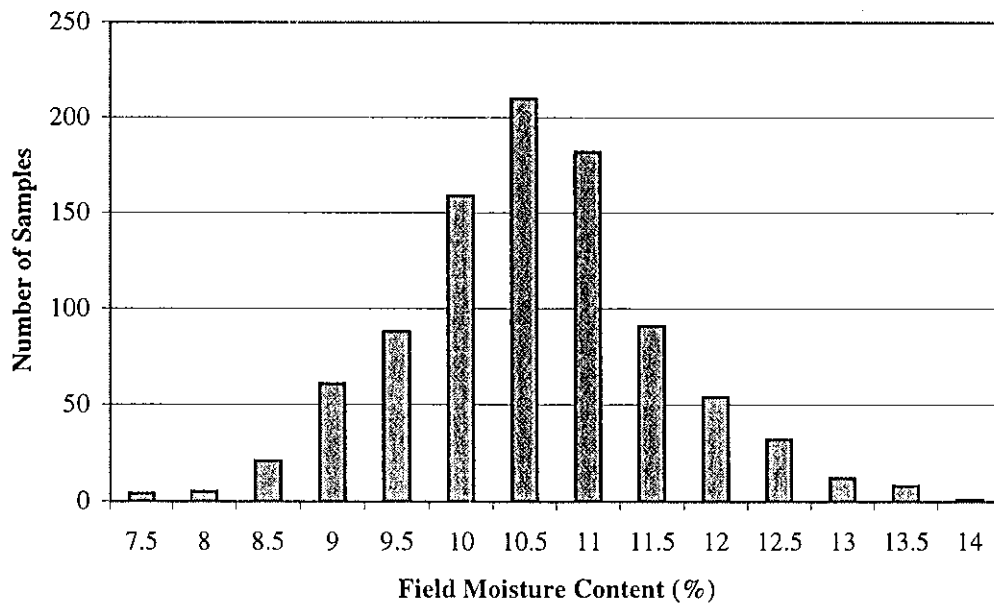
MOUNT POLLEY MINING CORPORATION		
MOUNT POLLEY MINE		
STAGE 2C CONSTRUCTION ZONE B - FIELD DENSITY AND MOISTURE CONTENT HISTOGRAMS		
<i>Knight Piésold</i> CONSULTING	PROJECT NO. 11162/13	REF. NO. 5
	REV. 0	FIGURE 2.5

Notes:
 1. N=931
 2. Dry density and moisture content measured by nuclear densometer.

Histograms were generated to illustrate the results of the 931 Field Density and Moisture Content tests conducted in Zone B during Stage 2C construction. The histograms are shown on Figure 2.5.

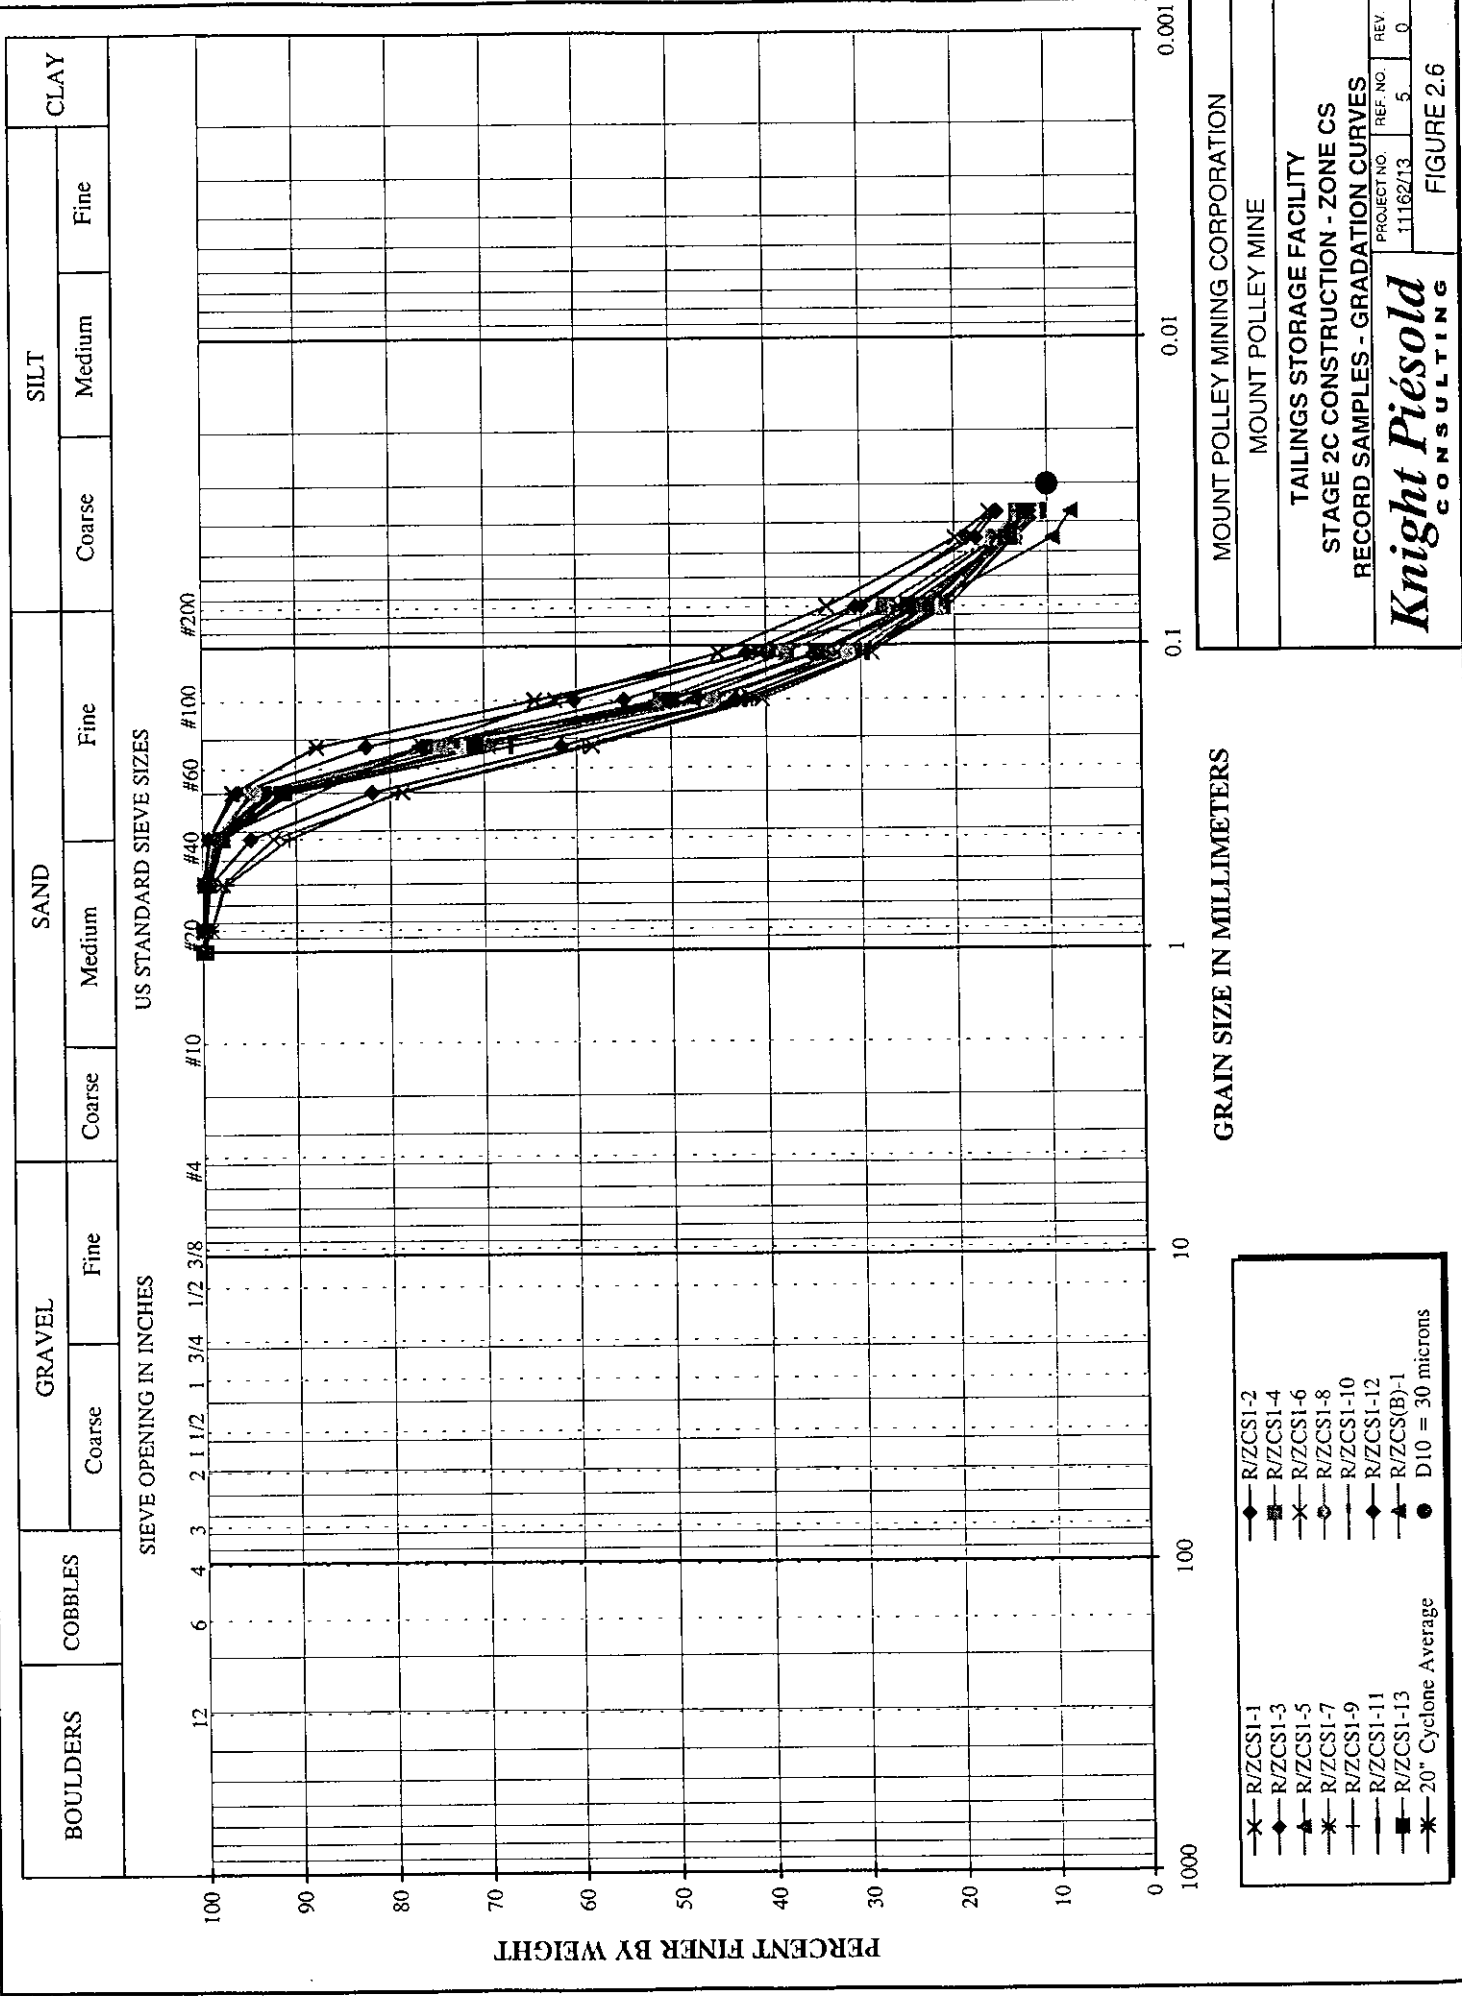
FIGURE 2.6

MOUNT POLLEY MINING CORPORATION
MOUNT POLLEY MINE
TAILINGS STORAGE FACILITY
STAGE 2C CONSTRUCTION - ZONE CS
RECORD SAMPLES - GRADATION CURVES

A total of fourteen (14) samples were taken for record testing of Zone CS. Particle size analyses were conducted on all samples. Moisture content, laboratory compaction and field density tests were conducted on two (2) samples of hydraulically placed Zone CS and one (1) sample of mechanically placed Zone CS.

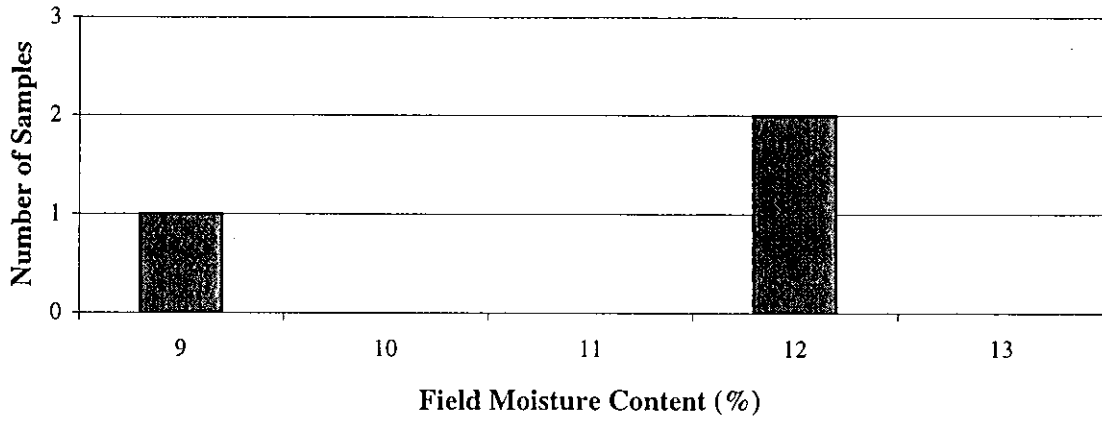
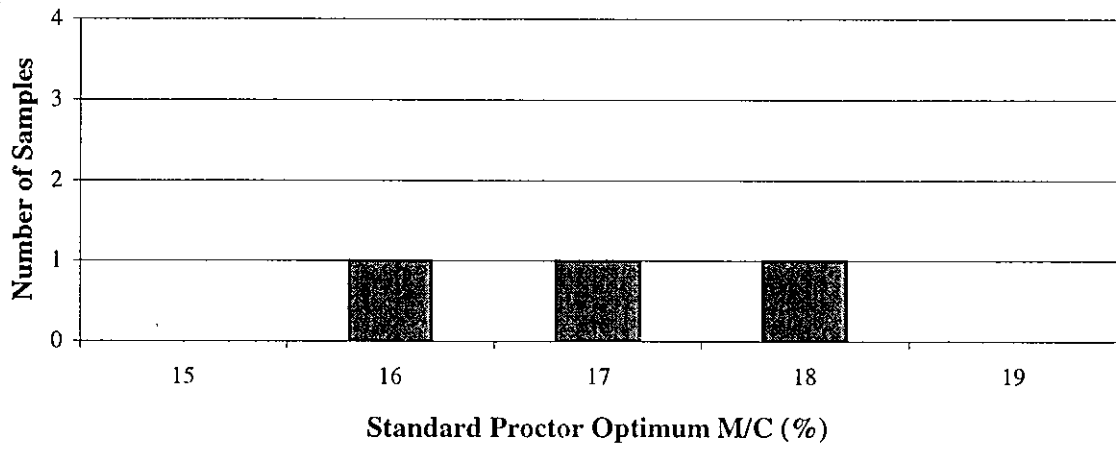
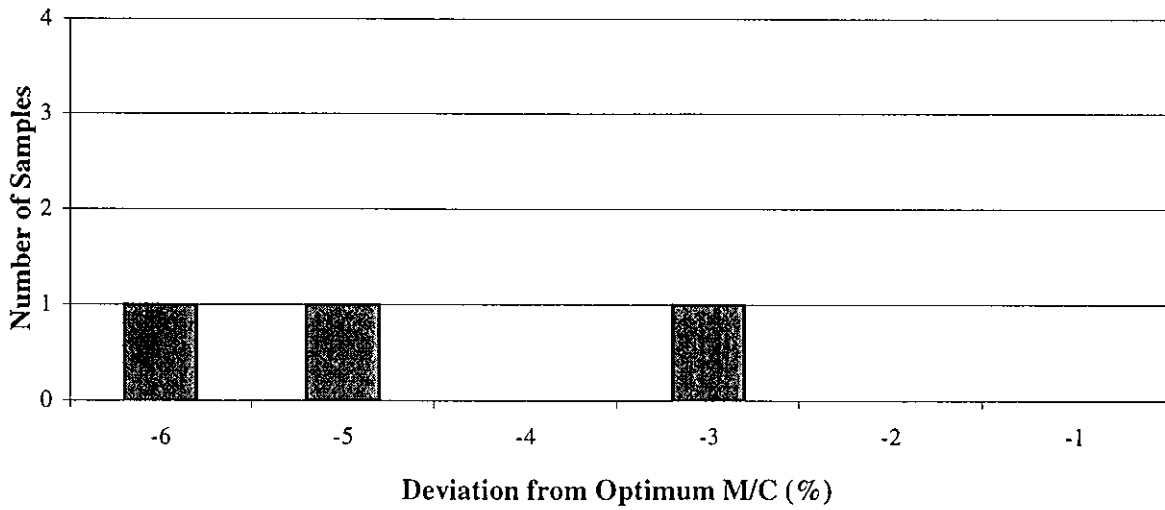
MOUNT POLLEY MINING CORPORATION		
MOUNT POLLEY MINE		
STAGE 2C CONSTRUCTION		
ZONE CS RECORD SAMPLES		
MOISTURE CONTENT HISTOGRAMS		
<i>Knight Piésold</i> CONSULTING	PROJECT NO. 11162/13	REF. NO. 1
	REV. 0	FIGURE 2.7

N=3

The median field moisture content, as measured with a nuclear densometer, was 11.6 percent, while the median optimum moisture content was 17.0 percent. The median deviation from optimum moisture content was 5.4 percent wet of optimum. There was no significant difference in the moisture contents of hydraulically and mechanically placed Zone CS.

Histograms for moisture content and density from the nuclear densometer were generated. These are shown on Figures 2.7 and 2.8.

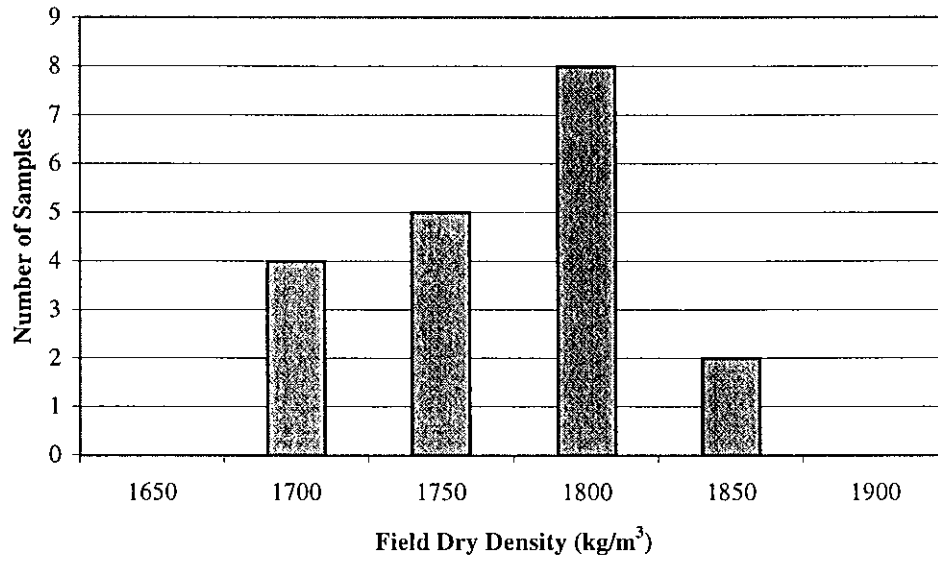
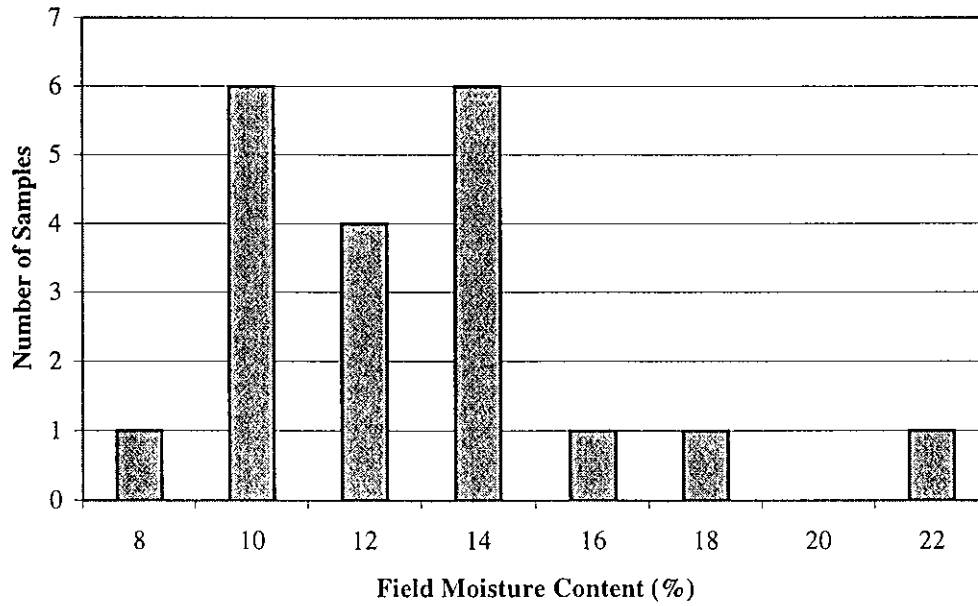
MOUNT POLLEY MINING CORPORATION		
MOUNT POLLEY MINE		
STAGE 2C CONSTRUCTION		
ZONE CS - FIELD DENSITY AND		
MOISTURE CONTENT HISTOGRAMS		
<i>Knight Piésold</i> CONSULTING	PROJECT NO. 11162/13	REF. NO. 5
	REV. 0	FIGURE 2.9

Notes:
 1. N=20
 2. Dry density and moisture content measured by nuclear densometer.

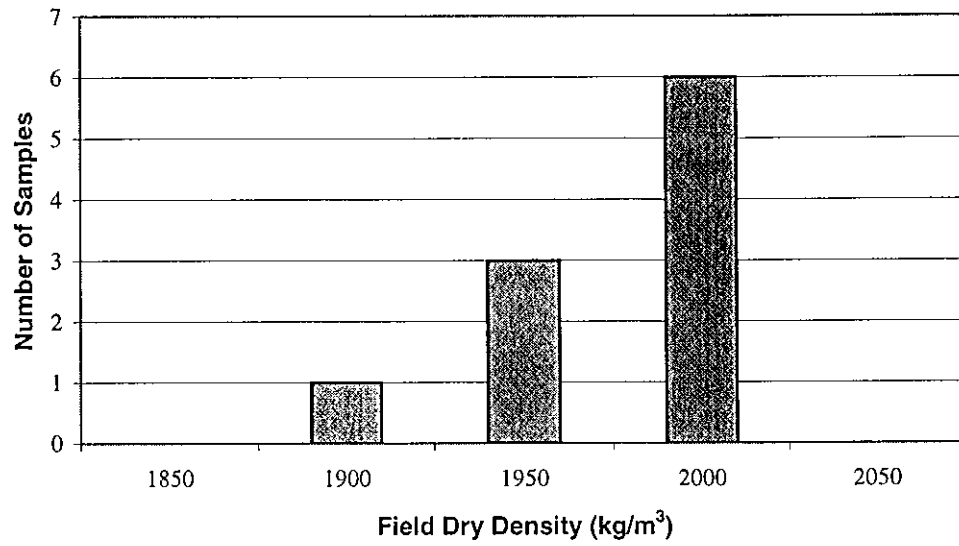
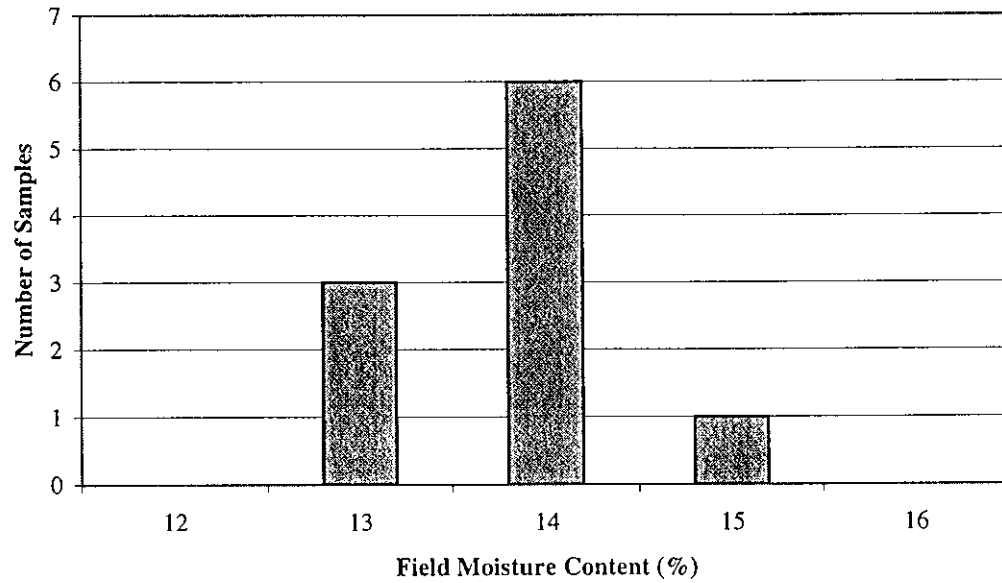
MOUNT POLLEY MINING CORPORATION		
MOUNT POLLEY MINE		
STAGE 2C CONSTRUCTION BASIN LINER - FIELD DENSITY AND MOISTURE CONTENT HISTOGRAMS		
<i>Knight Piésold</i> CONSULTING	PROJECT NO. 11162/13	REF. NO. 5
	REV. 0	FIGURE 2.10

Notes:
 1. N=10
 2. Dry density and moisture content measured by nuclear densometer.

No laboratory testwork was conducted on basin liner material. A total of ten (10) field density and moisture content tests were conducted with a nuclear densometer. The median dry density of basin liner material was 1958 kg/m³ and the median field moisture content was 13.2 percent.

Histograms for moisture content and density are shown on Figure 2.9.

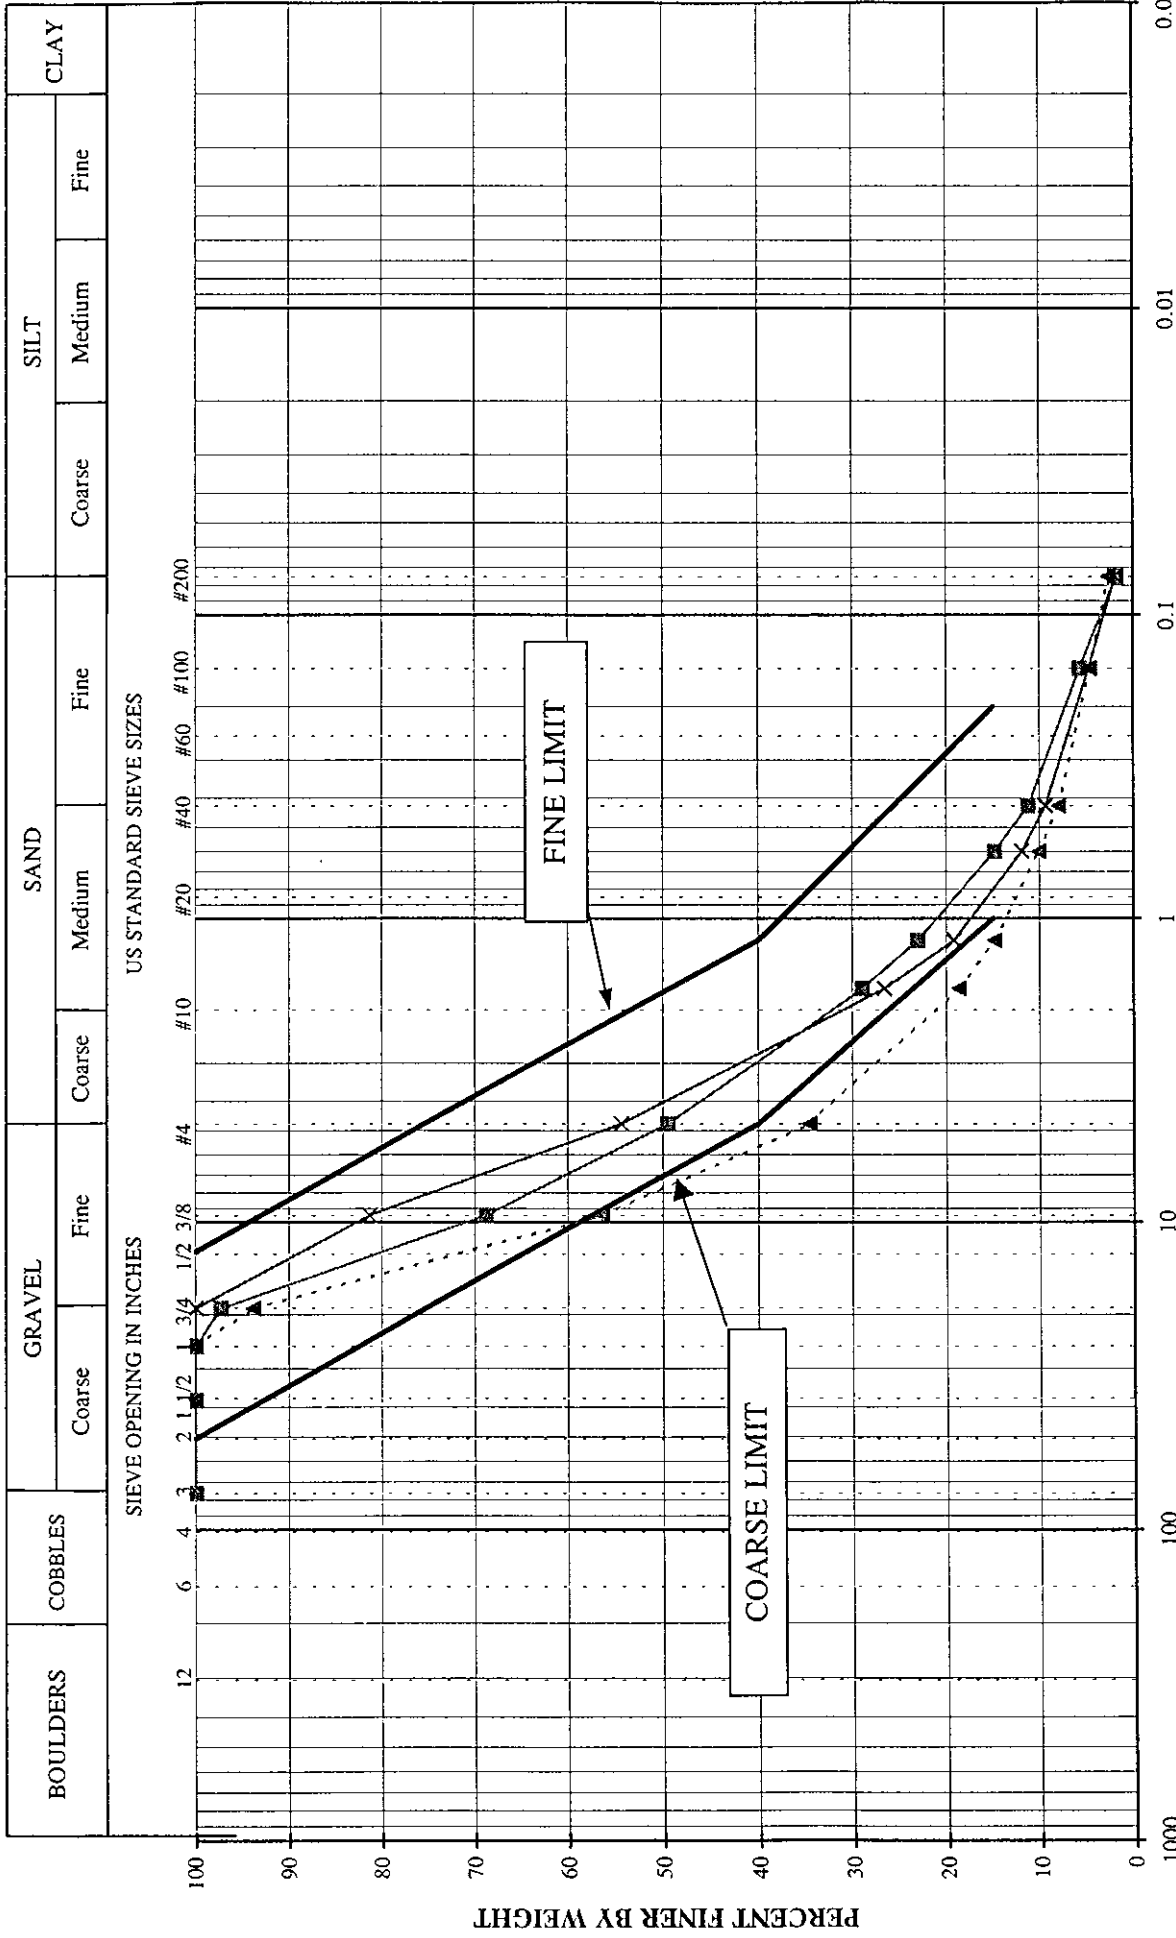
FIGURE 2.11

Note: Sample R/ZF-2 slightly exceeds coarse limit, but still satisfies filter relationship with surrounding materials.

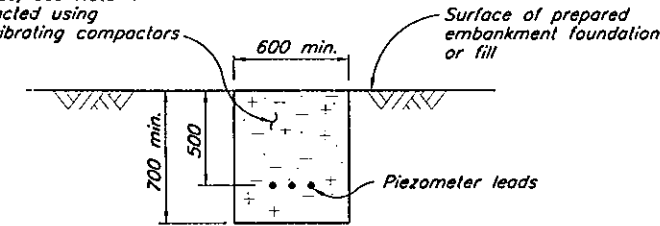
Bedding and backfill for piezometer leads, see Note 4
Material compacted using hand-guided vibrating compactors

TYPICAL SECTION THROUGH PIEZOMETER LEAD TRENCH IN PREPARED EMBANKMENT FOUNDATION OR FILL

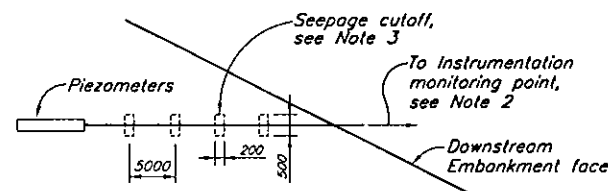
DETAIL A
TYPICAL DETAIL OF SEEPAGE CUTOFF FOR PIEZOMETER LEADS IN GLACIAL TILL
NTS

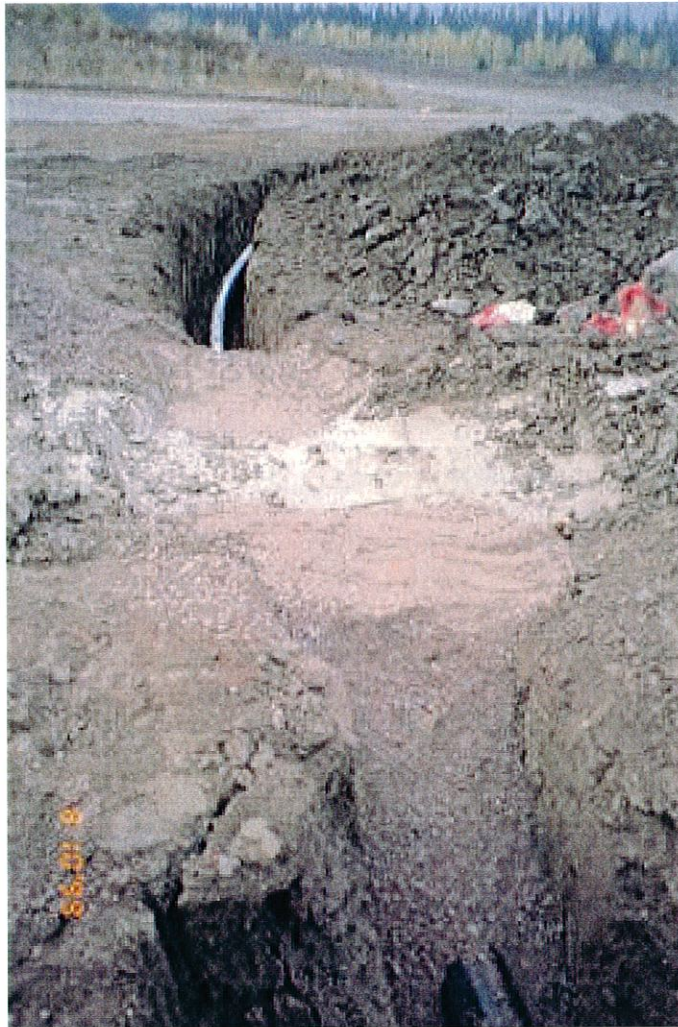
Photo No. 4: Upstream toe drain outlet. Backfill around the downstream seepage collars consisted of bentonite-modified till and filter sand.

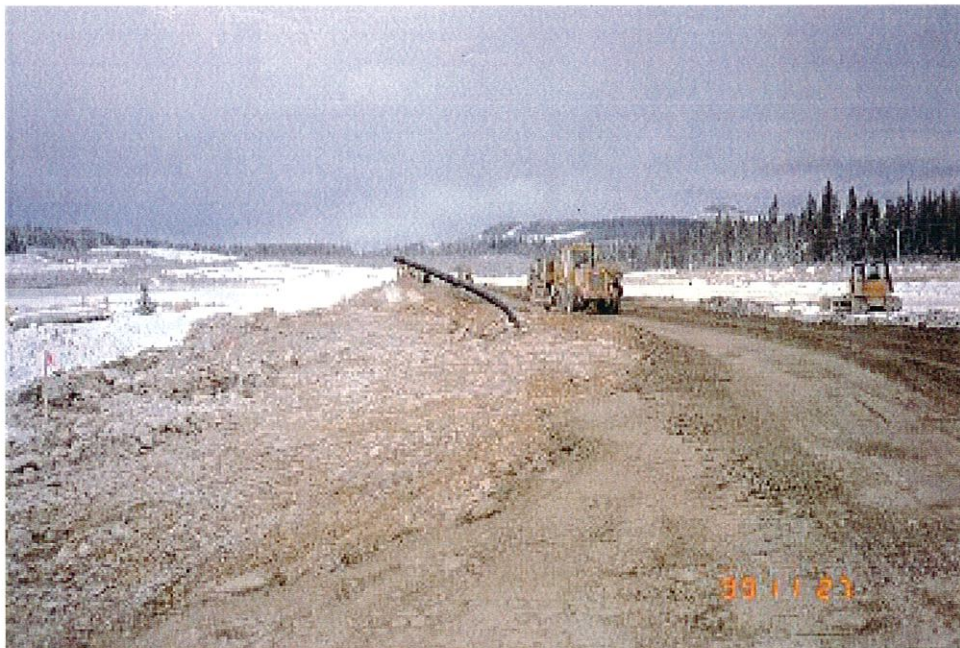
Photo No. 6: Perimeter Embankment upstream toe drain (to be installed later) will tie into the exposed pipe.

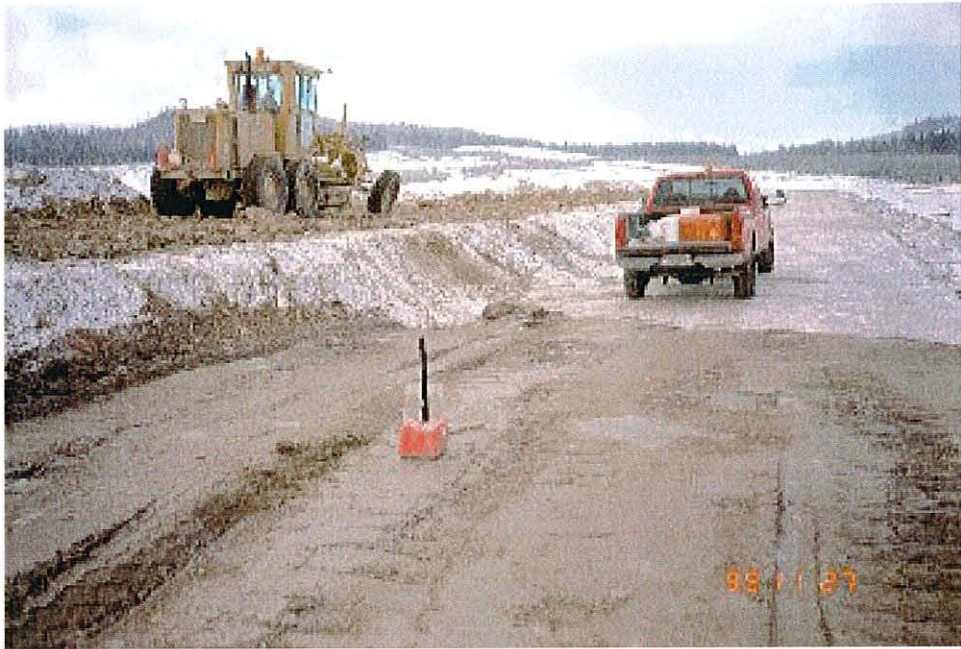
Photo No. 8: Density testing of Zone S fill.
