**MOUNT POLLEY MINING CORPORATION  
MOUNT POLLEY MINE**

**TAILINGS STORAGE FACILITY  
REPORT ON 2010 ANNUAL INSPECTION**

VA101-1/29-2  
Rev 1  
January 25, 2011

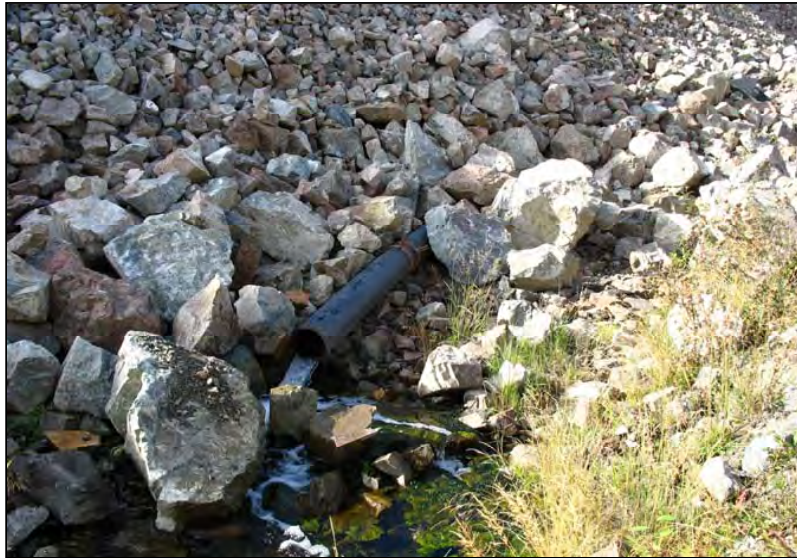
**PHOTO 3** – Perimeter Embankment Toe Drain Flow.

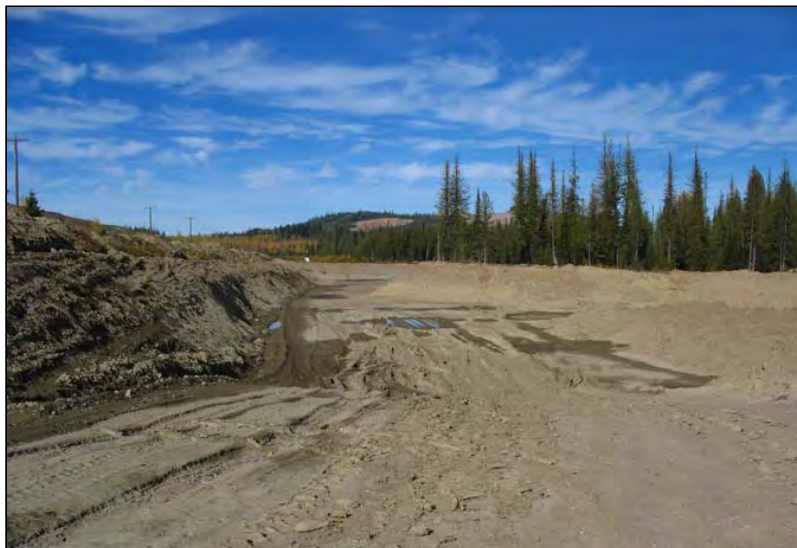
**PHOTO 4** – Glacial Till borrow Downstream of Perimeter Embankment.

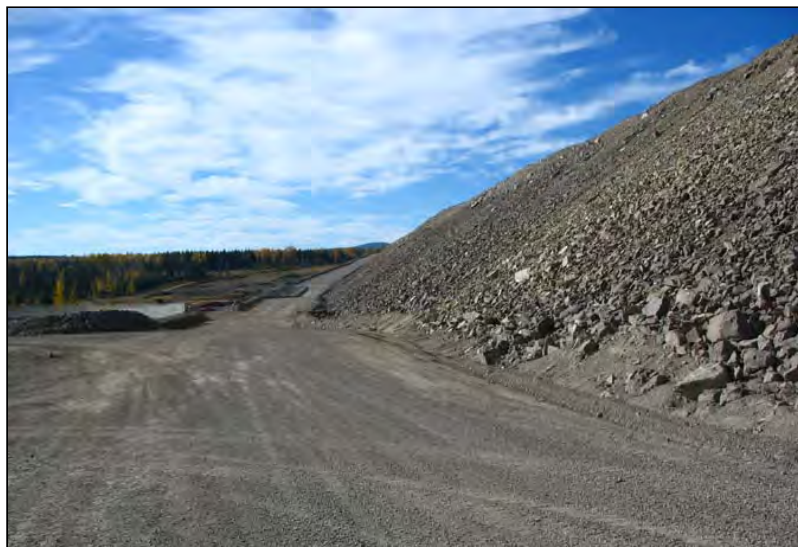
**PHOTO 8** – Downstream Slope of Main Embankment.

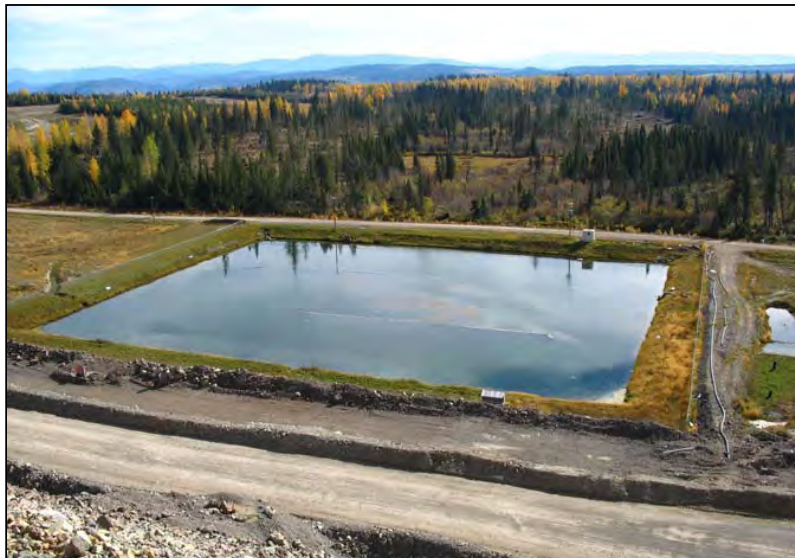
**PHOTO 9** – Main Embankment Seepage Collection and Recycle Pond.

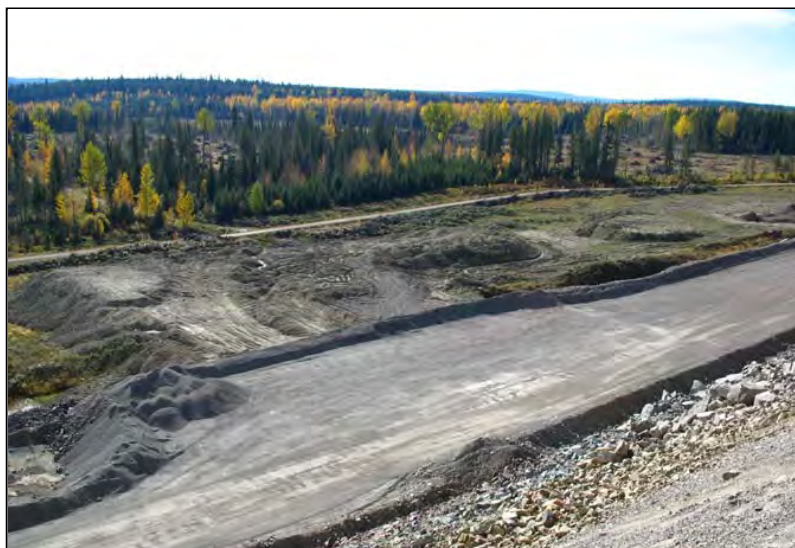
**PHOTO 10** – Main Embankment Buttress.

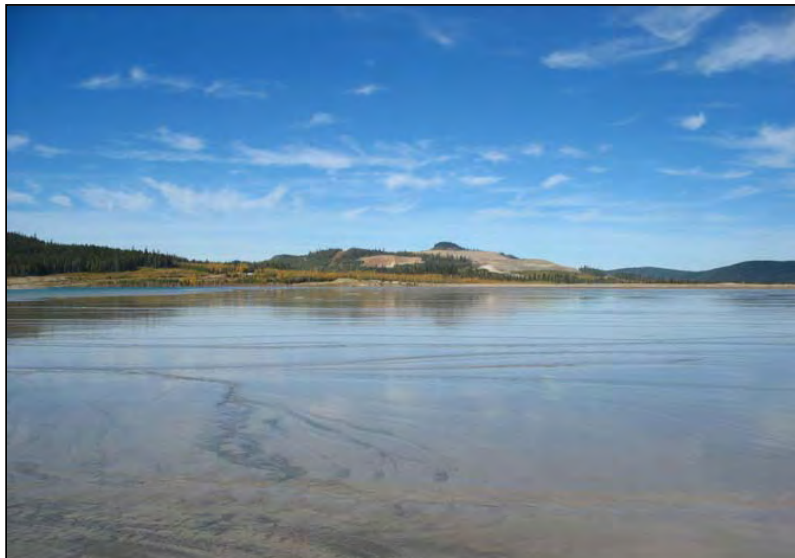
**PHOTO 11** – Tailings Beach, From Main Embankment looking towards Perimeter Embankment.

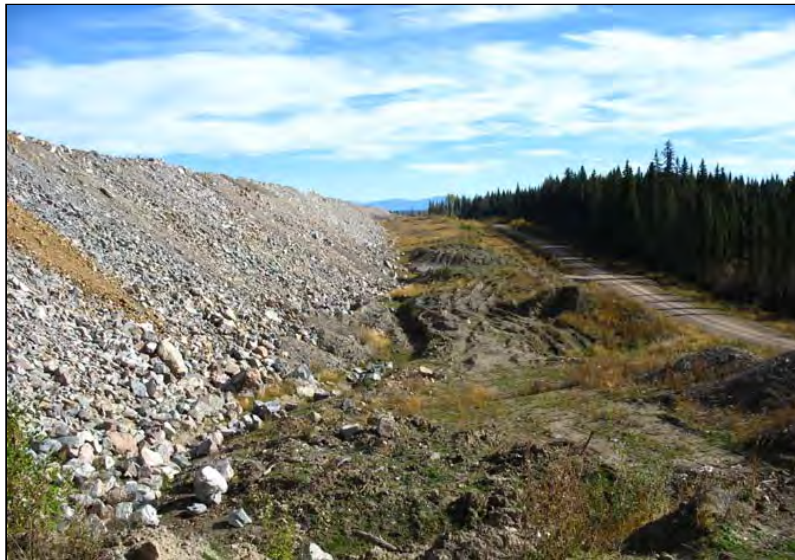
**PHOTO 12** – Downstream Slope of South Embankment.

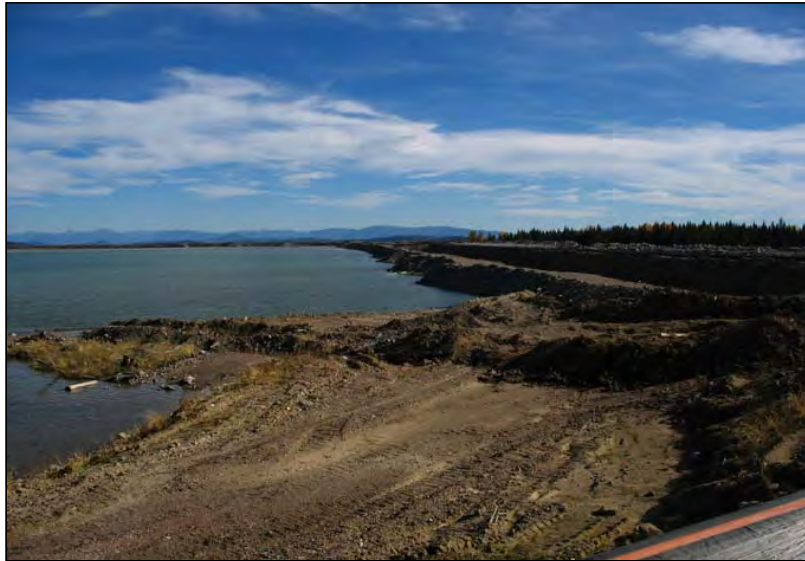
**PHOTO 13** – South Embankment – Supernatant Pond adjacent to the dam

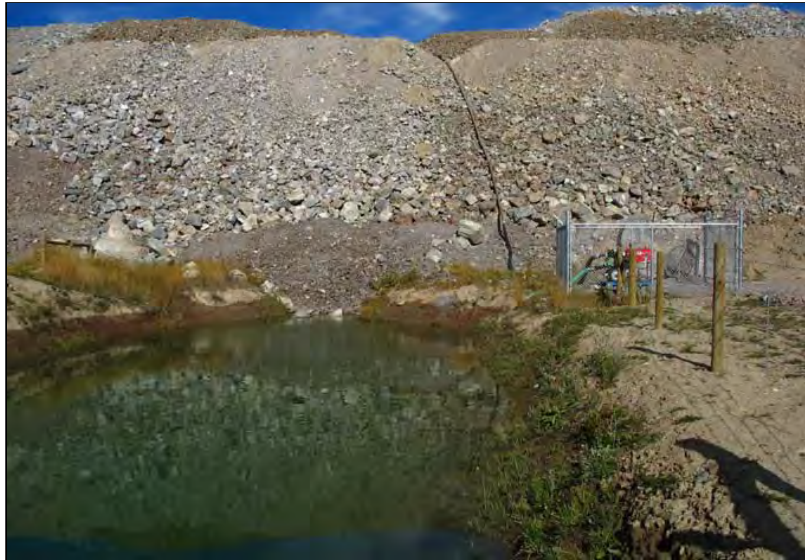
**PHOTO 14** – South Embankment Seepage Collection and Recycle Pond.

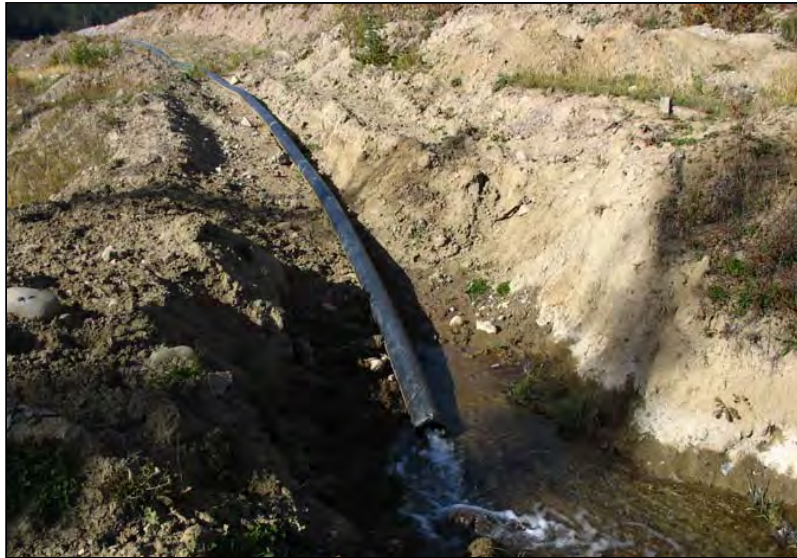
**PHOTO 15** – South Embankment Upstream Toe Drain flow.

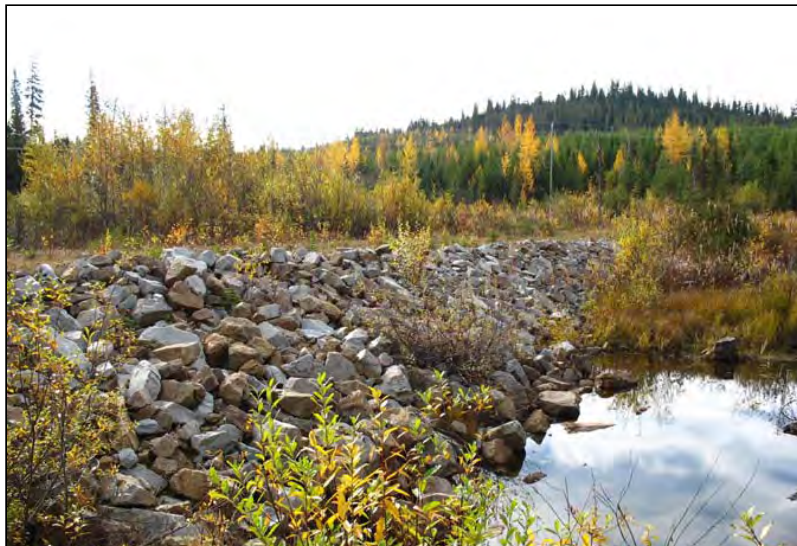
**PHOTO 16** – South Bootjack Dam.
