## **MOUNT POLLEY MINING CORPORATION**

## MOUNT POLLEY MINE

## TAILINGS STORAGE FACILITY 2012 ANNUAL REVIEW

DOCUMENT NO.:
 MP13-01

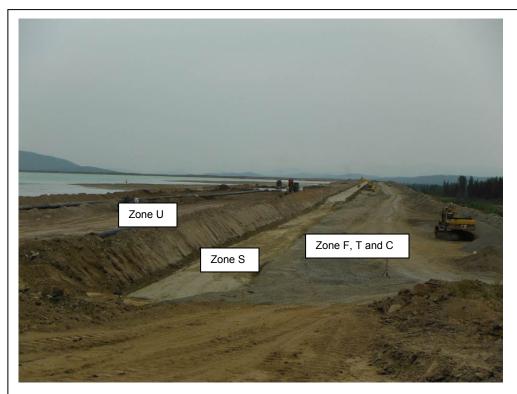
Photo 1: South embankment fill placement near corner 4.

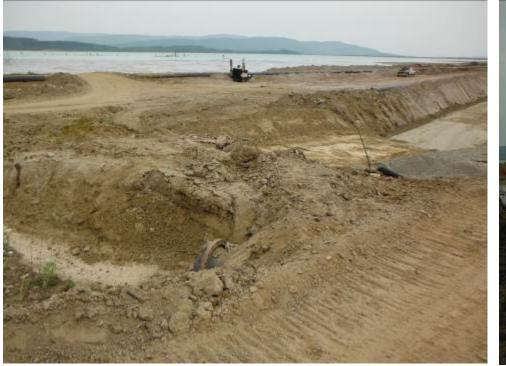
Photo 2: South embankment abutment tie-in

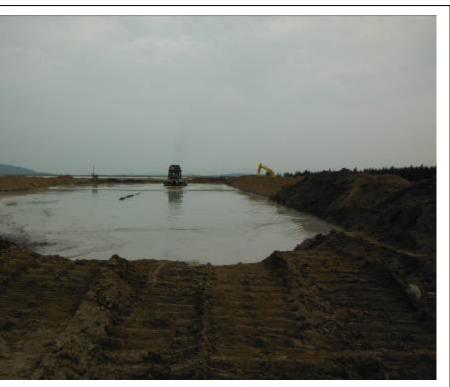
Photo 6: South embankment Zone C (downstream shell), looking west. Drain pumpback to impoundment shown.

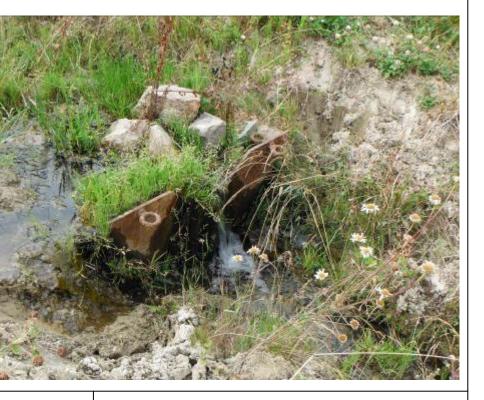
Photo 9: Main embankment downstream toe, looking south at Main embankment collection pond.

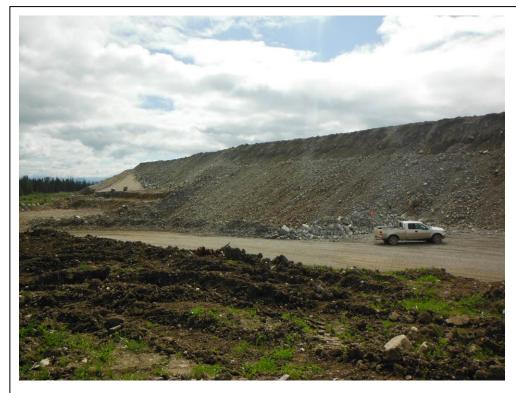
Photo 12: Perimeter embankment new access at Corner 1, looking northeast.

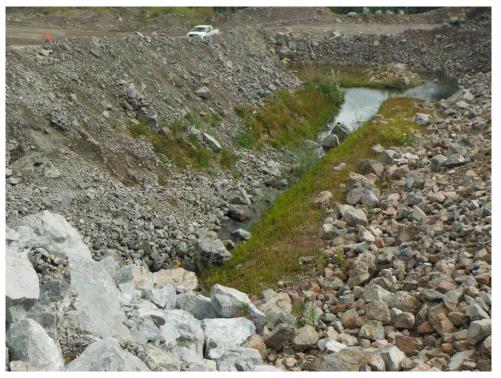
Photo 13: Perimeter drain discharge as impacted by haul road connection.

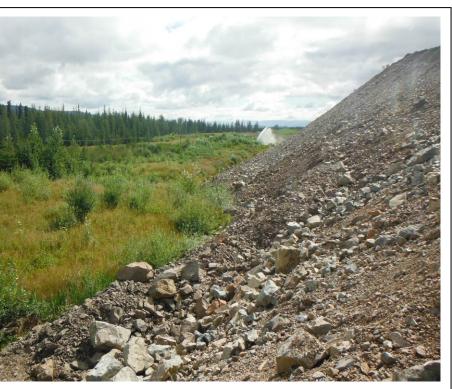
Photo 14: Perimeter embankment downstream looking east northeast.

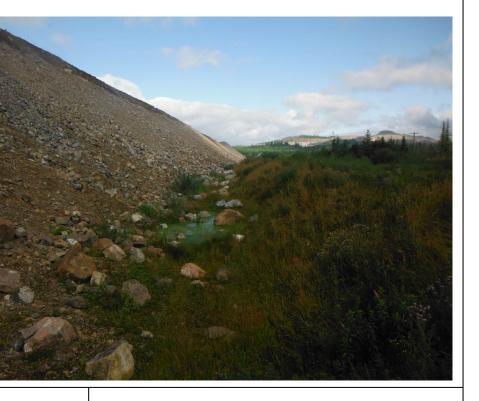
Photo 17: Perimeter embankment toe, looking west.

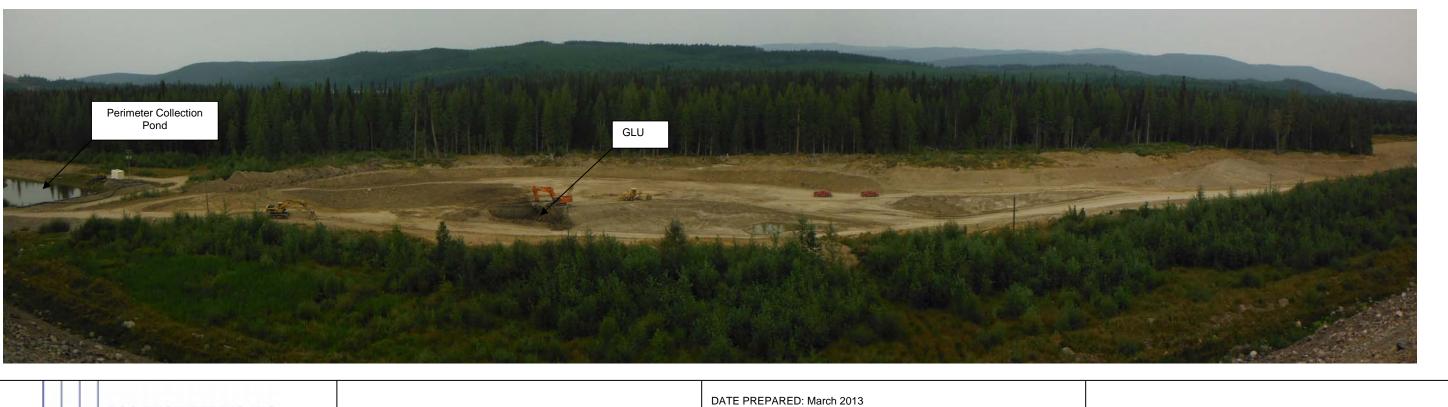
Photo 21: Perimeter borrow pit
