MOUNT POLLEY MINING CORPORATION
MOUNT POLLEY MINE

TAILINGS STORAGE FACILITY
REPORT ON 2008 ANNUAL INSPECTION

**TAILINGS STORAGE FACILITY
REPORT ON 2008 ANNUAL INSPECTION
(REF. NO. VA101-1/24-1)**

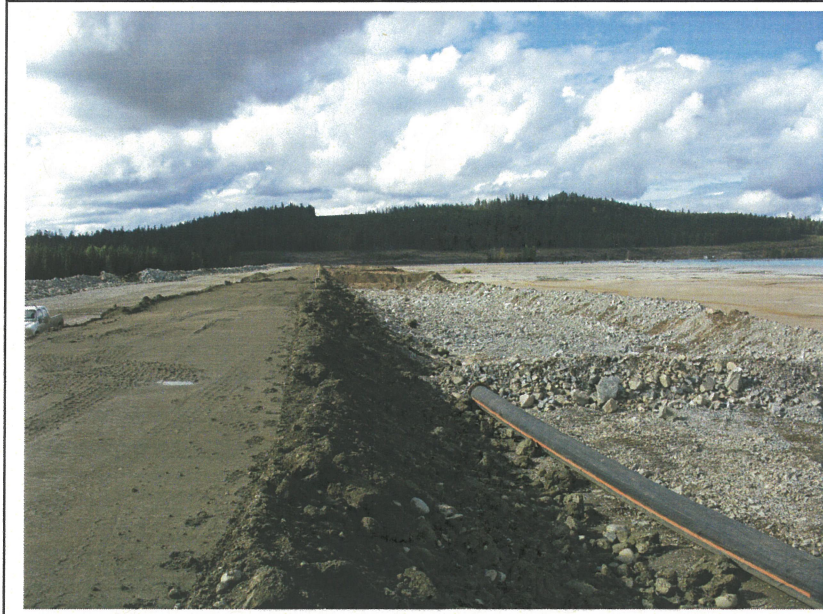
**PHOTO 1** – Components of the TSF, Zone S (left) Zone U (centre) and Tailings Beach (right)

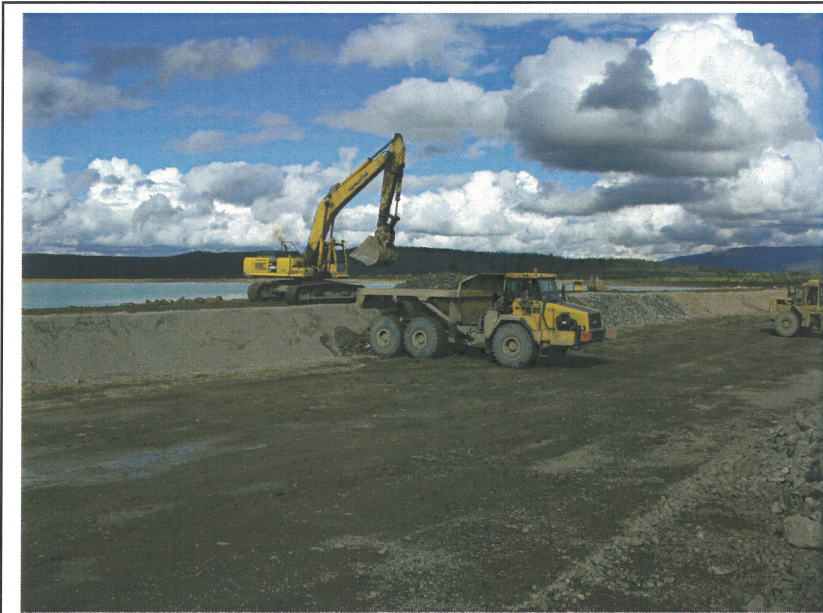
**PHOTO 2** – Downstream components of TSF, Zone C (foreground), Truck is placing Zone T on top of Zone F, Excavator is sitting on Zone S at 954m

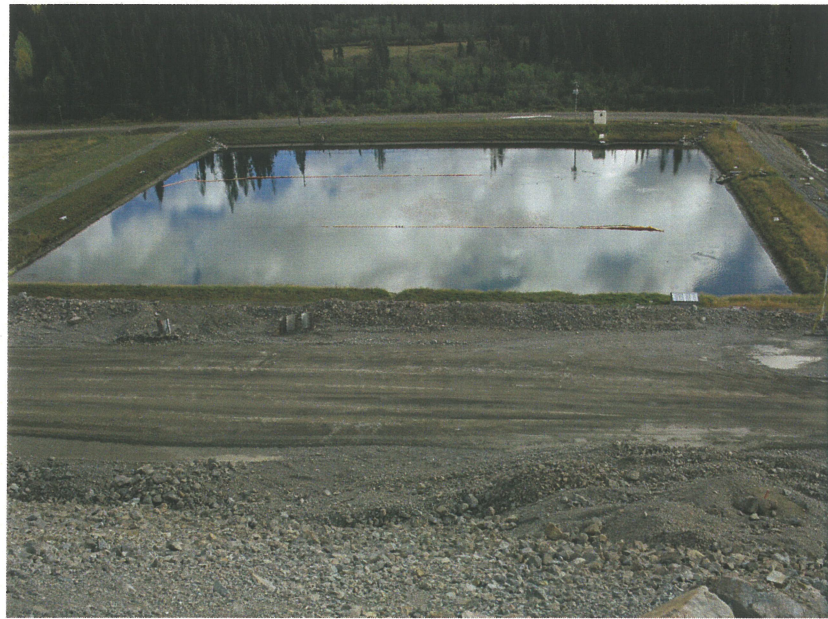
**PHOTO 5 – Main Embankment Seepage Pond**

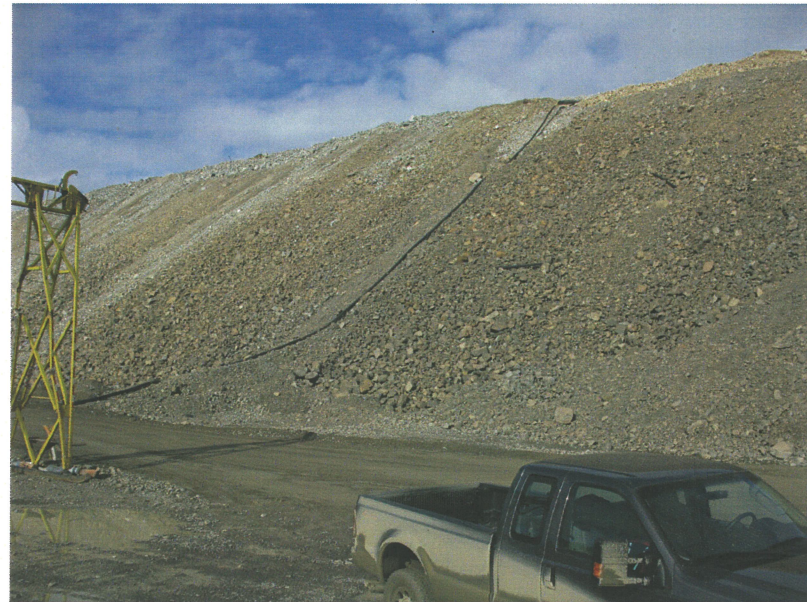
**PHOTO 6 – Main Embankment Seepage Pond Return Pipe**

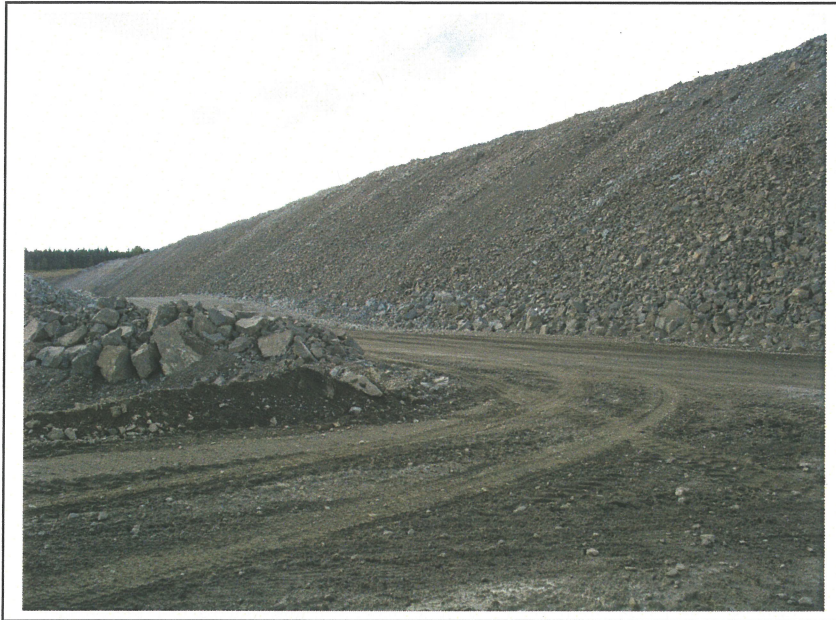
**PHOTO 7** – Main Embankment looking west

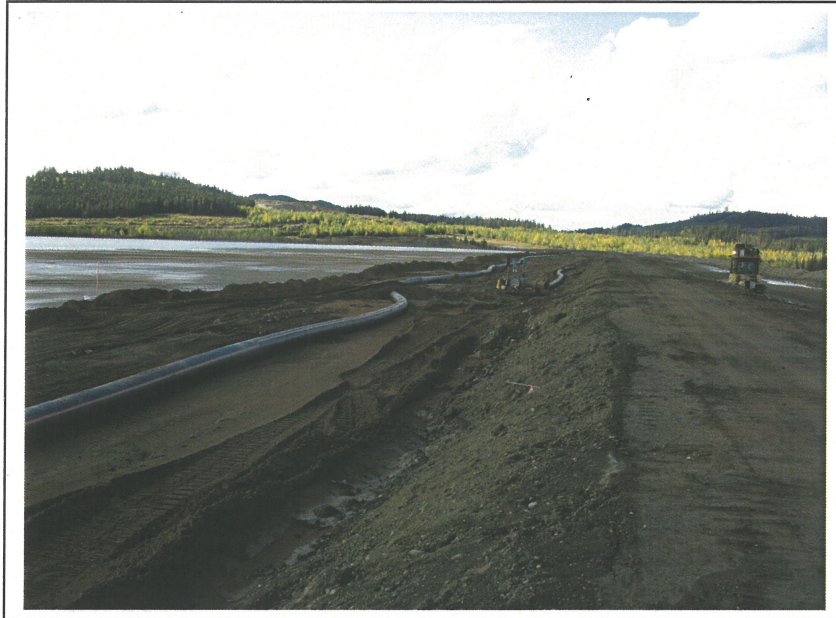
**PHOTO 9** – Perimeter Embankment Zones U and S. The Zone U on the left was constructed using tailings sand cells.

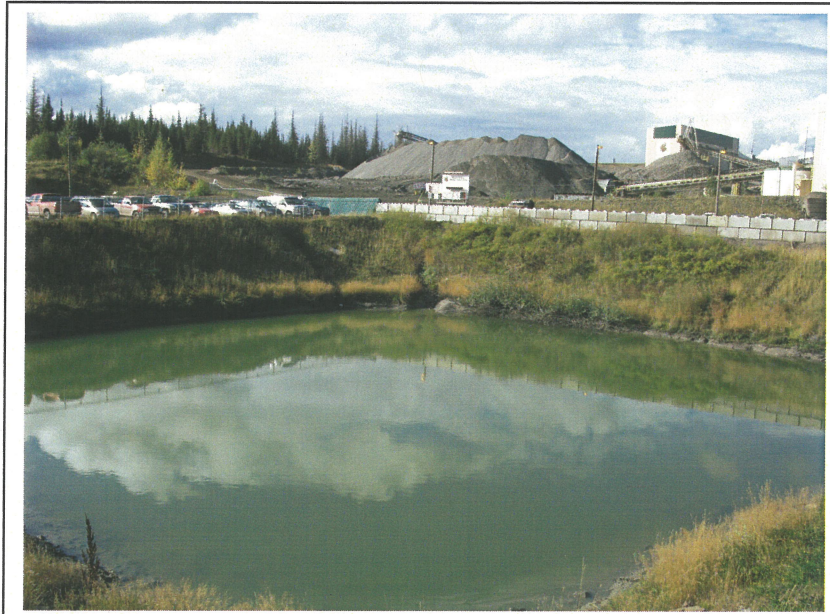
**PHOTO 13 – Mill Site Sump**

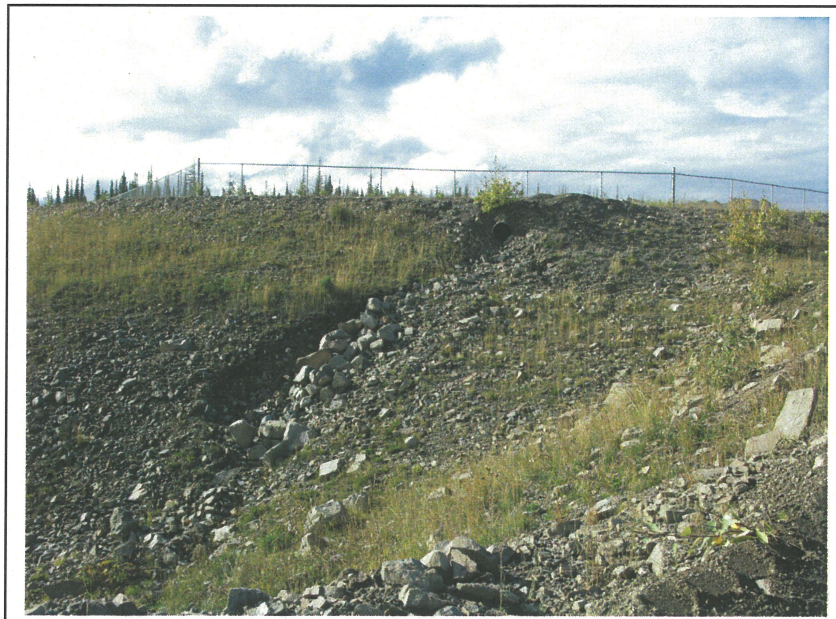
**PHOTO 14 – Mill Site Sump Emergency overflow**

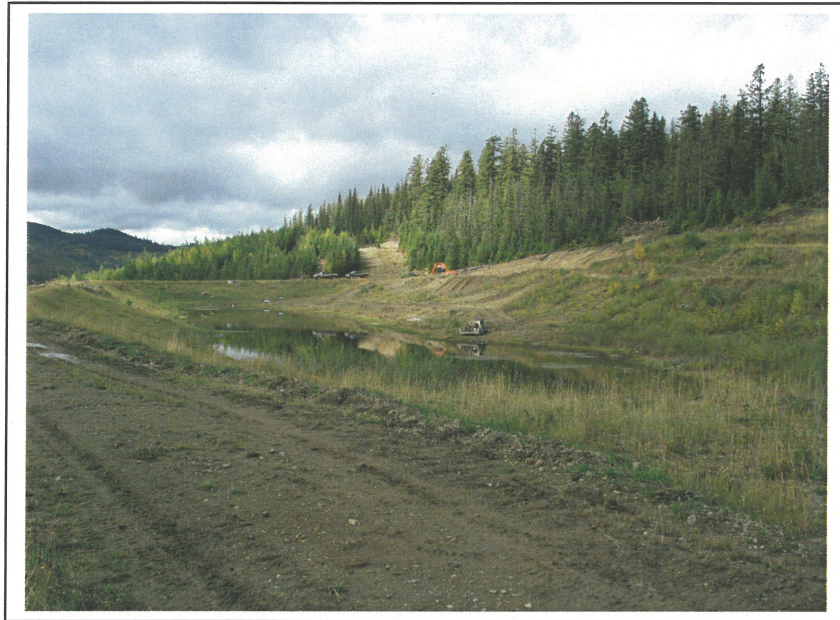
**PHOTO 15 – Southeast Sediment Pond**

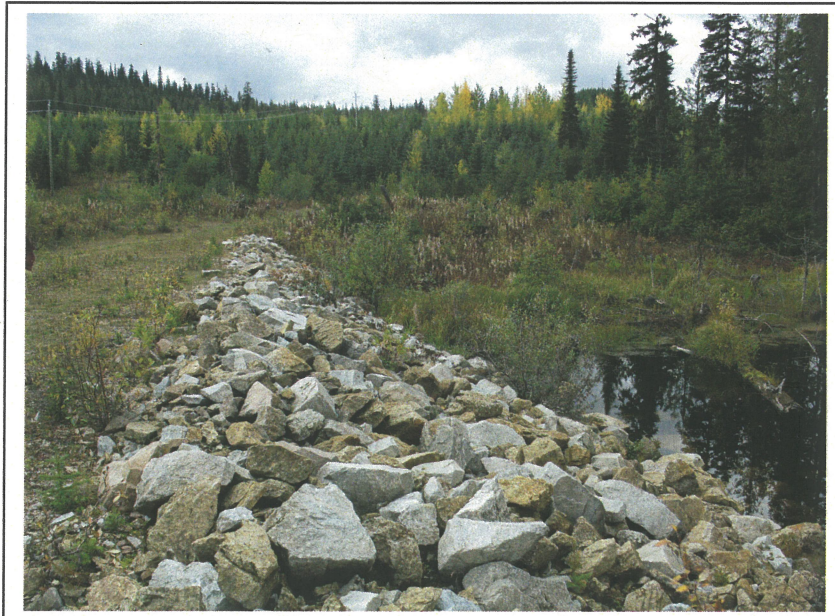
**PHOTO 17 – South Bootjack Dam**
