MOUNT POLLEY MINING CORPORATION
MOUNT POLLEY MINE

TAILINGS STORAGE FACILITY
REPORT ON 2002 ANNUAL INSPECTION
(REF. NO. VA101-00001/3-1)

Knight Piésold Ltd.

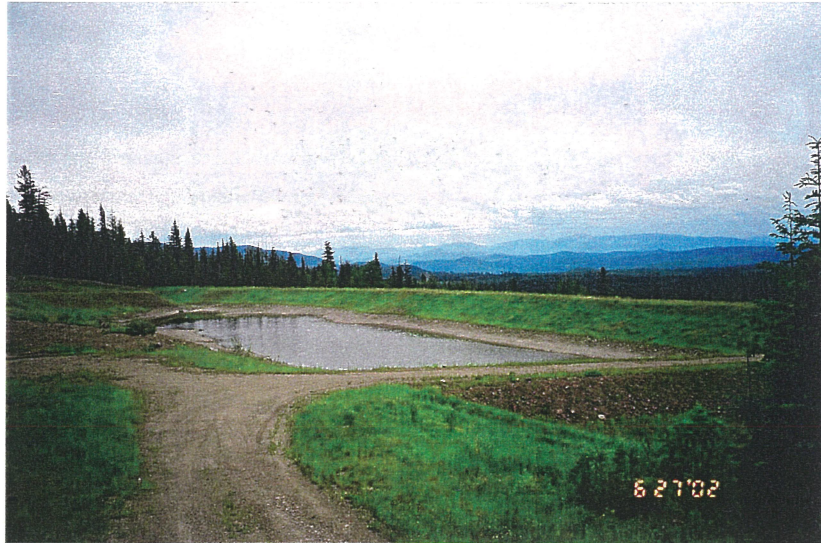
PHOTO 1: Southeast Sediment Control Pond

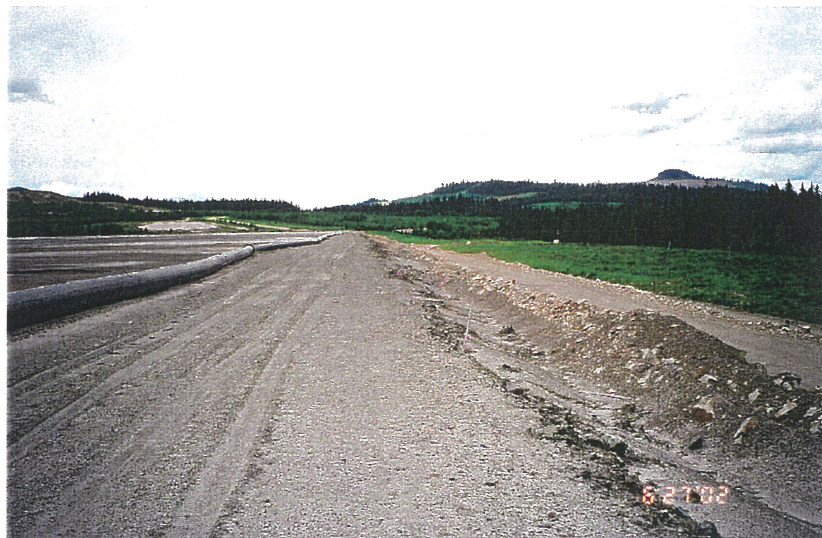
PHOTO 2: Perimeter Embankment

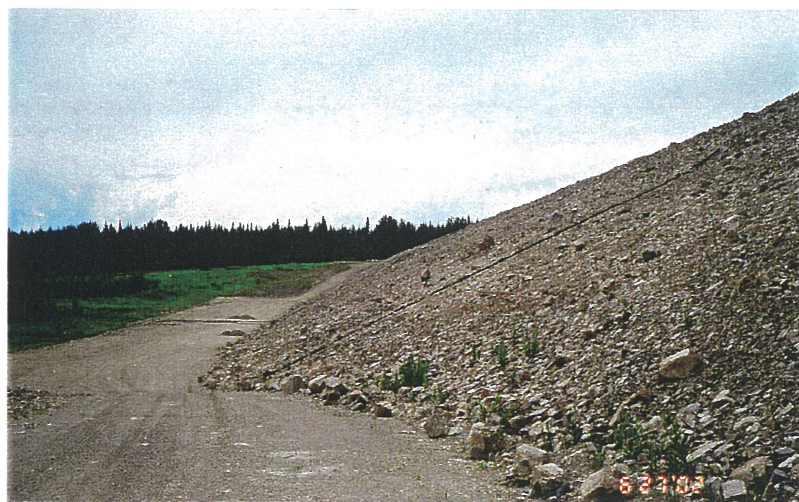
PHOTO 4: Main Embankment

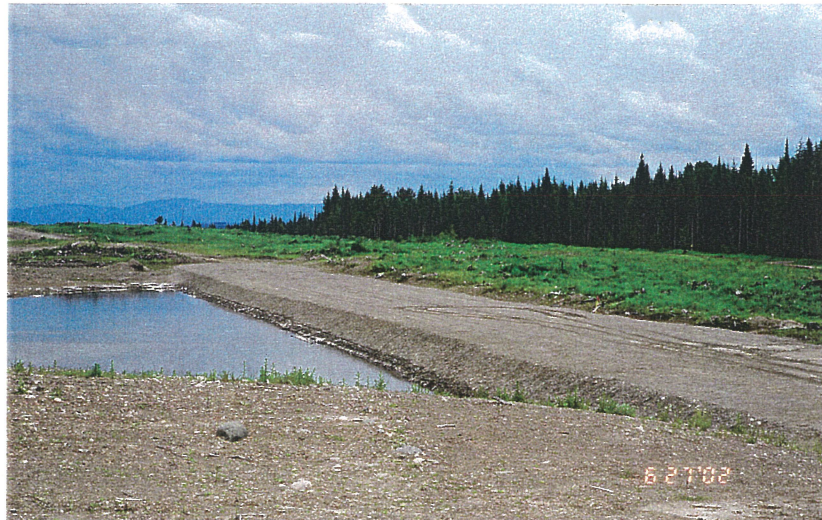
PHOTO 5: South Embankment

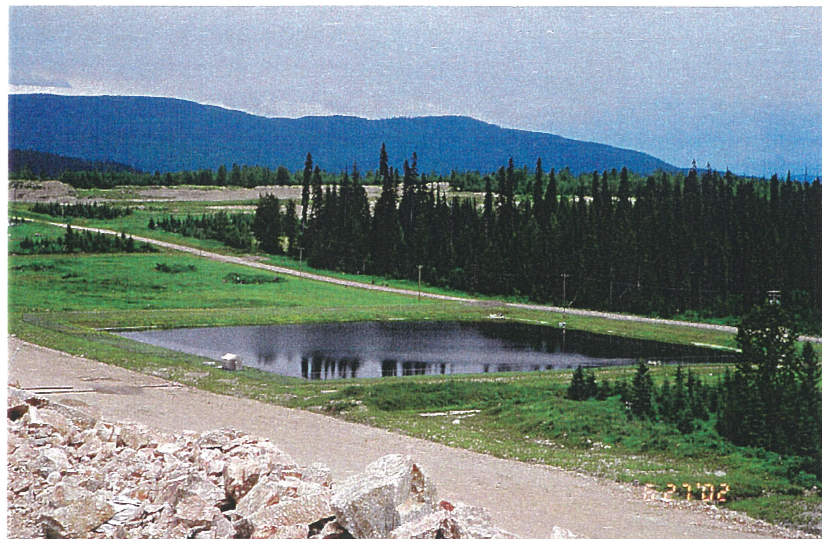
PHOTO 6: Main Embankment Seepage Recycle Pond

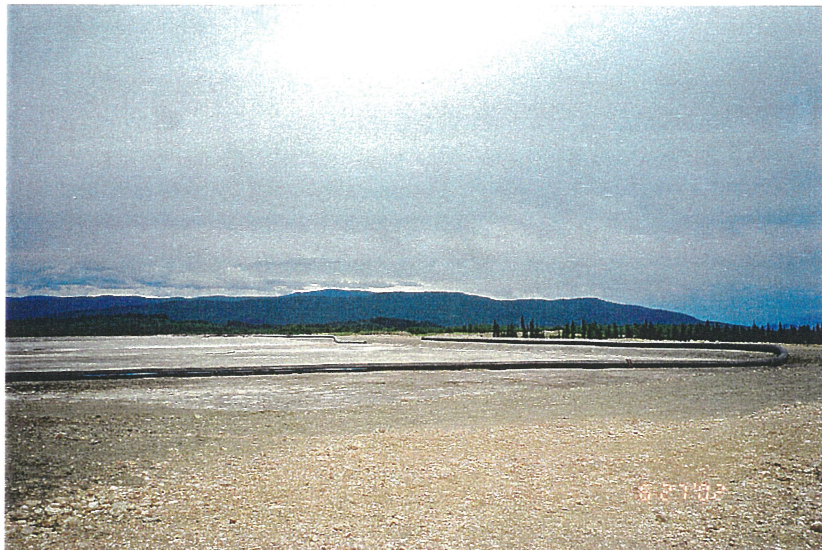
PHOTO 7: Tailings Impound beach

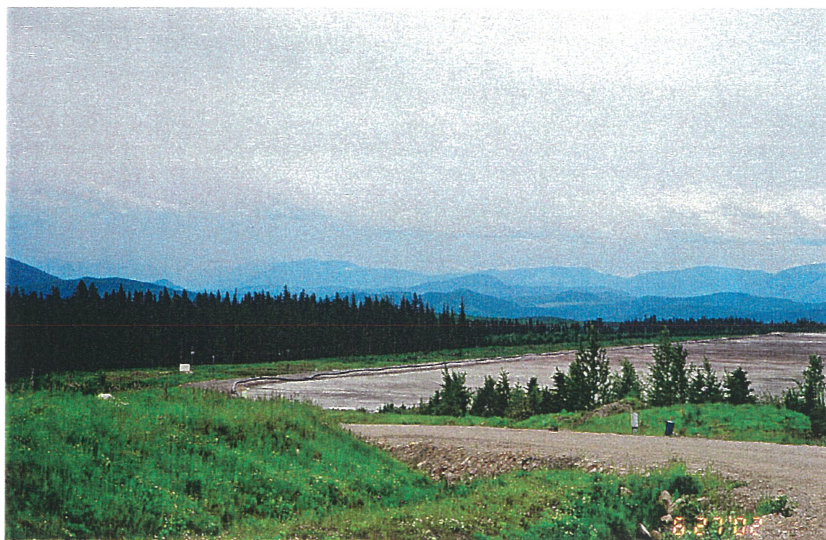
PHOTO 8: Tailings Impound – south view

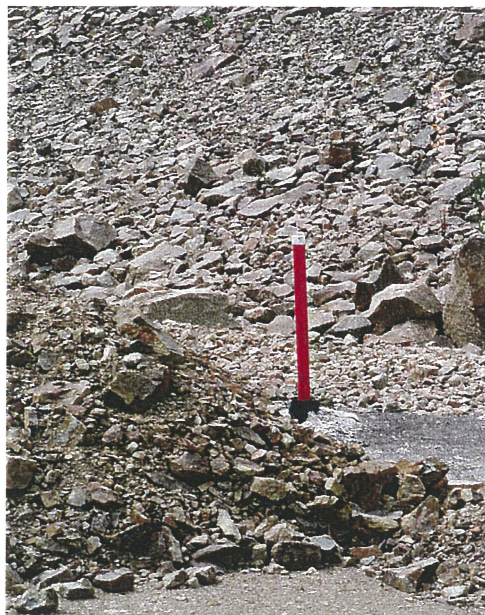
- Piezometer data indicated that the embankments are performing as designed.
- Aside from the initial reading, only one slope inclinometer reading is currently available. It is recommended that monitoring with the inclinometer probe be undertaken annually and that a 'poor-boy' monitoring rod should be constructed for use monthly, during the care and maintenance period.

PHOTO 9: Slope Inclinometer at toe of Main Embankment
