MOUNT POLLEY MINING CORPORATION
MOUNT POLLEY MINE

TAILINGS STORAGE FACILITY
REPORT ON 2007 ANNUAL INSPECTION
(REF. NO. VA101-01/20-1)

Rev. No.	Revision	Date	Approved
Rev 0	Issued in Final	December 19, 2007	<i>AKB</i>

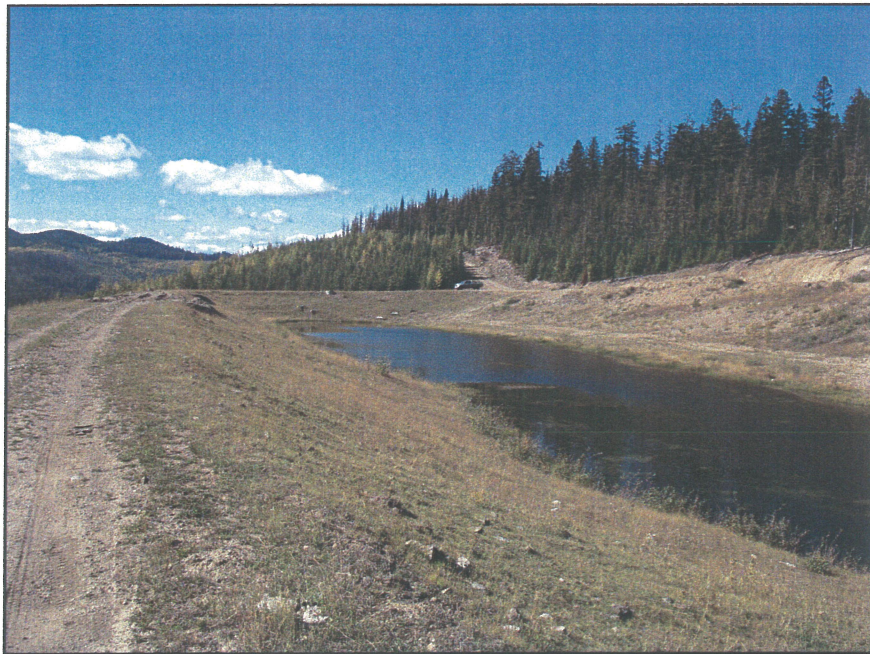
PHOTO #1 – Southeast Sediment Control Pond

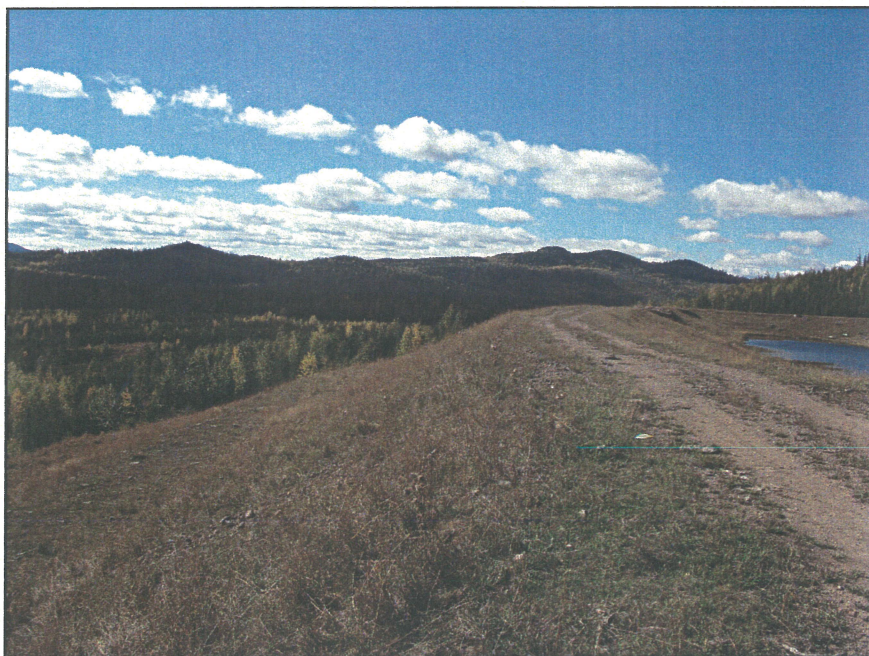
PHOTO #2 – Southeast Sediment Control Pond crest and downstream slope

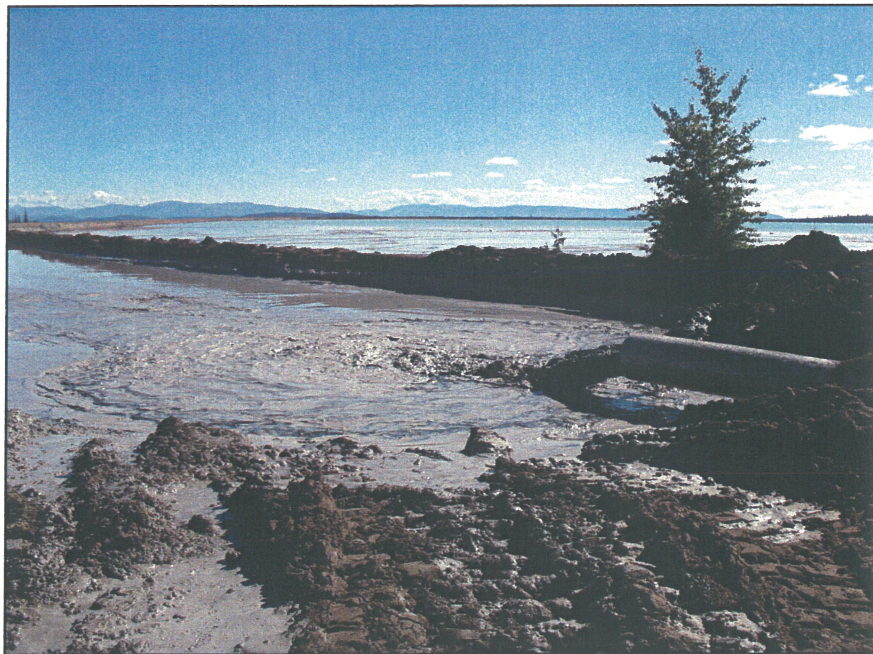
PHOTO 7 – Single point discharge on the Perimeter Embankment during sand cell construction.

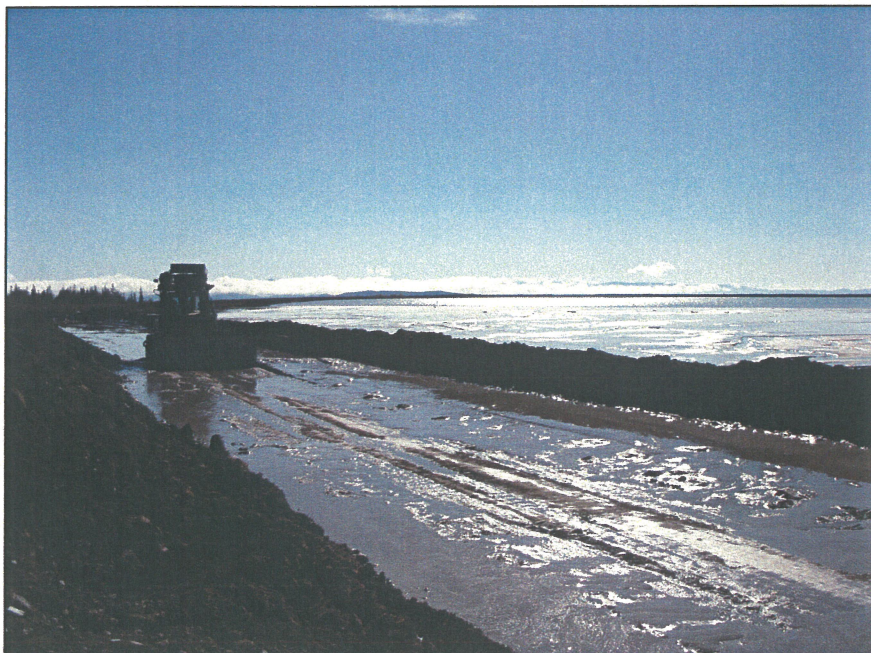
PHOTO 8 – Sand cell construction on the Perimeter Embankment

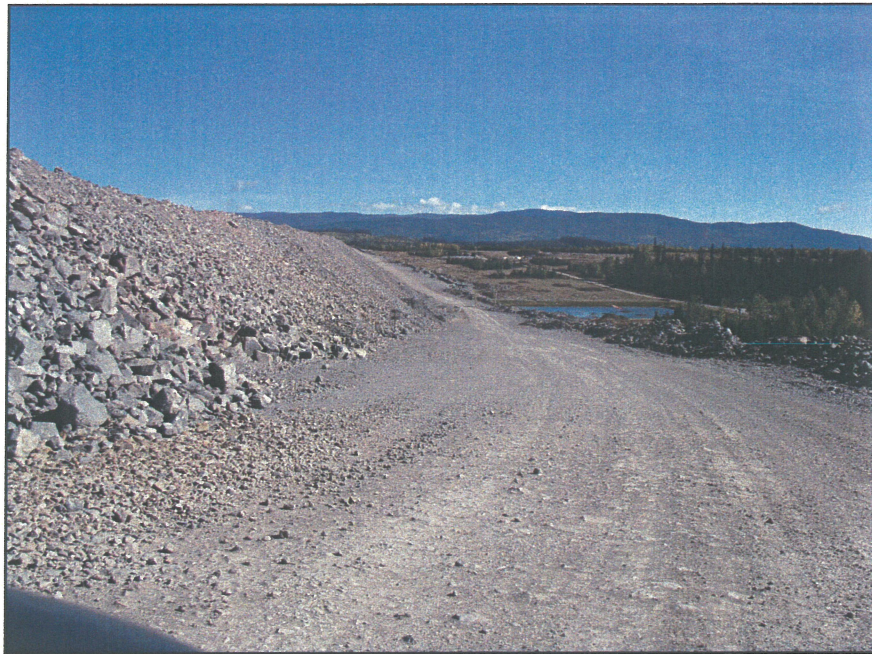
PHOTO 9 – Main Embankment downstream slope looking east.

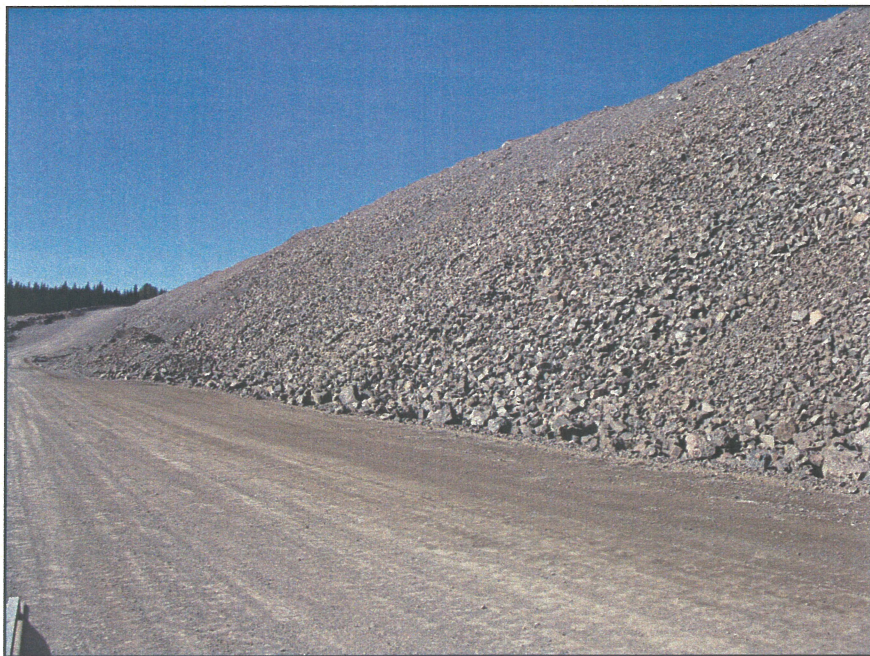
PHOTO 10 – Main Embankment downstream slope looking west.

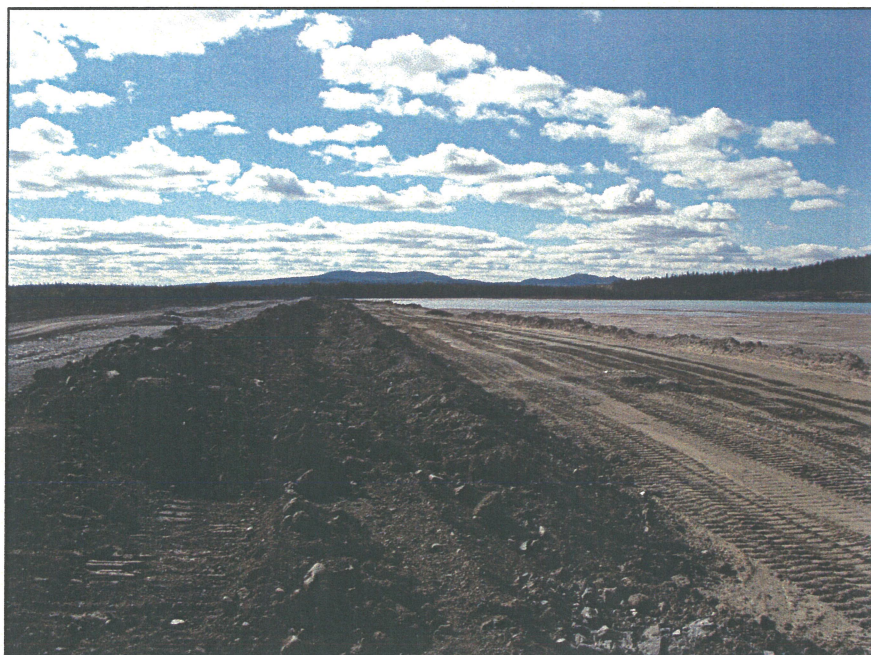
PHOTO 12 – Main Embankment crest looking west.

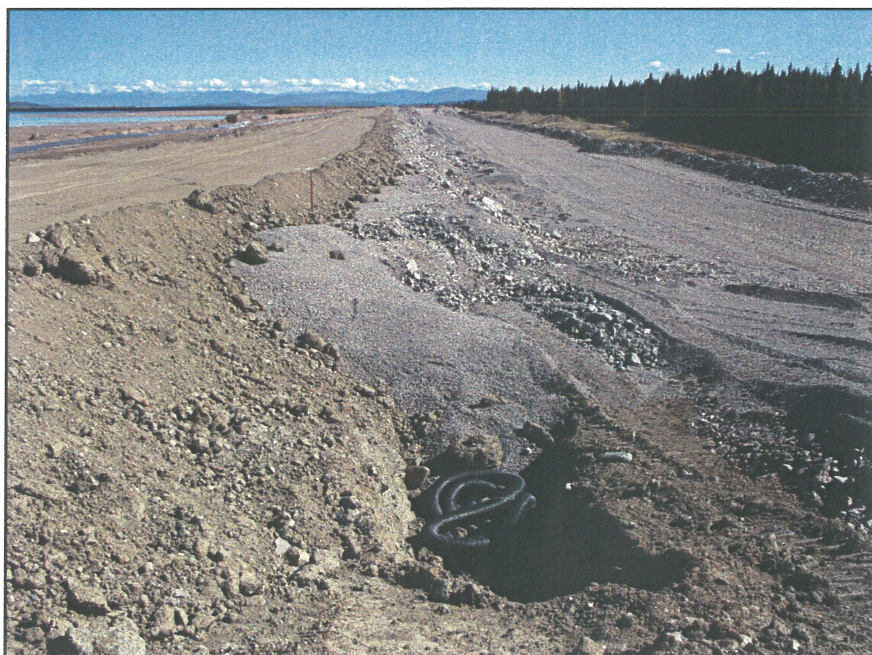
PHOTO 14 – South Embankment crest and downstream area.

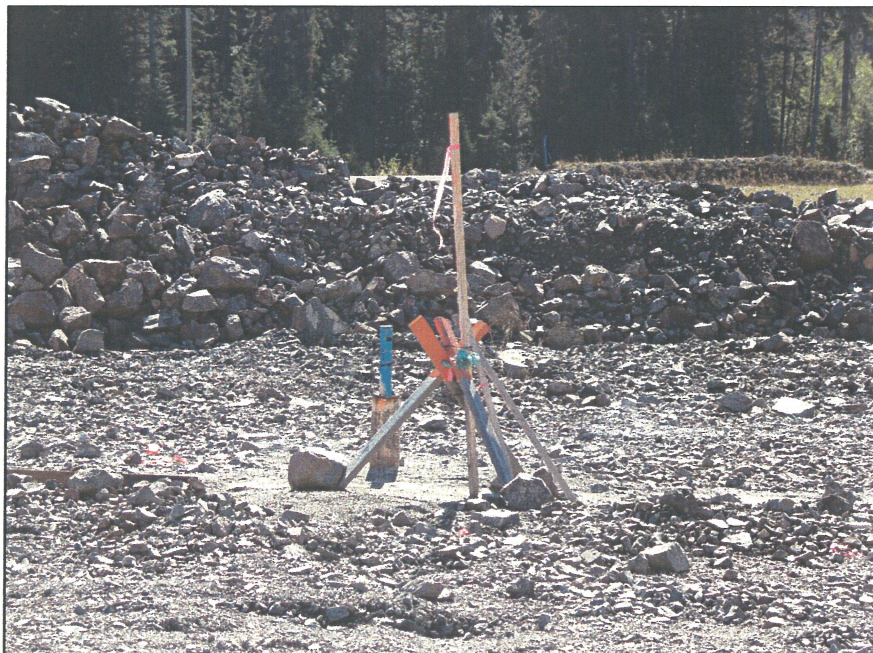
PHOTO 16 – Existing inclinometer at the Main Embankment.

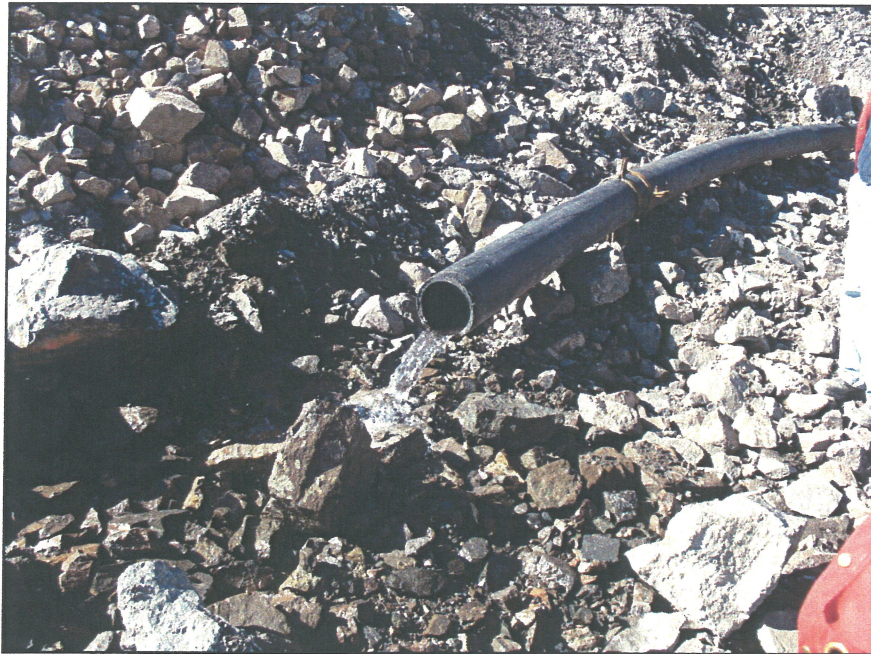
PHOTO 17 – Perimeter Embankment upstream toe drain flow

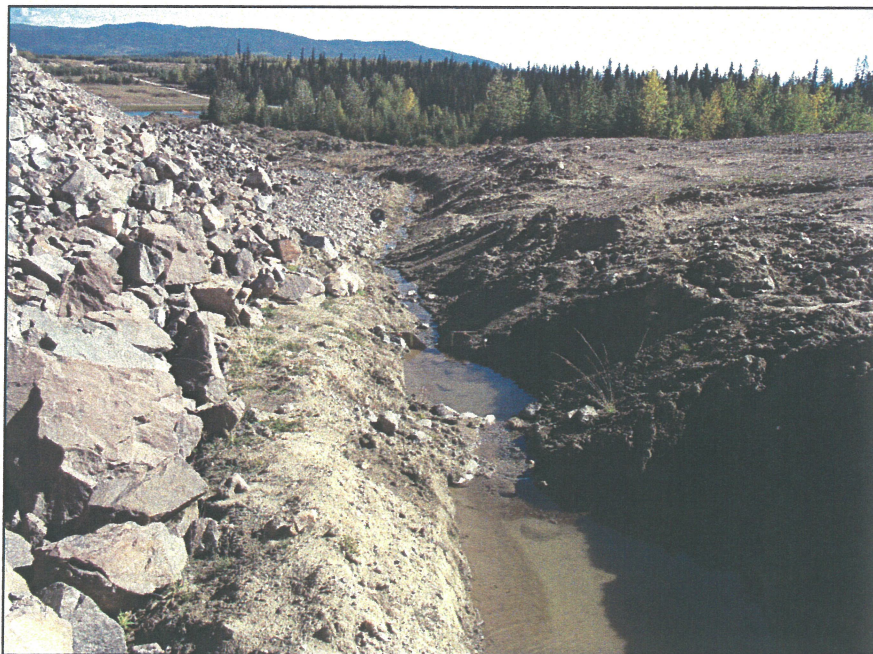
PHOTO 19 – Seepage from the Main/South Embankment corner routed to the Main Embankment Seepage Collection Pond.
