**MOUNT POLLEY MINING CORPORATION
MOUNT POLLEY MINE**

**REPORT ON
1999 ANNUAL INSPECTION
(REF. NO. 11162/13-9)**

MOUNT POLLEY MINING CORPORATION

1999 ANNUAL INSPECTION

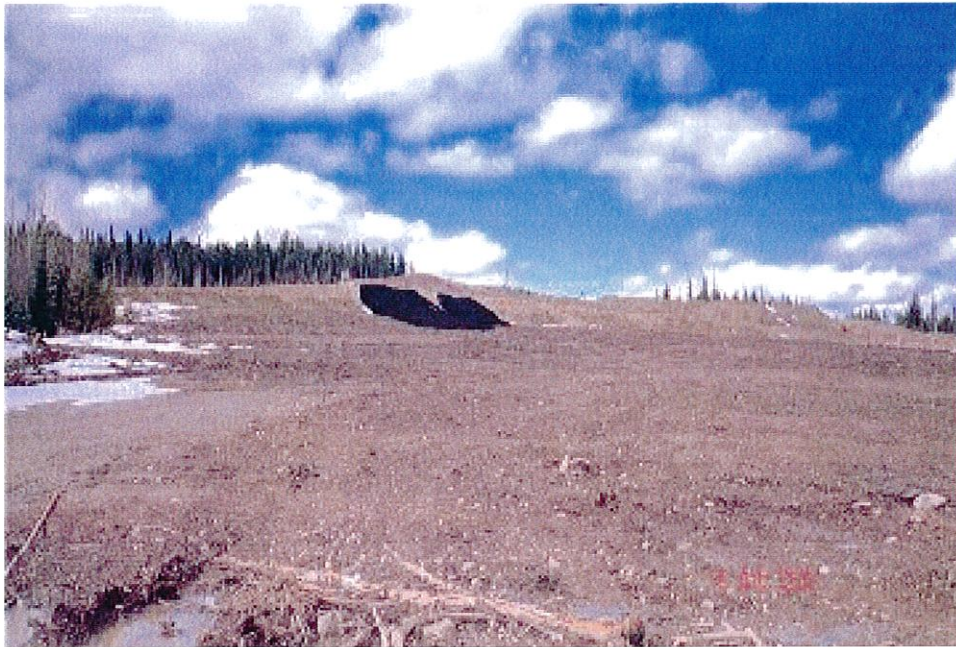
Photo No. 7: Biosolids Area, northeast of the tailings impoundment.
