MOUNT POLLEY MINING CORPORATION
MOUNT POLLEY MINE

TAILINGS STORAGE FACILITY
REPORT ON 2009 ANNUAL INSPECTION

**TAILINGS STORAGE FACILITY
REPORT ON 2009 ANNUAL INSPECTION
(REF. NO. VA101-1/27-1)**

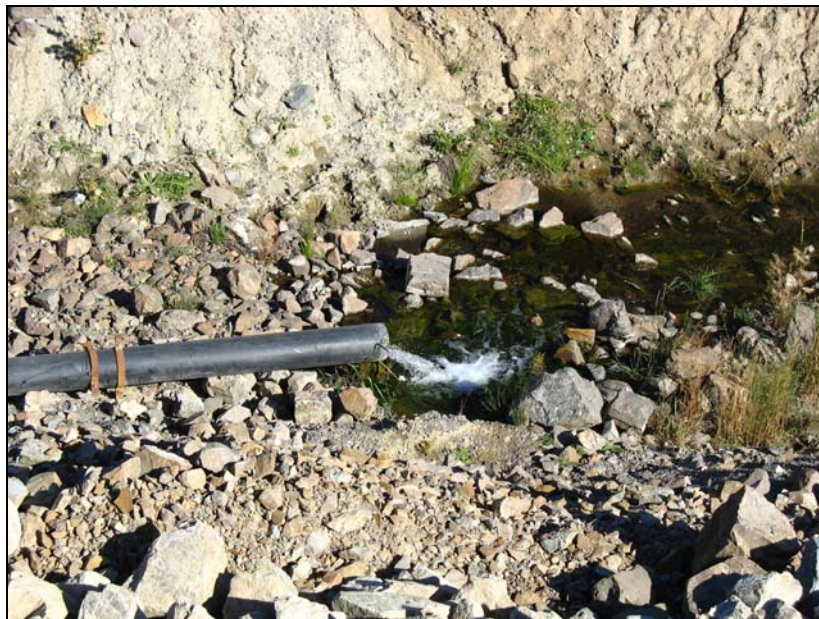
PHOTO 2 – Perimeter Embankment Toe Drain flow.

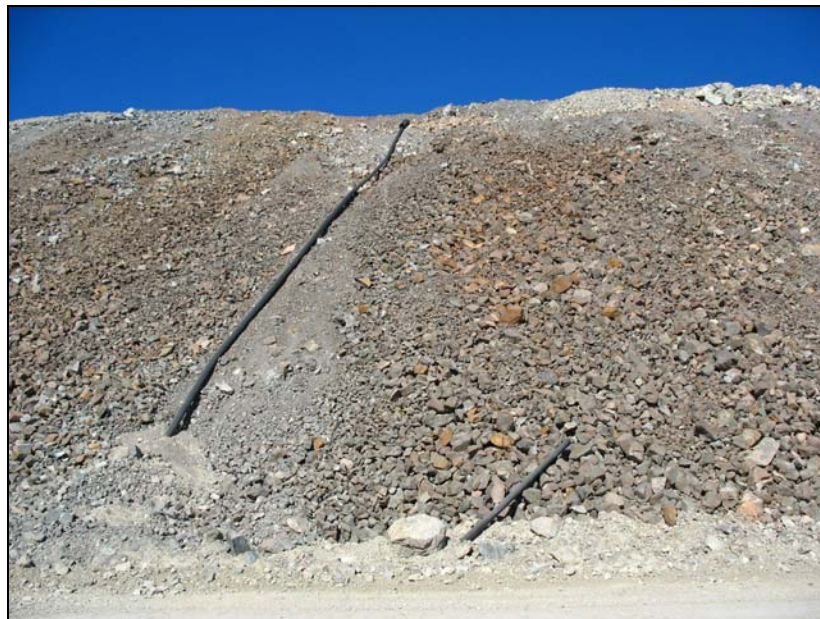
PHOTO 4 – Main Embankment Seepage Collection Pond Return Pipe

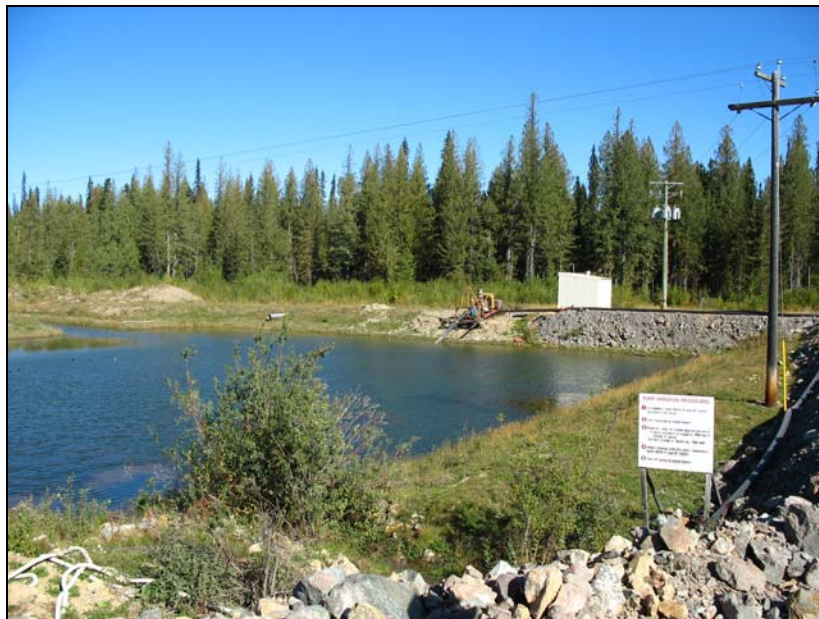
PHOTO 6 – Perimeter Embankment Seepage Collection Pond

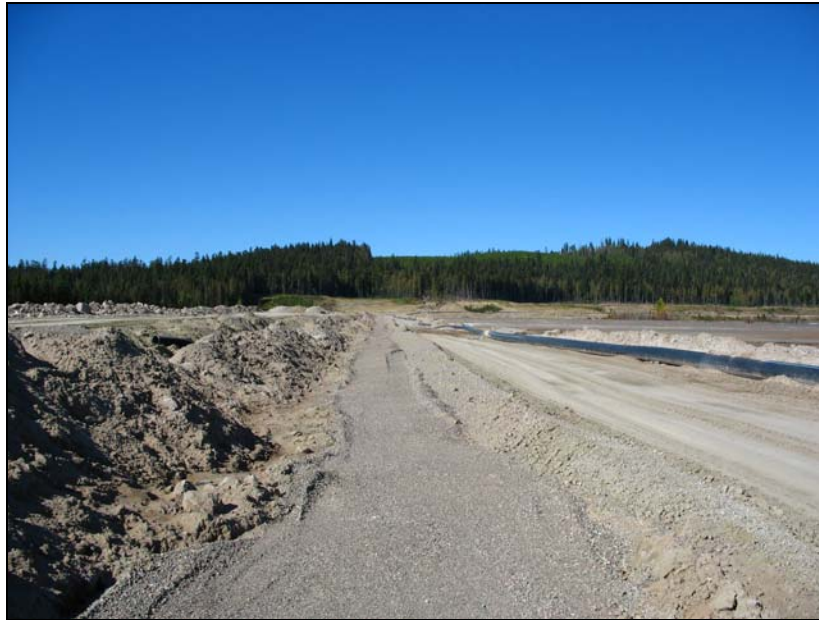
PHOTO 7 – South Embankment upstream toe drain.

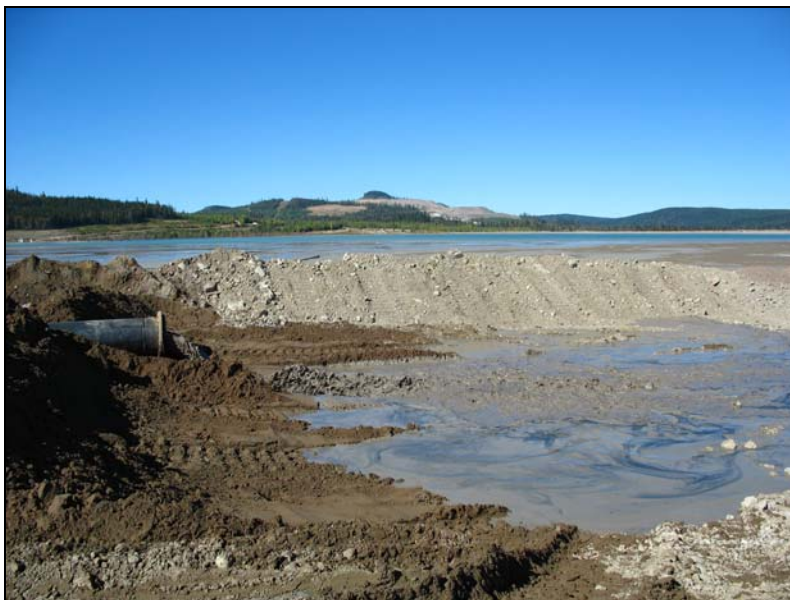
PHOTO 8 – Sand cell construction on Main Embankment.

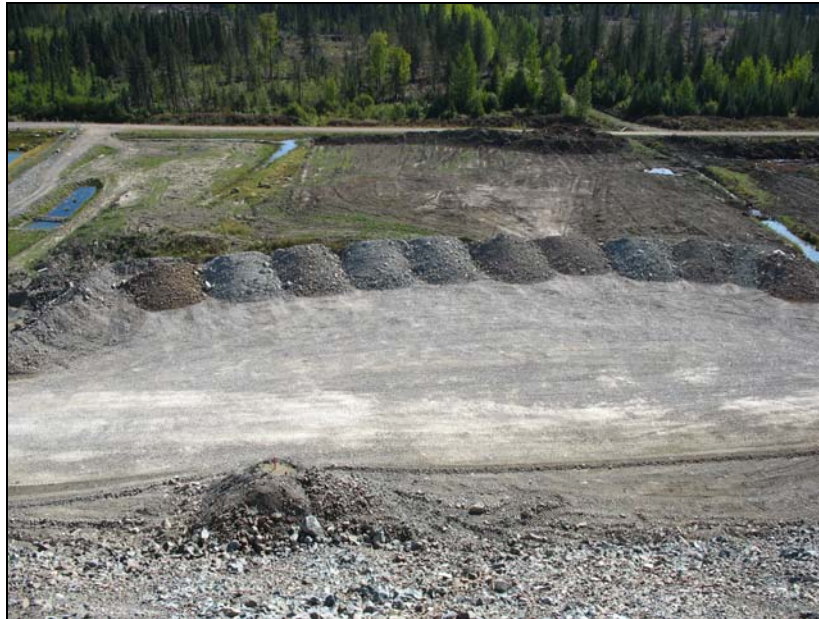
PHOTO 9 – Buttress construction at the Main Embankment.

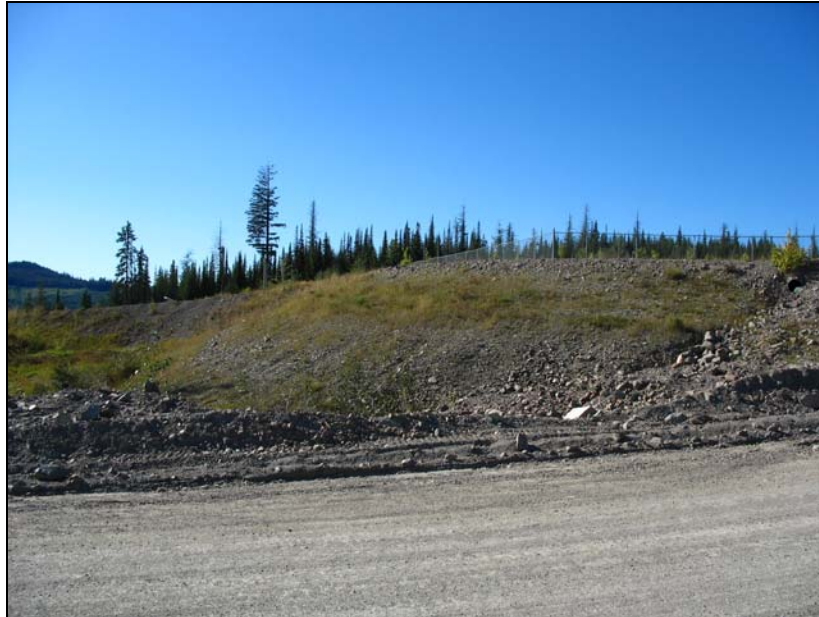
PHOTO 10 – Mill Site Sump Embankment

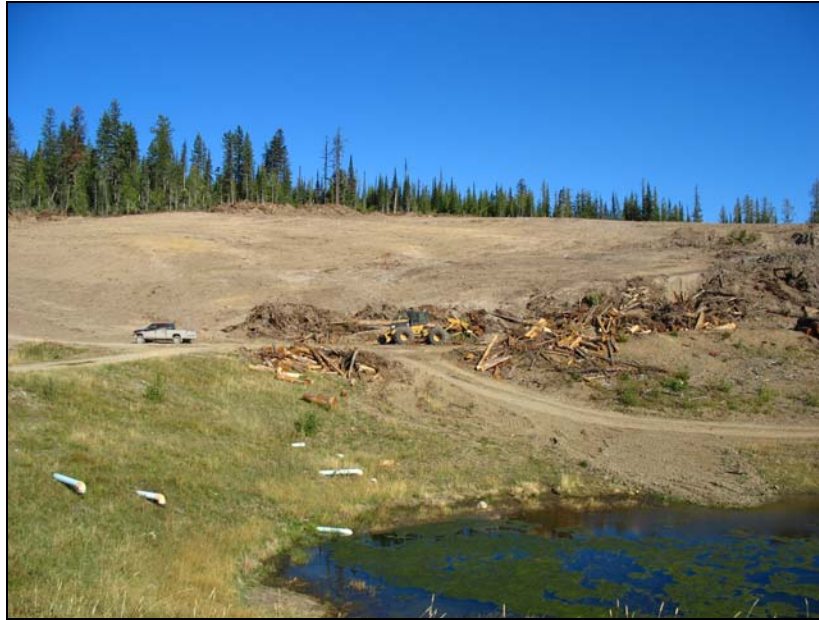
PHOTO 11 – Southeast Sediment Pond, west end showing outlet pipes

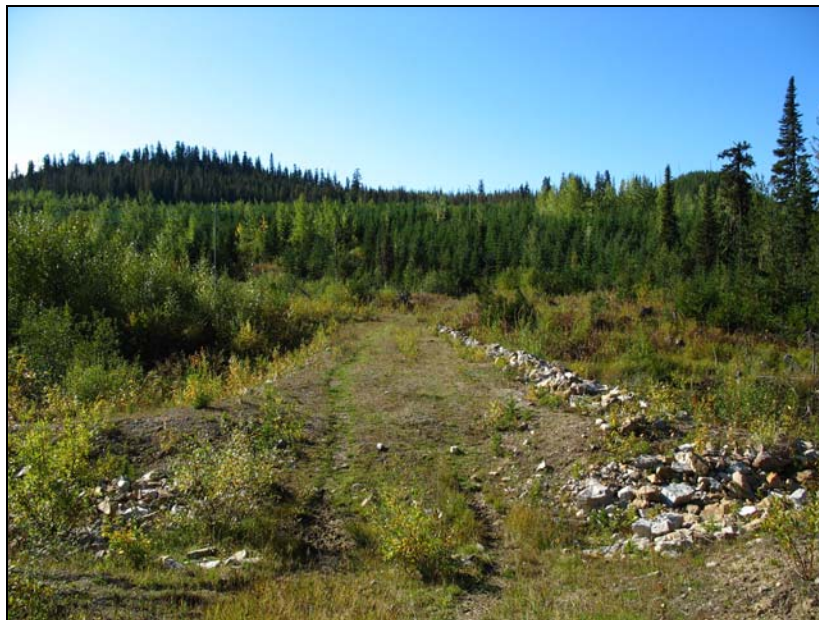
PHOTO 12 – South Bootjack Dam
