MOUNT POLLEY MINING CORPORATION
MOUNT POLLEY MINE

TAILINGS STORAGE FACILITY
REPORT ON 2010 ANNUAL INSPECTION

**TAILINGS STORAGE FACILITY
REPORT ON 2010 ANNUAL INSPECTION
(REF. NO. VA101-1/29-2)**

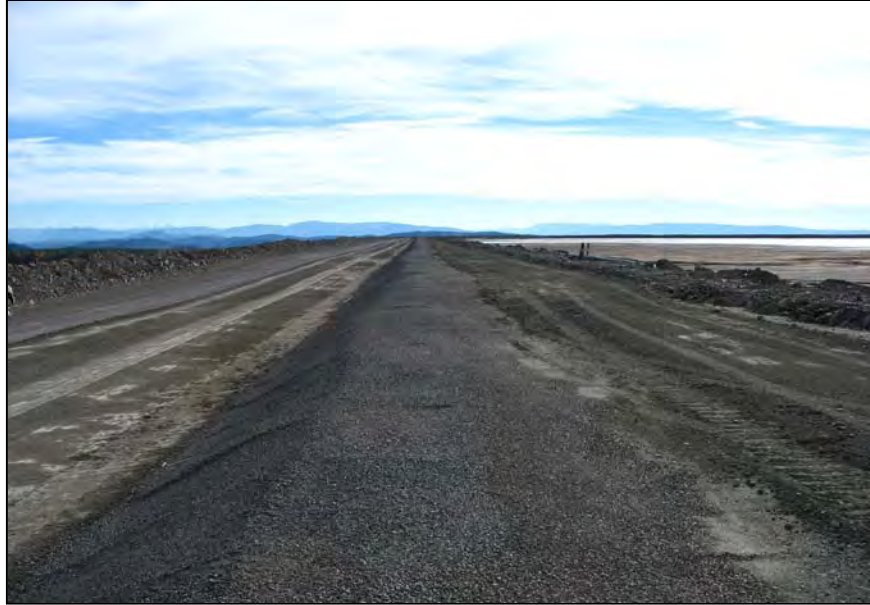
PHOTO 1 – Perimeter Embankment Crest.

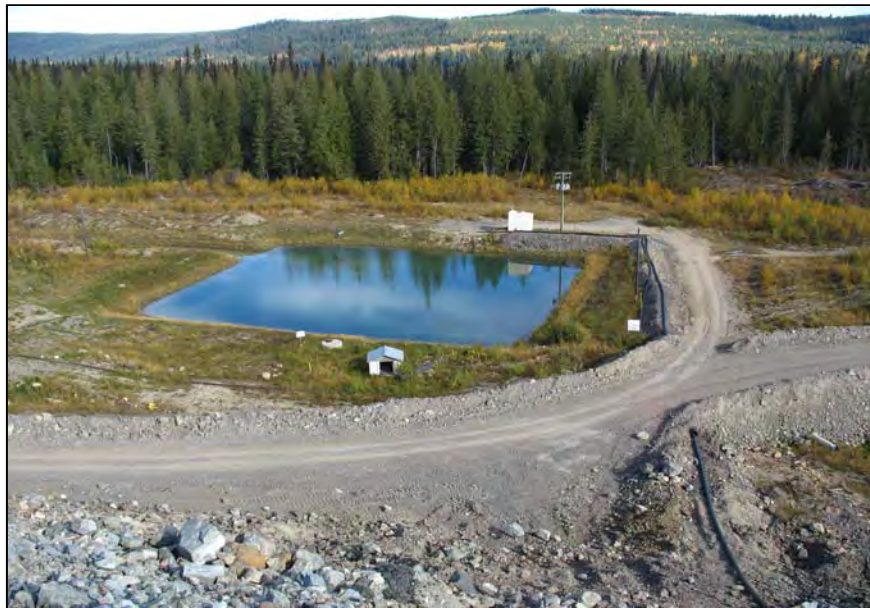
PHOTO 2 – Perimeter Embankment Seepage Collection and Recycle Pond.

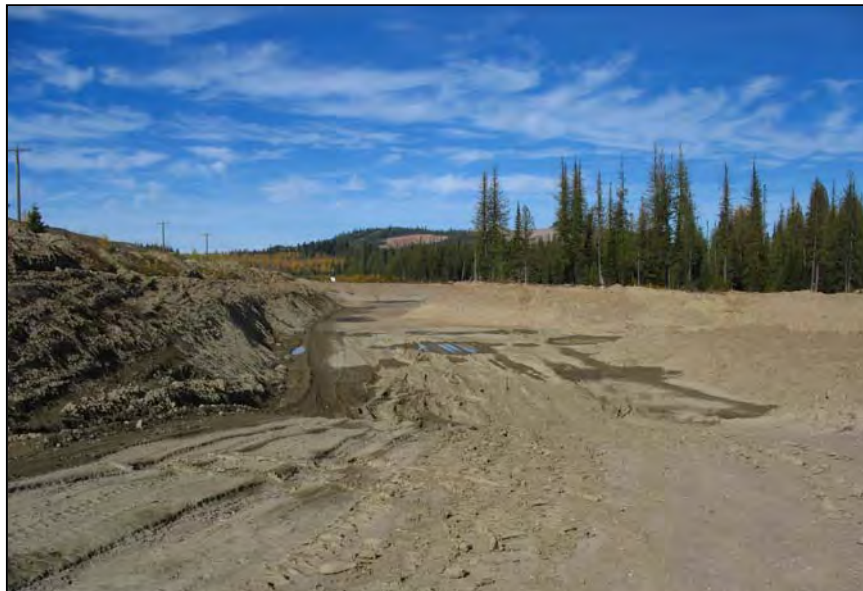
PHOTO 4 – Glacial Till borrow Downstream of Perimeter Embankment.

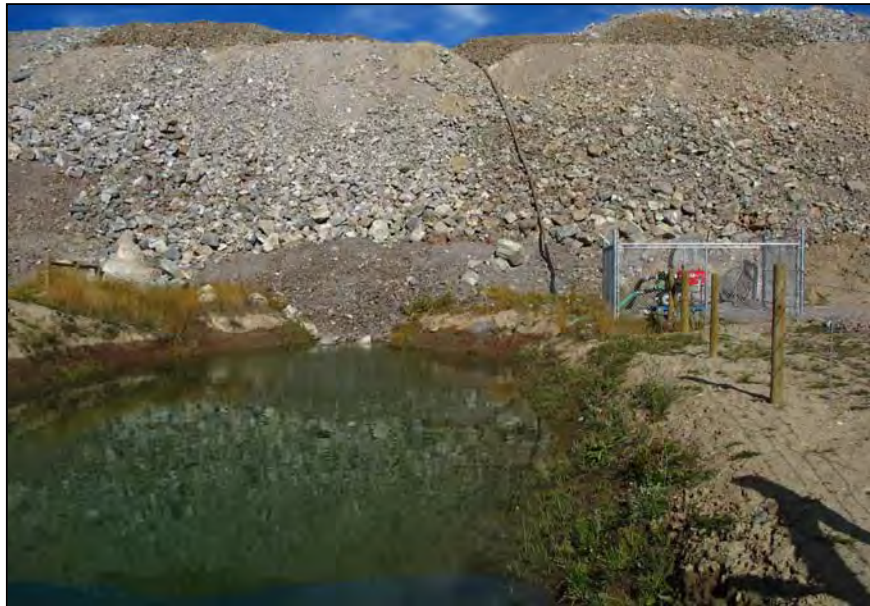
PHOTO 14 – South Embankment Seepage Collection and Recycle Pond.
