MOUNT POLLEY MINING CORPORATION

MOUNT POLLEY MINE

TAILINGS STORAGE FACILITY 2012 ANNUAL REVIEW

PROJECT NO.: 1197001
DATE: April 8, 2013
DOCUMENT NO.: MP13-01

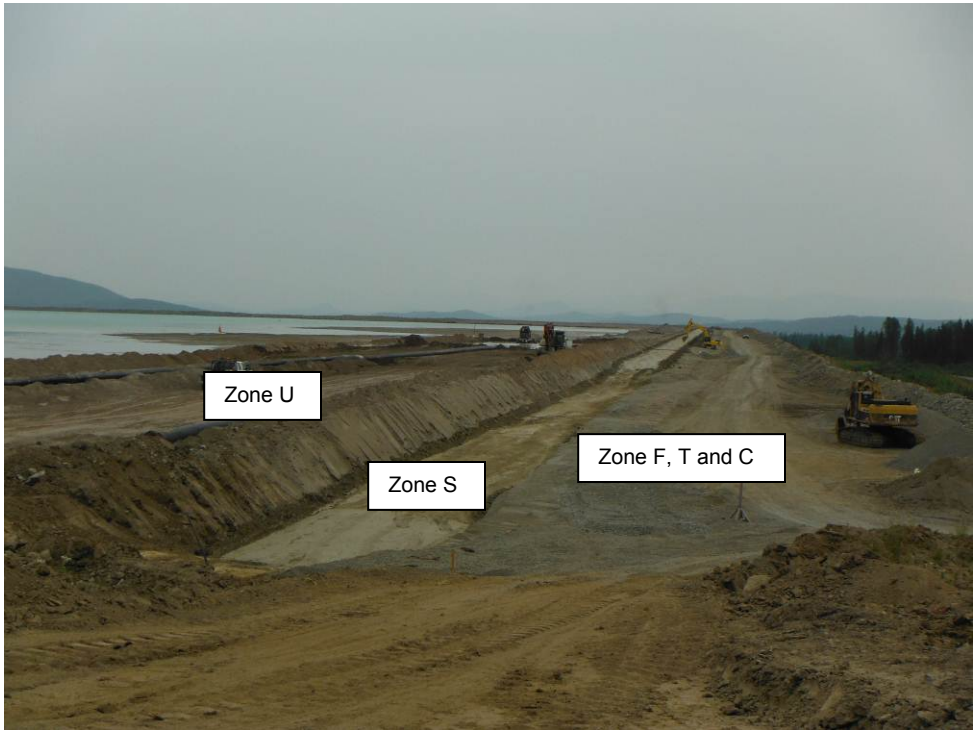
Photo 1: South embankment fill placement near corner 4.

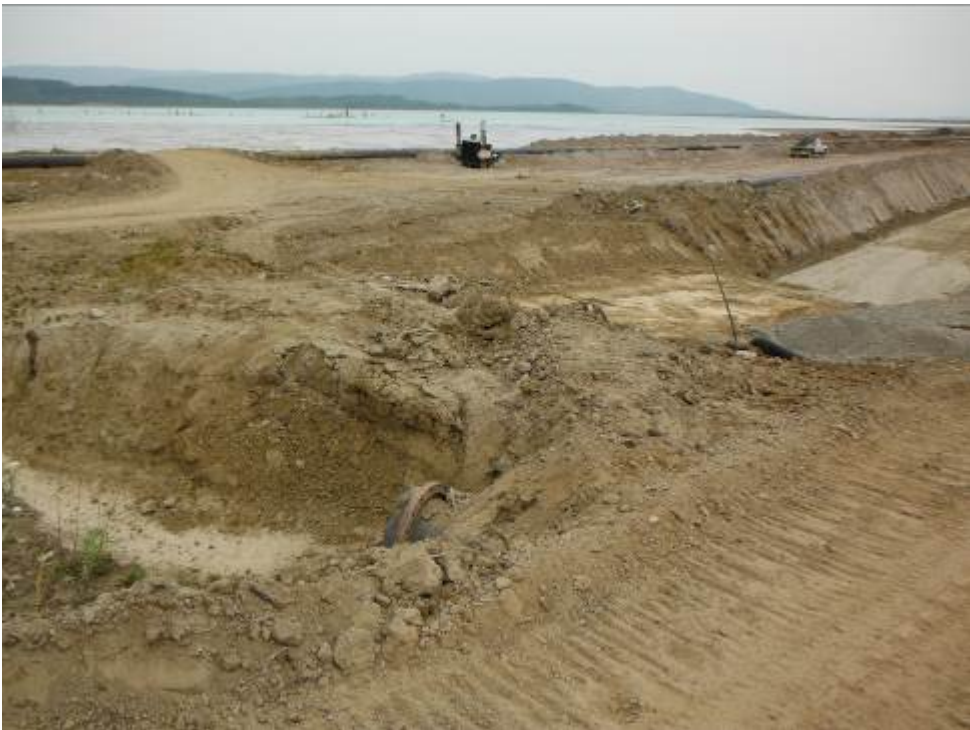
Photo 2: South embankment abutment tie-in

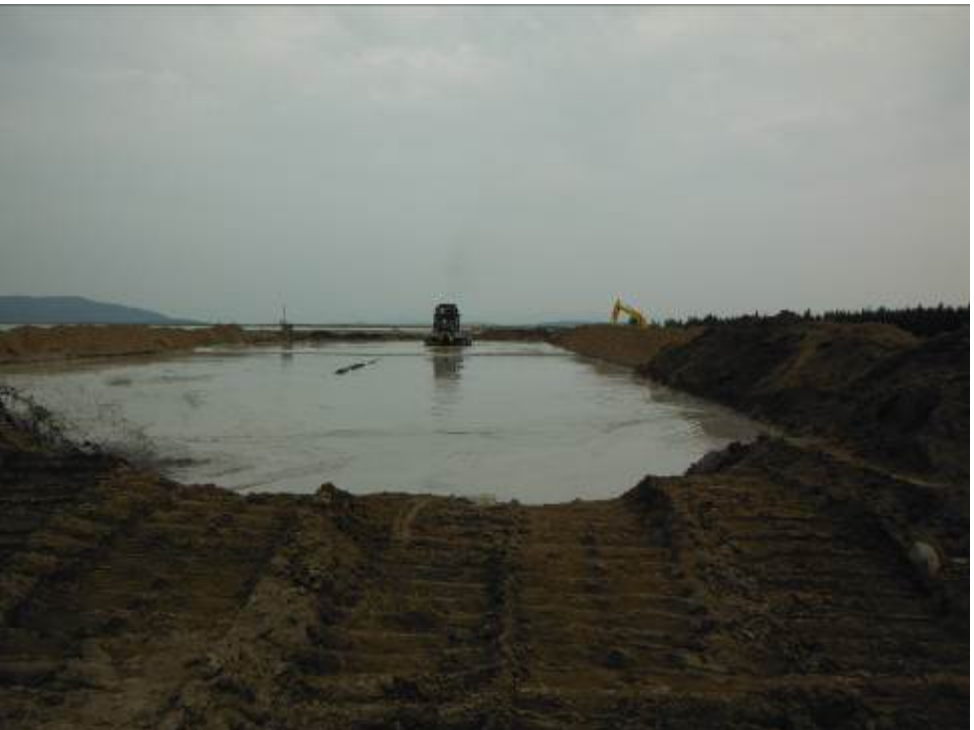
Photo 3: Zone U sand cell construction along South embankment.

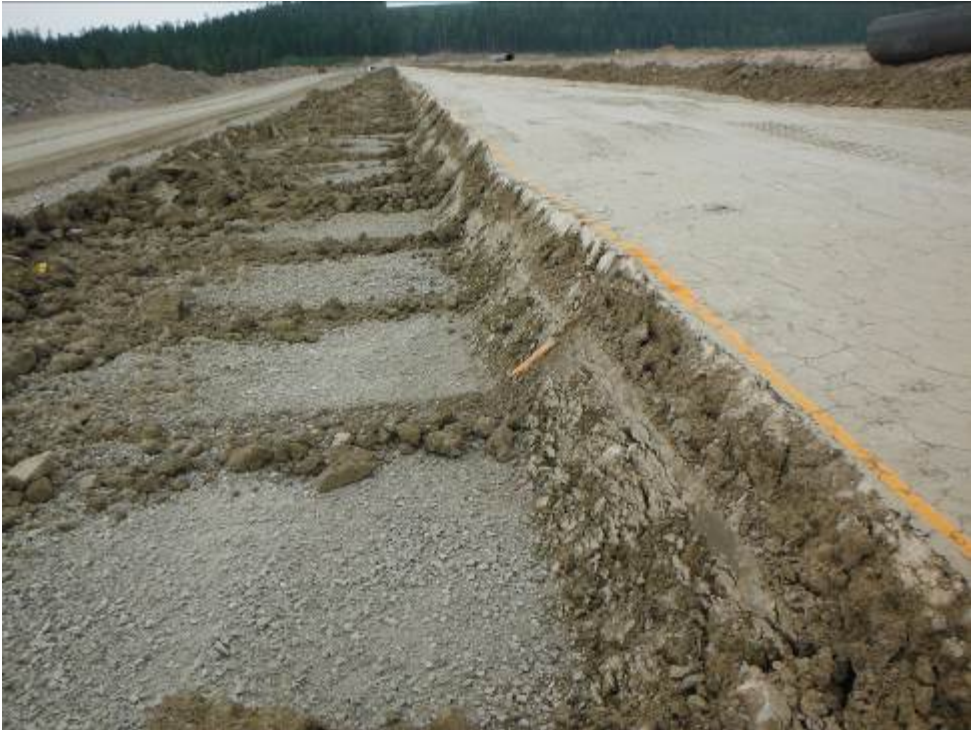
Photo 5: South embankment Zone C (downstream shell), looking west. Drain extension shown.

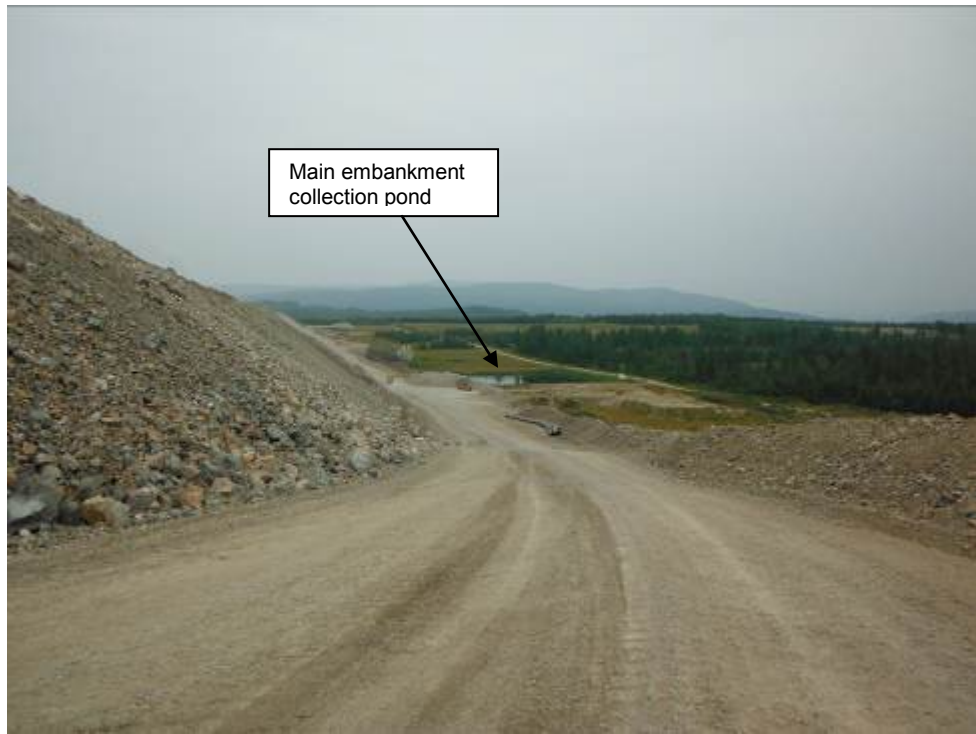
Photo 7: Main embankment, looking north.

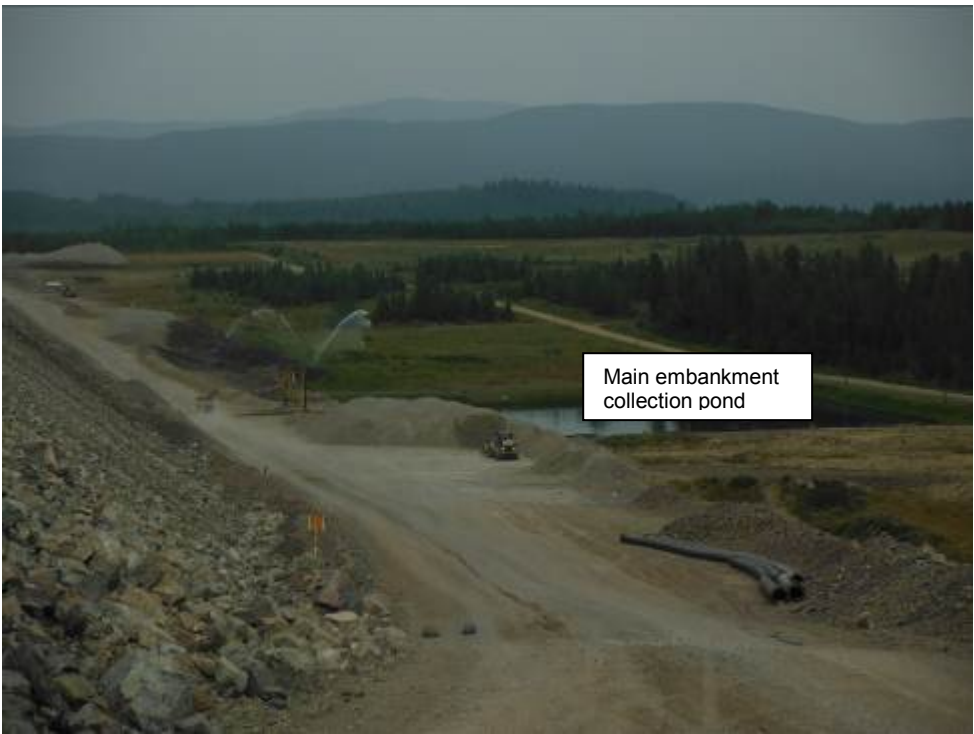
Photo 8: Main embankment, looking north at Main embankment collection pond.

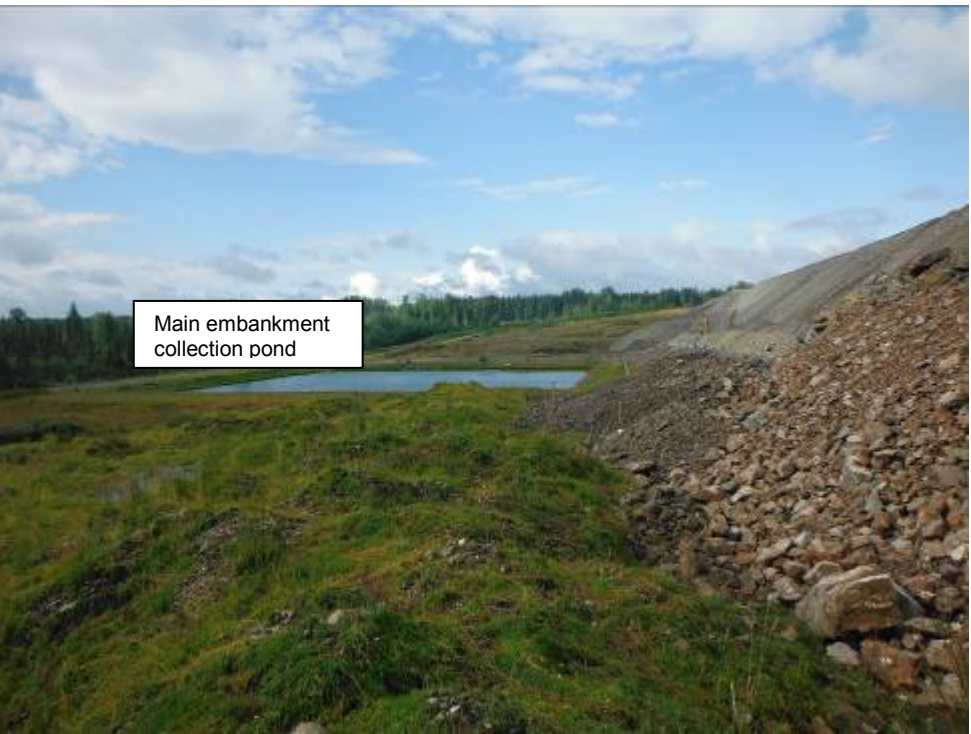
Photo 9: Main embankment downstream toe, looking south at Main embankment collection pond.

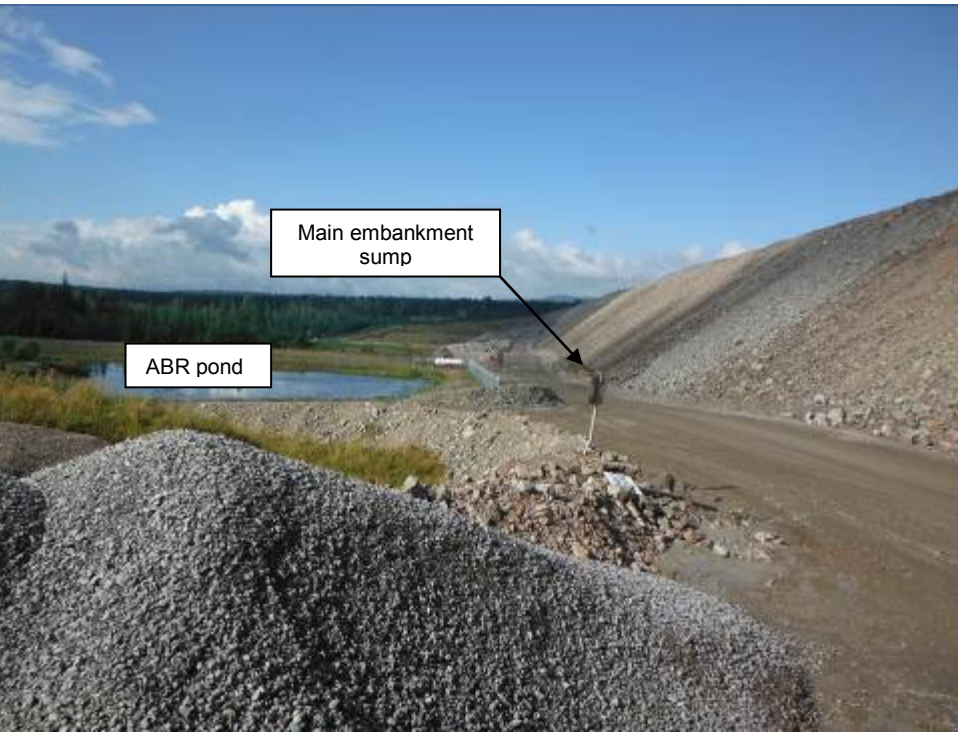
Photo 10: Main embankment downstream toe, looking north at ABR pond and Main embankment sump.

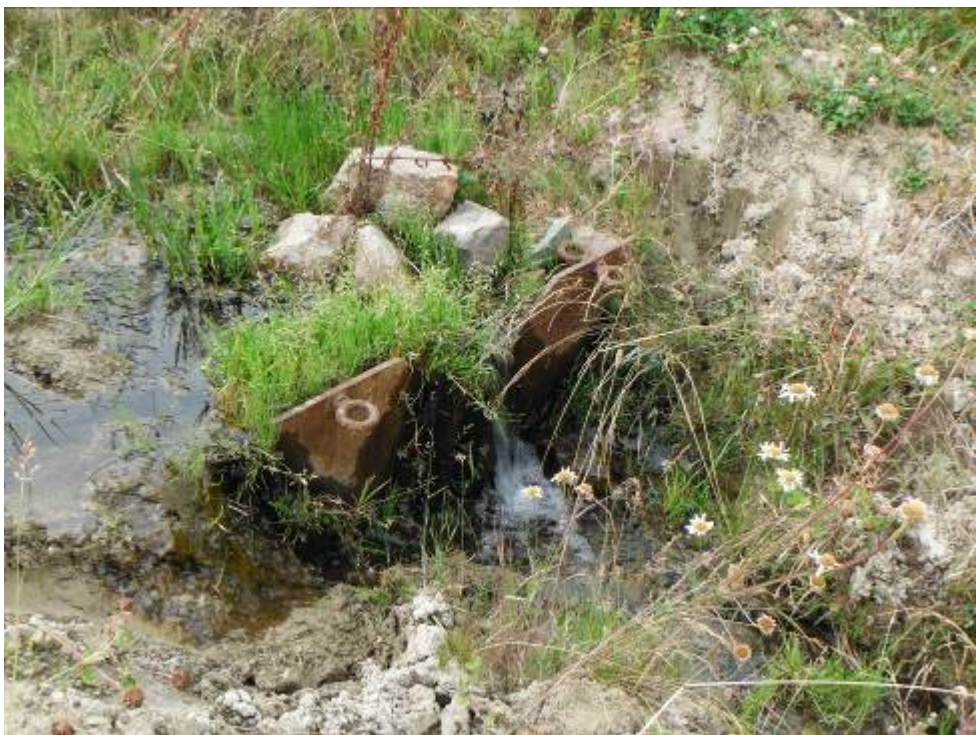
Photo 12: Corner 3 seep flow, evidence of previous monitoring

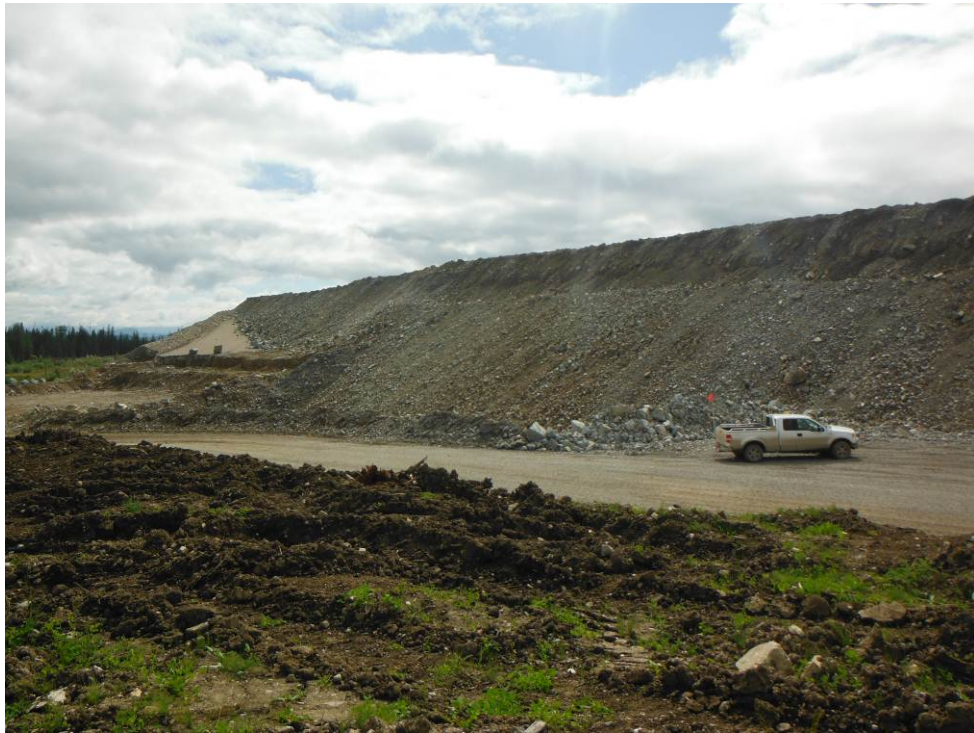
Photo 12: Perimeter embankment new access at Corner 1, looking northeast.

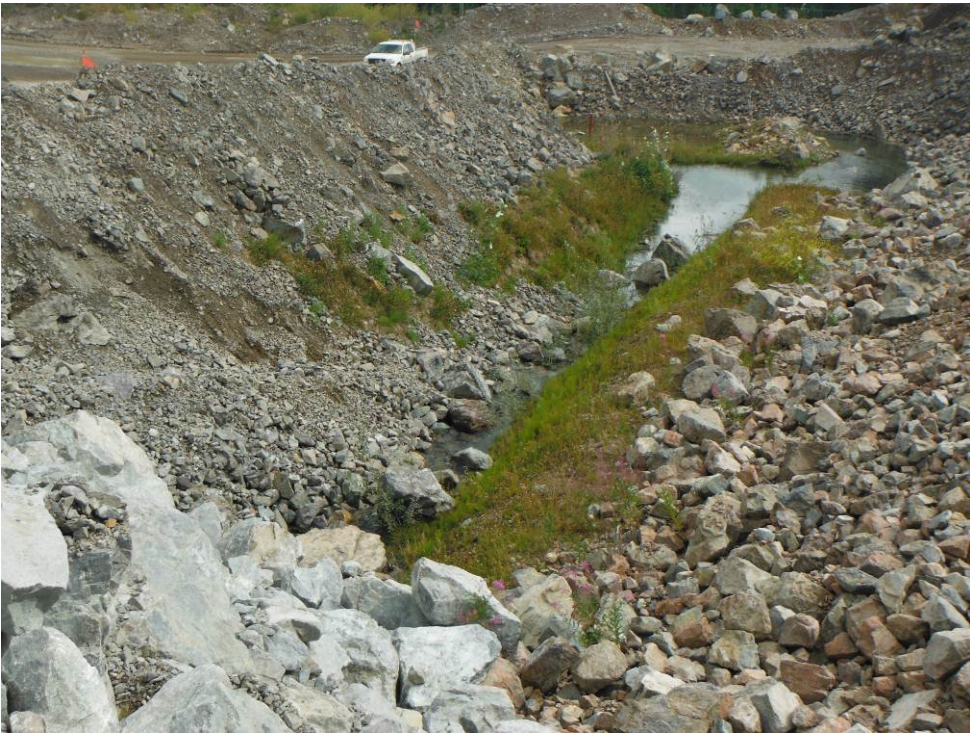
Photo 13: Perimeter drain discharge as impacted by haul road connection.

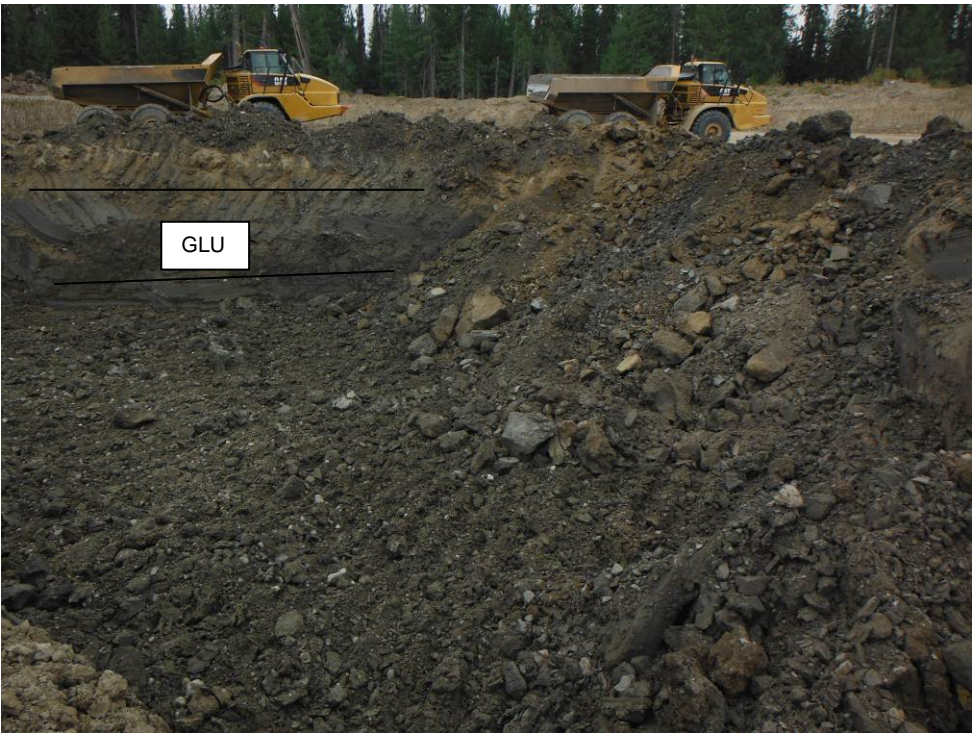
Photo 19: Glaciolacustrine unit (GLU) encountered in Perimeter borrow pit.

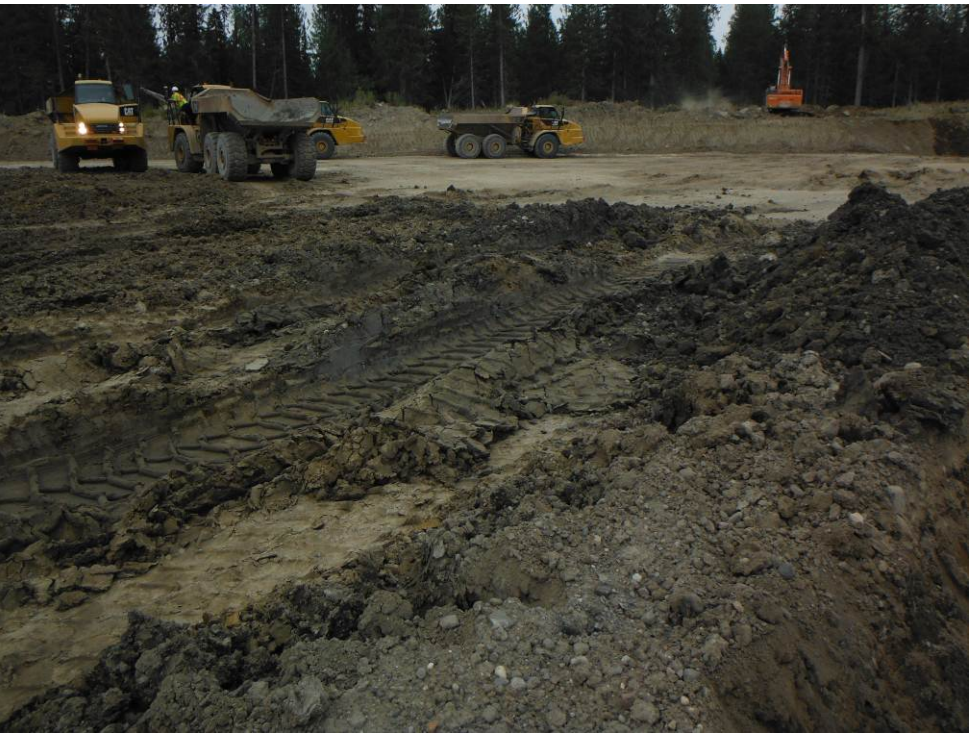
Photo 20: 'Punchy' GLU material, unsuitable for use as Zone S core.
