# **Independent Expert Engineering Investigation and Review Panel**

## **Report on Mount Polley Tailings Storage Facility Breach**

#### **Attachment D6: Panel Boreholes and Sampling**

# Panel Borehole Logs

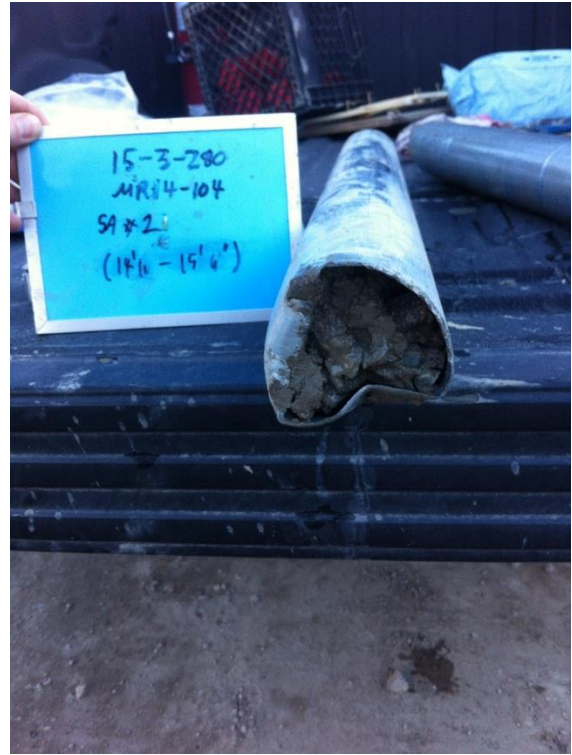
MR14-104 SAMPLE #2

**SEVERE DAMAGE –  
SAMPLE BAG REQUIRED**

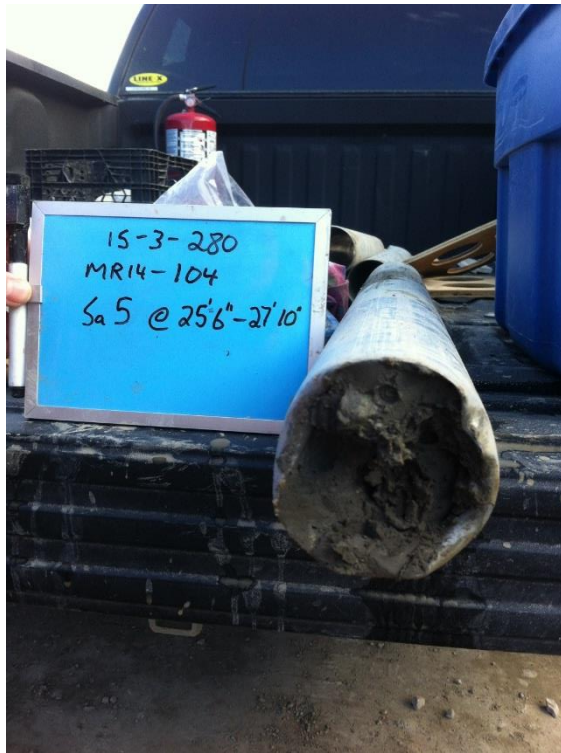
MR14-104 SAMPLE #5

## SEVERE DAMAGE – SAMPLE BAG REQUIRED

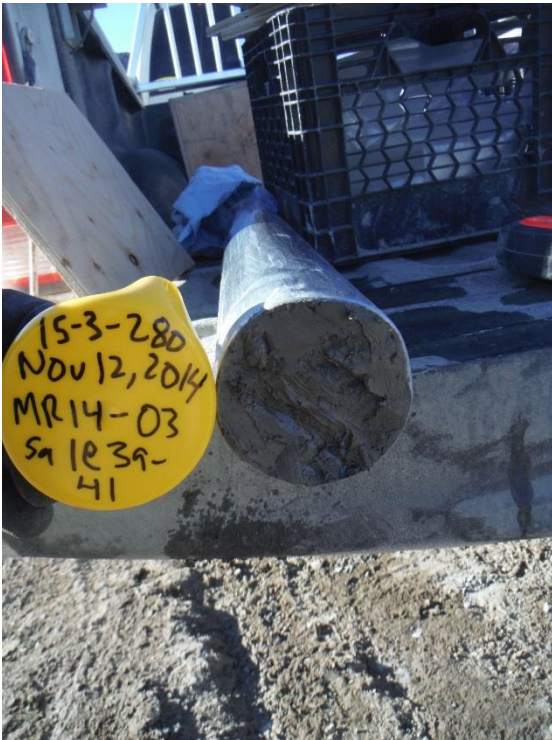
**RH14-117 SAMPLE #1 – FIELD LABEL INCORRECT**

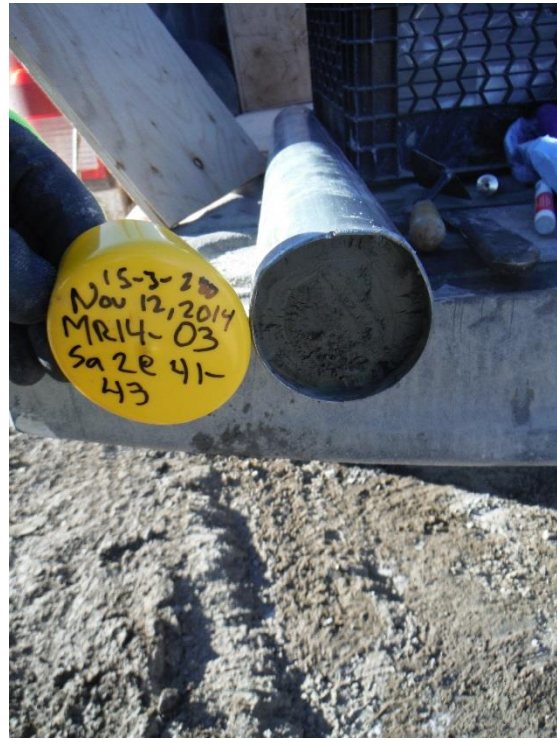
**RH14-117 SAMPLE #2 – FIELD LABEL INCORRECT**

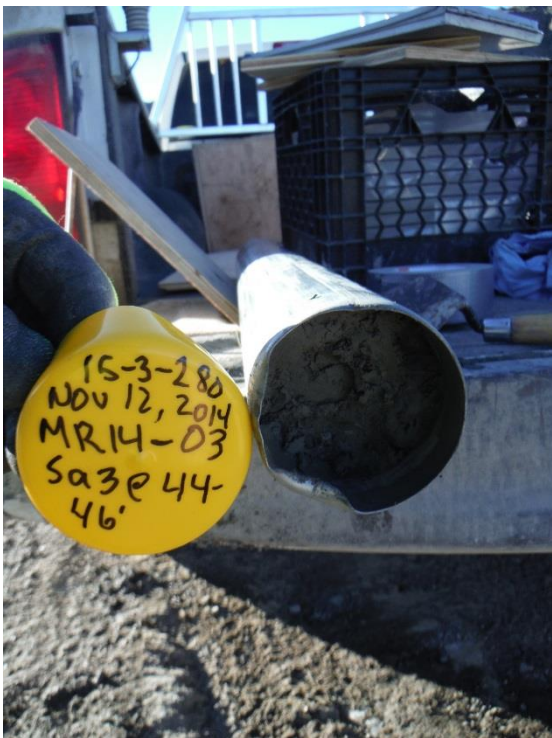
**RH14-117 SAMPLE #3 – FIELD LABEL INCORRECT**

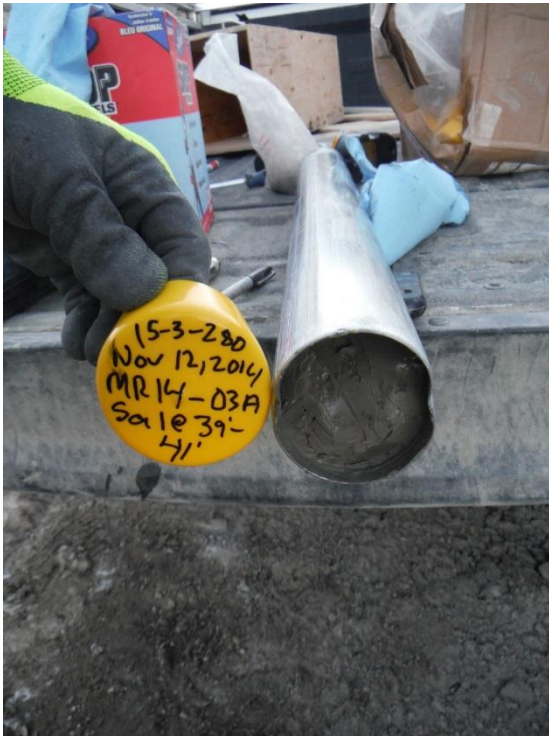
**RH14-117A SAMPLE #1 – FIELD LABEL  
INCORRECT**

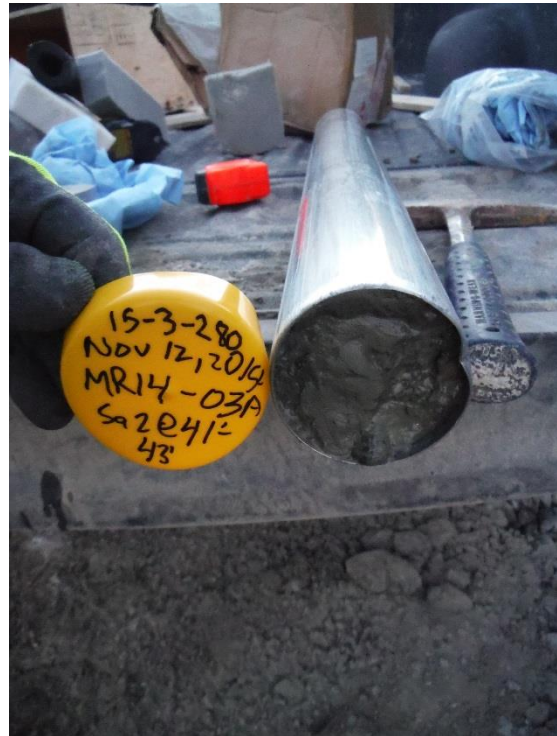
**RH14-117A SAMPLE #2 – FIELD LABEL  
INCORRECT**

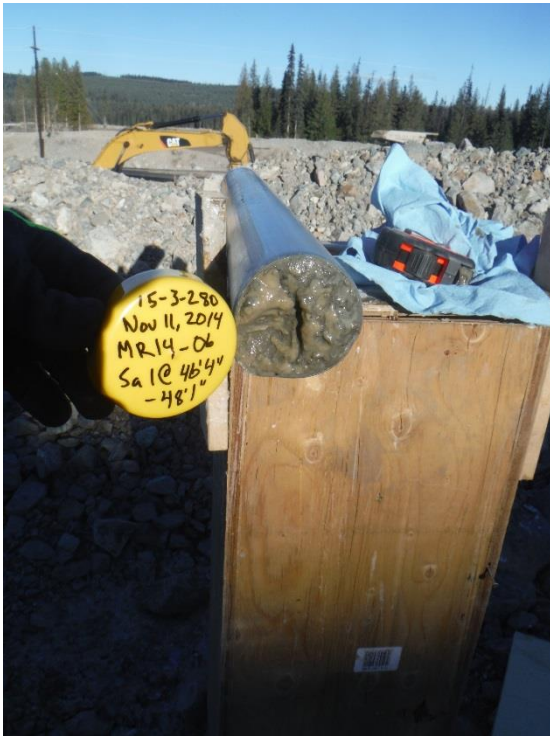
RH14-118 SAMPLE #1 – FIELD LABEL INCORRECT

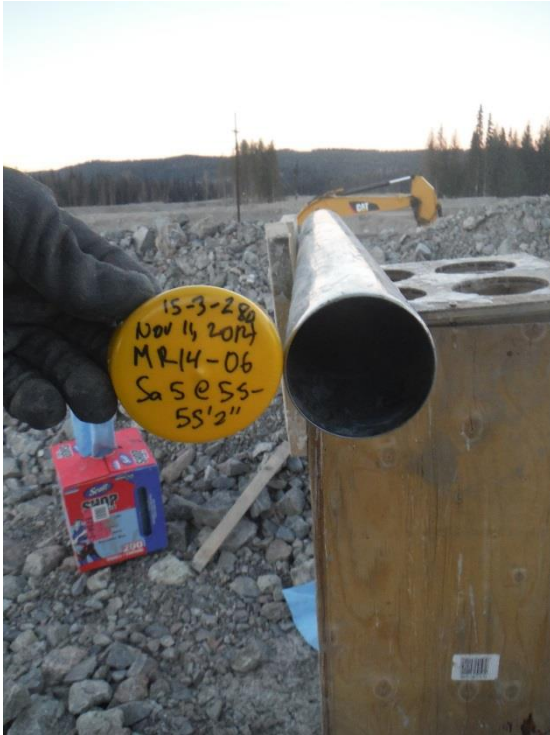
**RH14-118 SAMPLE #5 – FIELD LABEL INCORRECT**
